Inside the Soladin 600

Property of :		
Project : Soladin 600	Rev : 1	Sub 0
Subname : PC-Interface		
Date :30-Sep-2006		
Hardware Engineer :		
CAD Engineer :		
Company :		
Address :		
City :		
State : Nederland		
Initial date Aug 2006	Page : 1	of : 1

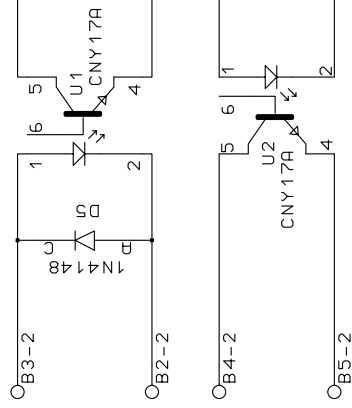
To Processor PIC18F252
inside the Soladin 600

Connector to interface
