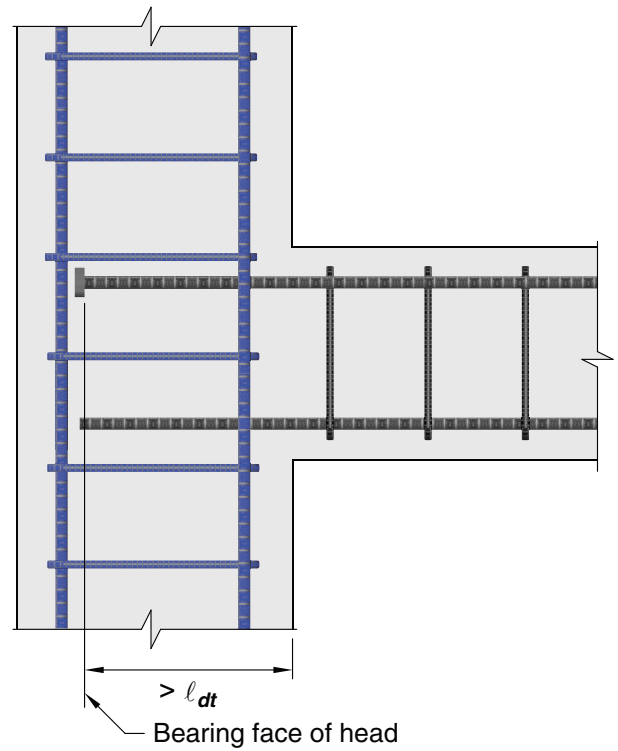
Fig. R25.4.4.2b—Headed deformed bar extended to far side of column core with anchorage length that exceeds l_{dt} .

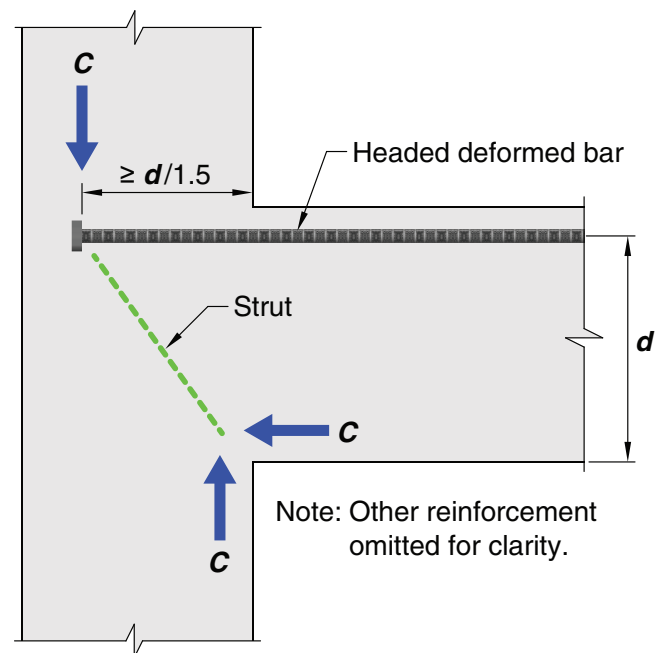
Fig. R25.4.4.2c—Breakout failure precluded in joint by keeping anchorage length greater than or equal to $d/1.5$.
