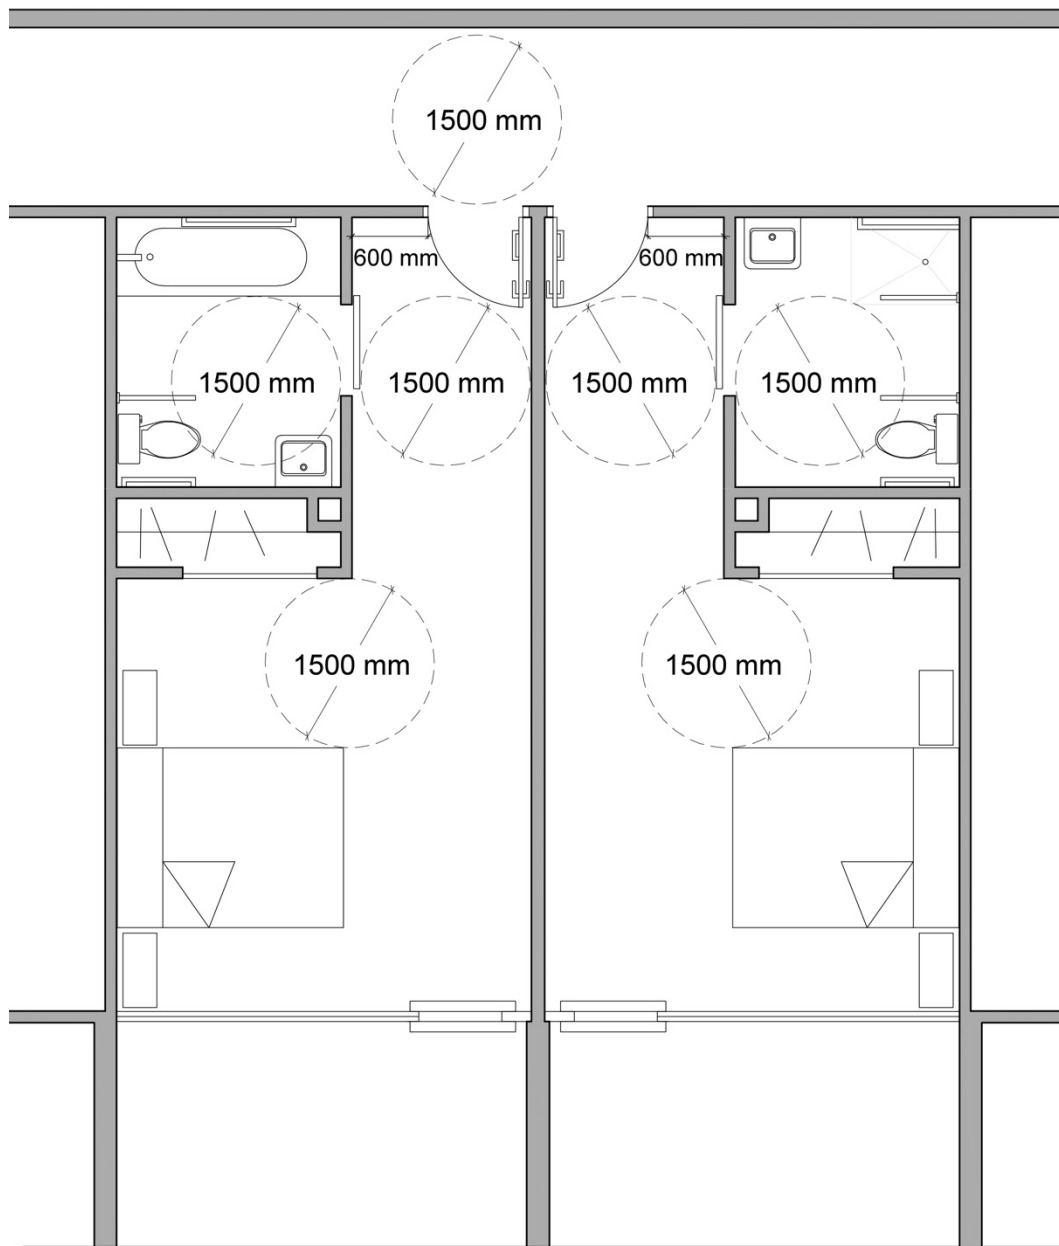
Figure 105. Example of two accessible rooms, one with roll-in shower and the other with accessible bathtub
