*Prospect Island Restoration Project*  
**daily averaged flow rate (GODIN filter)**

Project No. 11-1031

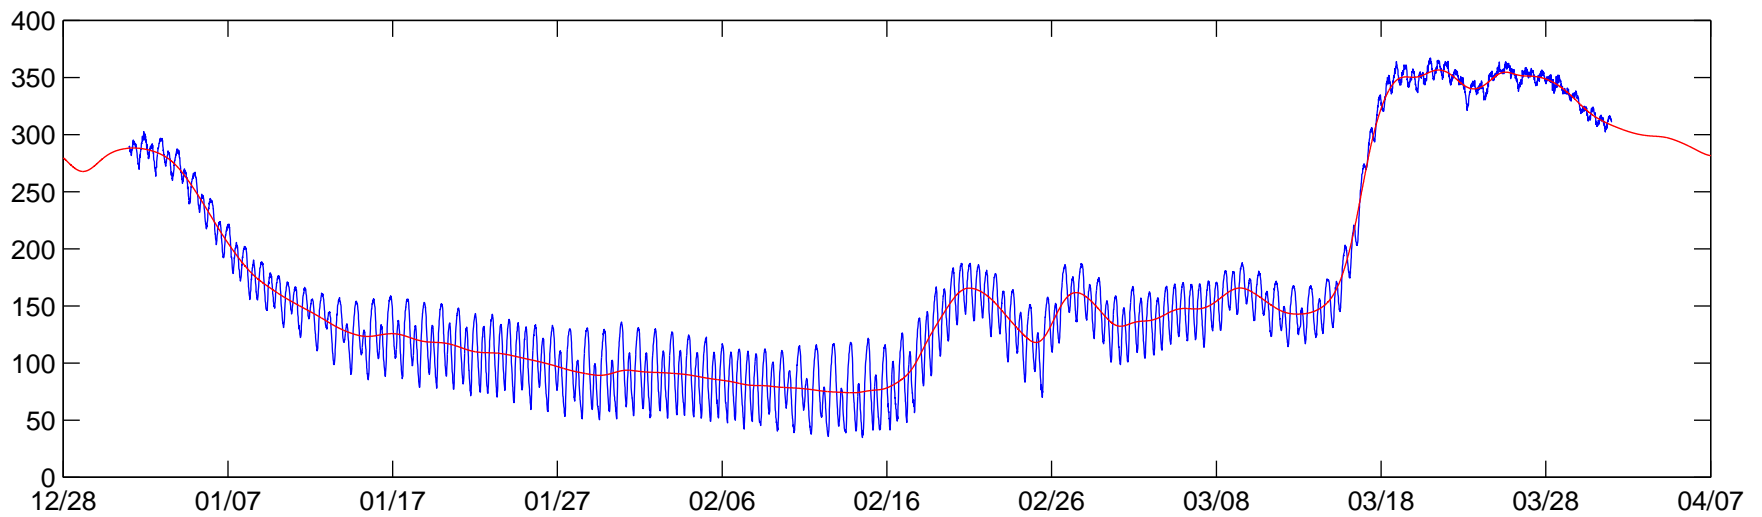
**Figure A-23**

Notes: Miner Slough at HWY 84 Bridge (cms)
