HOLMFIRTH CONSERVATION GROUP - GUIDANCE FOR COMPLETION OF BUILDINGS SURVEY FORM

HOLMFIRTH CONSERVATION GROUP **GUIDANCE FOR COMPLETION OF** **BUILDINGS SURVEY FORM** **(Amended 13 June 2016)**

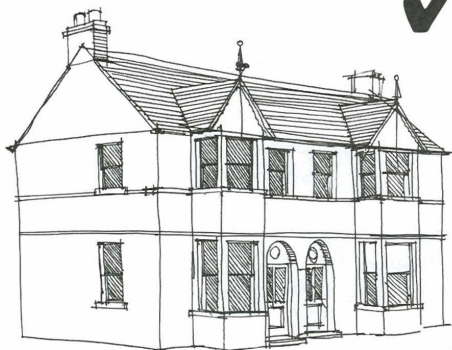
Victorian Semi-detached House:

Ornate character and original detail retained.
Unspoilt roof-line without dormer
Traditional rooflight possibly to rear pitch.

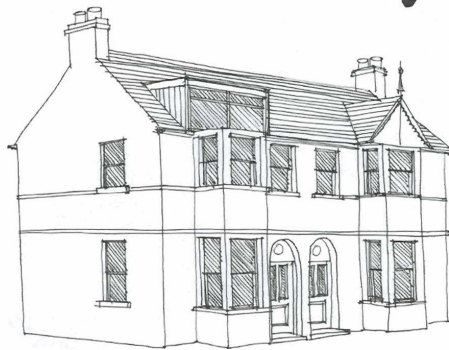
Victorian Semi-detached House:

Flat roof dormers to front and rear
Dormer windows large and dominating
Dormers spoil symmetry of dwellings

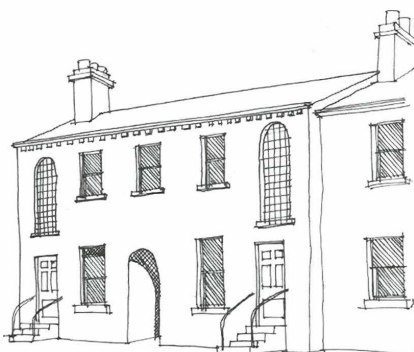
Georgian Terrace House:

Elegant character and original detail retained.
Unspoilt roofline without dormer.
Traditional rooflight possibly to rear pitch.

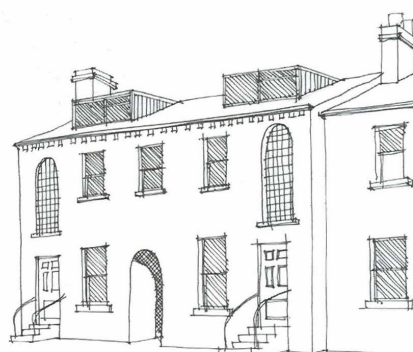
Georgian Terrace House:

Large flat roof dormers spoil roof line.
Dormer windows large and dominating.
Dormers out of character.

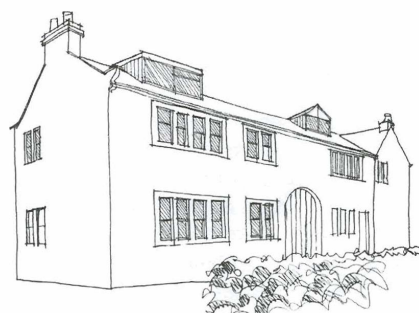
West Yorkshire Vernacular Dwelling:

Picture window dormer obtrusive and detracting from local character.

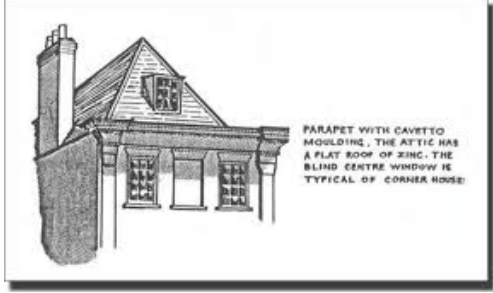
Parapet wall	Low ,usually enclosing a roof or a protective barrier at the edge of a terrace or on the side of a bridge

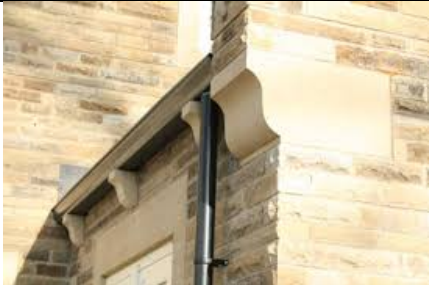
Corbels Bracket	In architecture a corbel or console is a structural piece of stone, wood or metal jutting from a wall to carry a superincumbent weight, a type of bracket . A corbel is a solid piece of material in the wall, whereas a console is a piece applied to the structure.

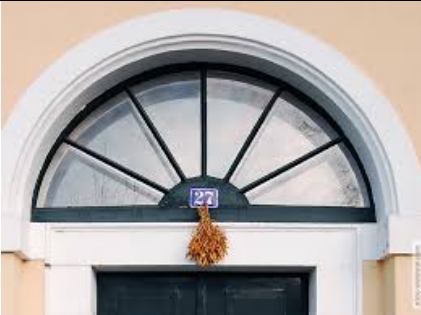
Fanlight	A fanlight is a window, semicircular or semi-elliptical in shape, with glazing bars or tracery sets radiating out like an open fan. It is placed over another window or a doorway, and is sometimes hinged to a transom

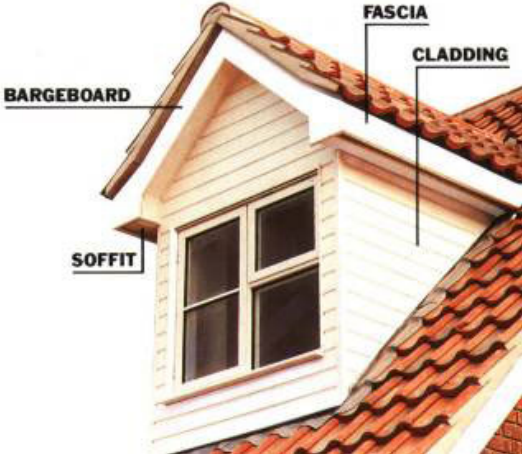
Fascia	Fascia is an architectural term for a vertical frieze or band under a roof edge, or which forms the outer surface of a cornice, visible to an observer.

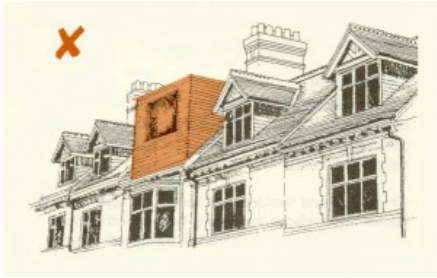
Dormer	A window that projects vertically from a sloping roof.

<div data-bbox="895 1267 1401 1335" style="border: 1px solid black; padding: 5px;"> <p>Inappropriate style of dormer extension surrounded by more appropriate dormers.</p> </div>
