## Hurricane Ian

Released: November 16, 2022

NHERI DesignSafe Project ID: PRJ-3709

### PRELIMINARY VIRTUAL RECONNAISSANCE REPORT (PVRR)

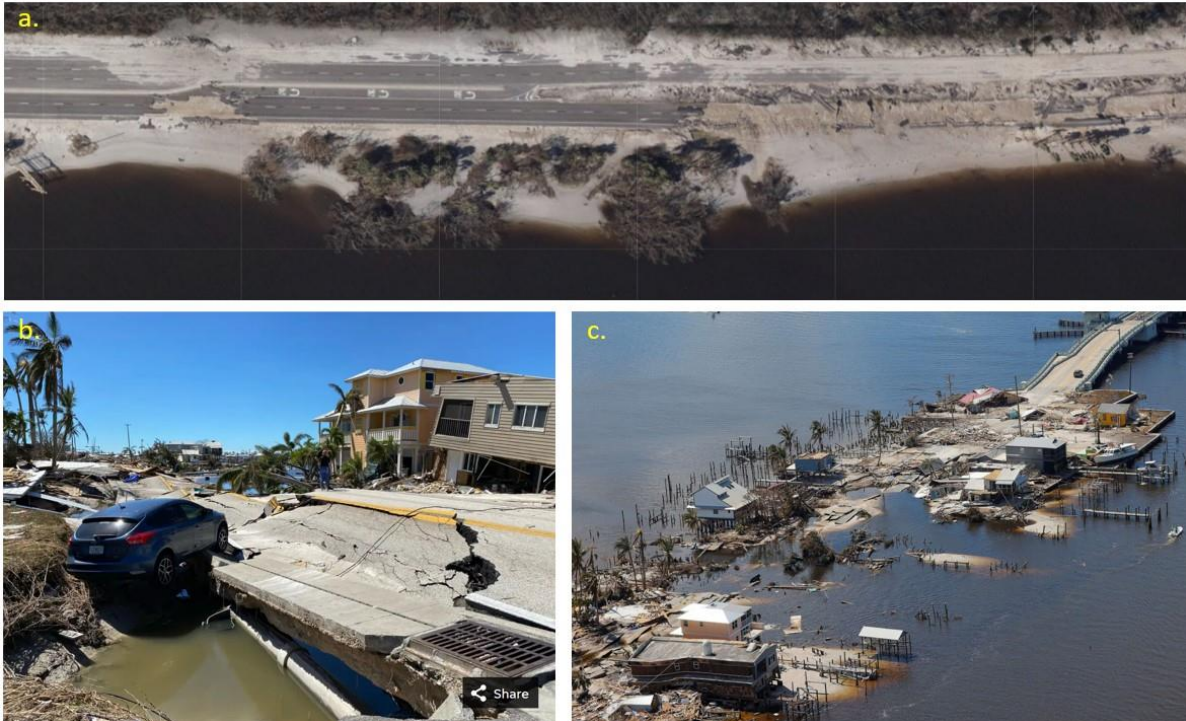
**Figure 5.3.** Observed damage coastal roadways, including (a) the McGregor Blvd in Fort Myers (source: NOAA Hurricane Ian Imagery), and (b), (c) the Pine Island Rd (Source: ABC news (2022) and Levy (2022) respectively).

Figure 5.2 summarizes the progression of road closures during the landfall of Hurricane Ian, initiating with coastal roadways and causeways in Lee County inundated by storm surge, which in several cases caused structural damage. This includes all the bridges to Pine Island (Gallman, 2022), the roadway connecting Captiva and Sanibel Islands, the Sanibel Causeway connecting Sanibel Island to Fort Myers (Levy, 2022), the Big Hickory Bridge, and Little Hickory Bridge (fl511.com). Damage was also observed to coastal highways in Fort Myers, with the most characteristic case being McGregor Blvd. The most common pattern of failure was the severe coastal erosion near the causeways and roads that led to scour and partial damage (e.g., differential settlements) or washout of pavements and causeways, and the damage to approach slabs, as shown in Figure 5.3.

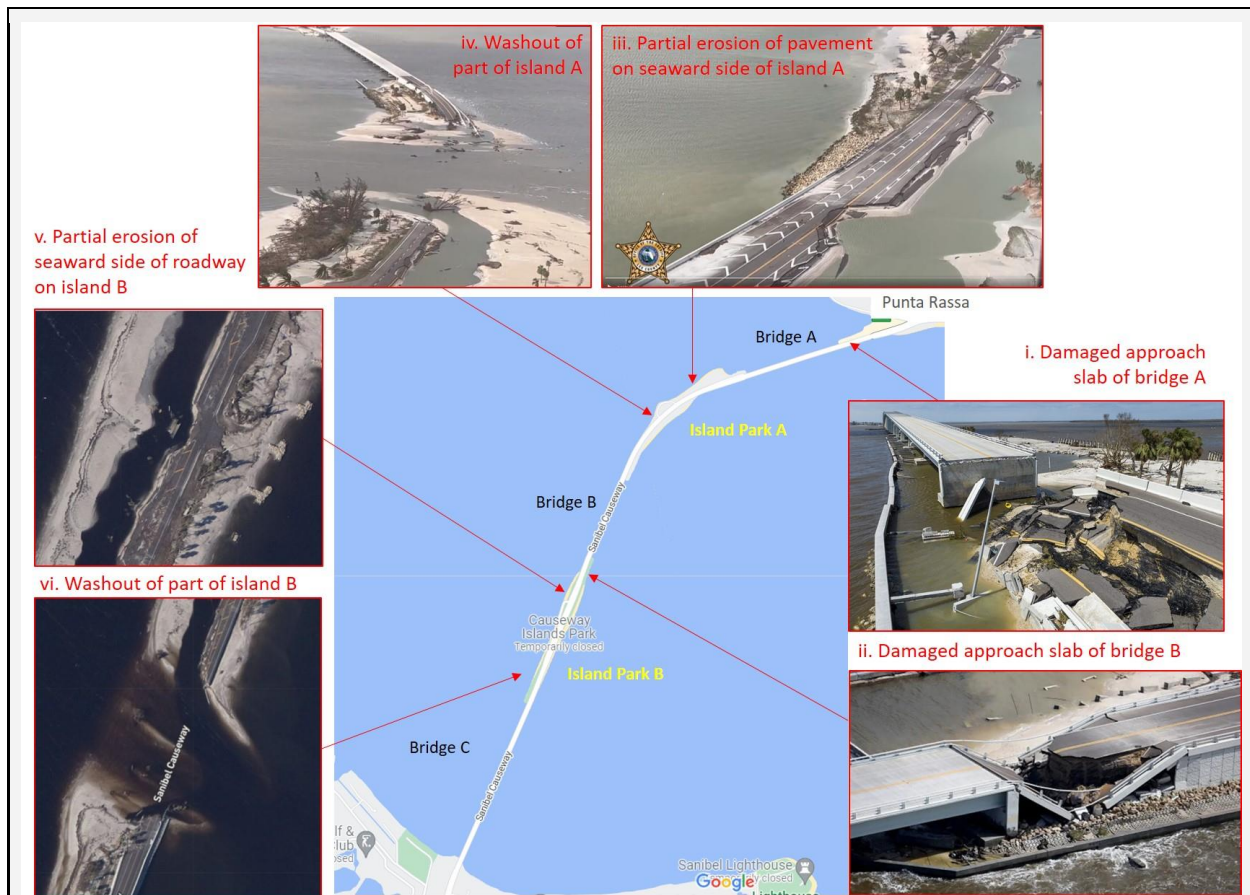
A notable case is the failure of the Sanibel Causeway, experiencing three different types of damage at different locations (see Fig. CS.5.3). The Sanibel Causeway consists of three bridges (A, B, C) and two islands (Causeway Island Park A, B) as shown in Fig. CS.5.3. Interestingly, in contrast to past hurricanes (e.g. Hurricane Katrina) that had uplifted bridge superstructures in multiple locations of the Gulf Coast Region, in this case the superstructures and their connections to the substructure (piers) were intact and the damage occurred at the approach slab of both Bridge A (on the mainland side) and Bridge B (on the south side). In both cases the approach slab was elevated (same elevation with the bridge span) and was supported on backfill material that was protected by wing-walls consisting of modular panels restrained by soil anchors embedded in the compacted fill. These panels were exposed to lateral loads from the surge and the waves. Since there is no observed erosion of the area in the vicinity of the wing-walls, it could be hypothesized that the lateral hydrodynamic loads made some of the panels unstable, which exposed the backfill material to hydrodynamic actions and scour. Once the backfill material started undergoing scour, the vertical pressures that were applied by the backfill on the slab and helped keep the slab in place were reduced, essentially leading to a simply supported slab.

**Figure CS.5.3.** Observed damage to Sanibel Causeway, including damage to approach slabs of bridge A (Source: Lasey (2022) and B (Source: Brackett and Wesner Childs, 2022), erosion and washout of island A (Source: Lee County Sheriff's Office) and erosion of island B (Source: NOAA Hurricane Ian Imagery).

Two other types of damage were also observed in the Sanibel Causeway, particularly 'at the two islands. The first type was the partial damage of the pavements on the seaward side, which was caused by the erosion of the soil below the roads, and the second type was the total washout of the road with the island below it (see Fig. CS.5.3). Interestingly, for both island A and B, the first type of damage occurred towards the north side of the island and the second type (total washout) occurred towards the south end. As shown in Figure CS.5.4, for island A at the location where a total washout was observed, the road was very close to the shore, which means that it could be exposed to surge and direct impact from the waves. On the other hand, at the location with partial damage and scour of the pavement, the road was located further from the shore. This would consequently imply that while in the former case the road would be subjected to hydrodynamic effects (e.g., scour) immediately after the instant at which the surge and waves reached the elevation of the road, in the latter case the road would be subjected to the same effects only after the sandy beach (on the seaward side) would have been eroded. Apart from this hypothetical explanation, other potential reasons that could have contributed to the different levels of damage are (i) differences in road elevations, (ii) directionality effects which may be important in the case of skewed bridge superstructures subjected to extreme

waves (e.g., Istrati and Buckle, 2021), (iii) differences in bathymetry, or (iv) other reasons not evident at this point.

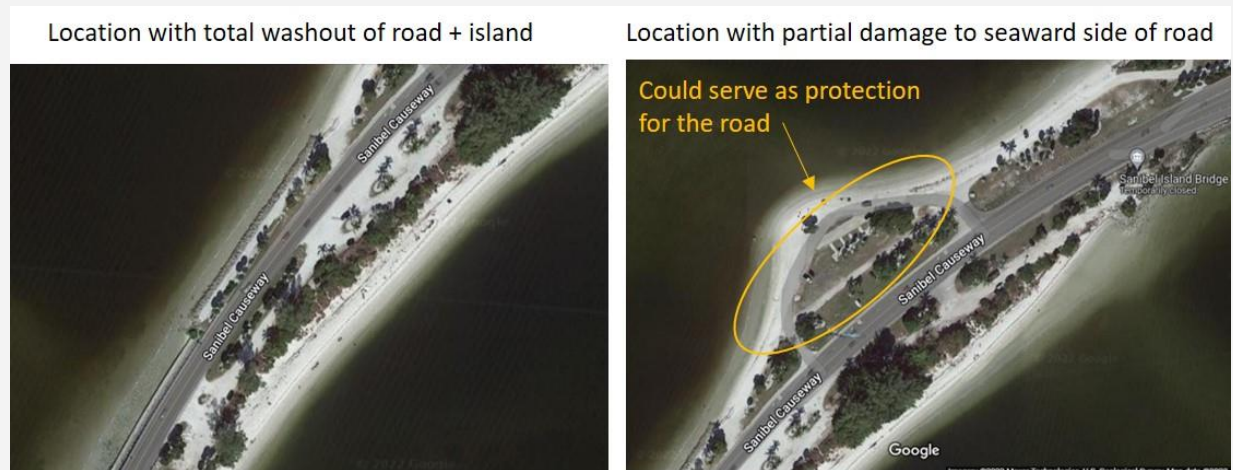
**Figure CS.5.4.** Selected locations of Causeway Island Park A before Hurricane Ian (modified from Google Maps).
