Verification and Validation Report: Mechatronics Engineering

Team # 34, ParkingLotHawk

March 9, 2023

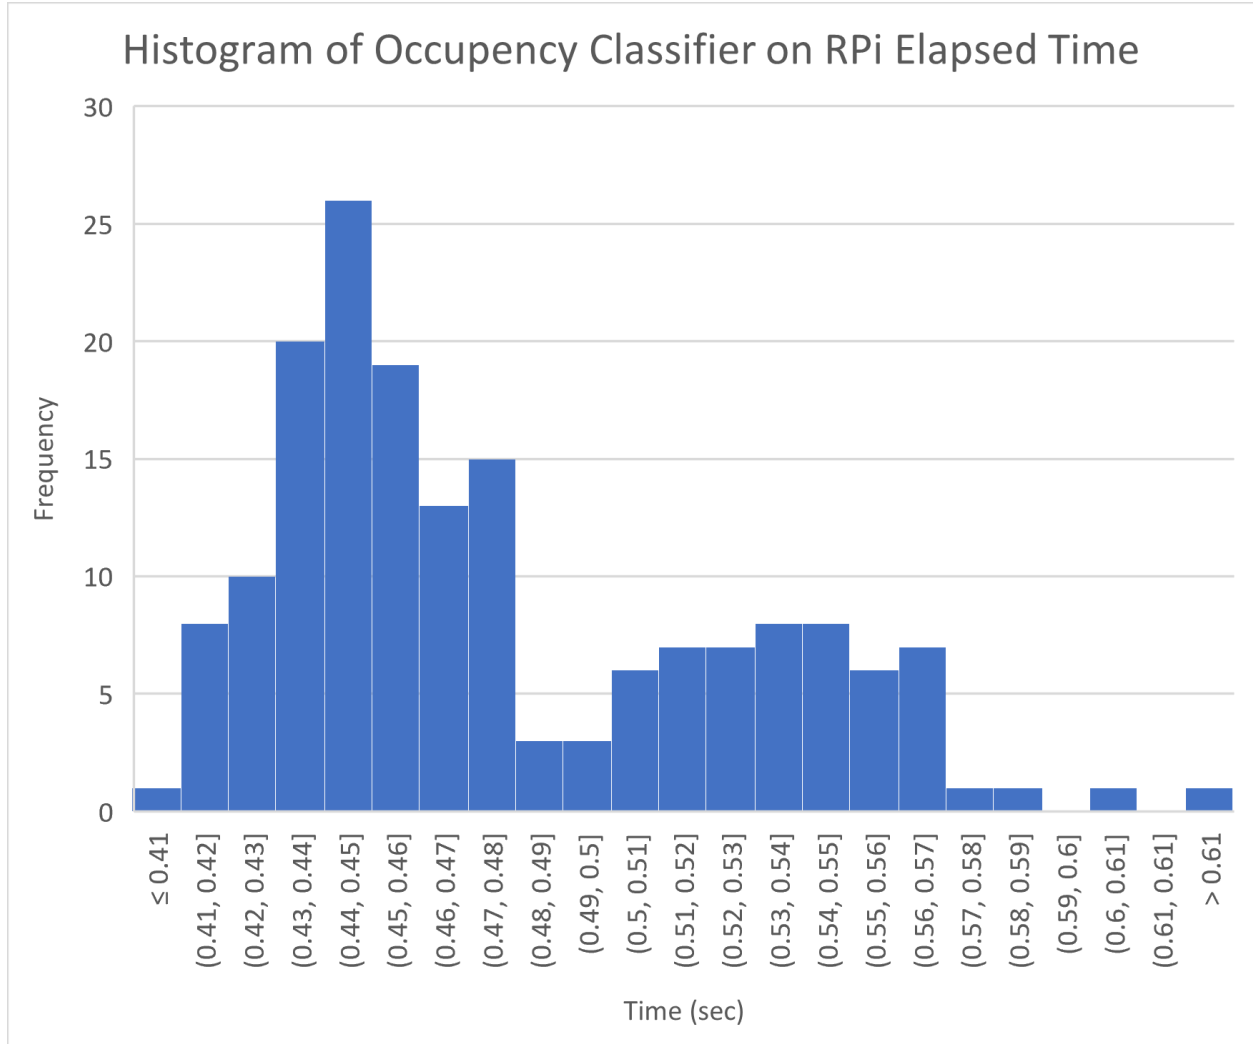
Figure 1: Occupancy Classifier Performance

Test Case Result ID	UTCR_011
Test Case Reference	UTC_011
Requirements Tested	GEN_005
Procedure	Curate a dataset of at least 50 images of varying weather, lighting, and height conditions (details in the full test case specification). Use the dataset to profile the performance of the algorithm (FPS) on the Raspberry Pi hardware. Also, use the dataset to estimate the classifier's accuracy.
Expected Result	The algorithm processes at least 0.5 frames per second on the Raspberry Pi Hardware. Given the simplicity of the classification task, an accuracy of 80% for assigning the center pixel correctly to either parking lot, nature, or occupied is required.
Actual Result	Among over 50 samples, the classifier takes on average 0.478 seconds with a standard deviation 0.048 sec, to process one frame. The maximum time to process a single frame was 0.68 sec. The histogram of time is shown in Figure 1 . The overall accuracy of the classifier was 51%. The classifier performed well on the nature classification task but performed poorly on classifying parking lots in sunny conditions. The classifier really struggled to correctly predict the center pixel as being occupied by some obstacle, scoring just 24%. Further analysis revealed that the obstacles were often confused with parking lots. Table 36 breaks down the results by object and weather type. Samples of the images tested are shown in Figure 2 .

Result Analysis	Fail. The classifier performs at a sufficient speed to satisfy the 0.5 FPS requirement. However, the accuracy of the classifier was well below the expected 80%, and is not fit for being used by the user.

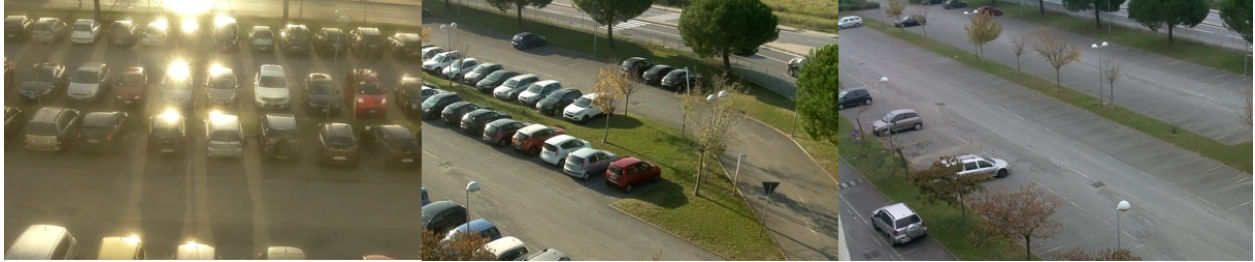
Figure 2: Sample Images for Sunny Occupied (Left), Sunny Nature (Middle), and Overcast Parking Lot (Right)

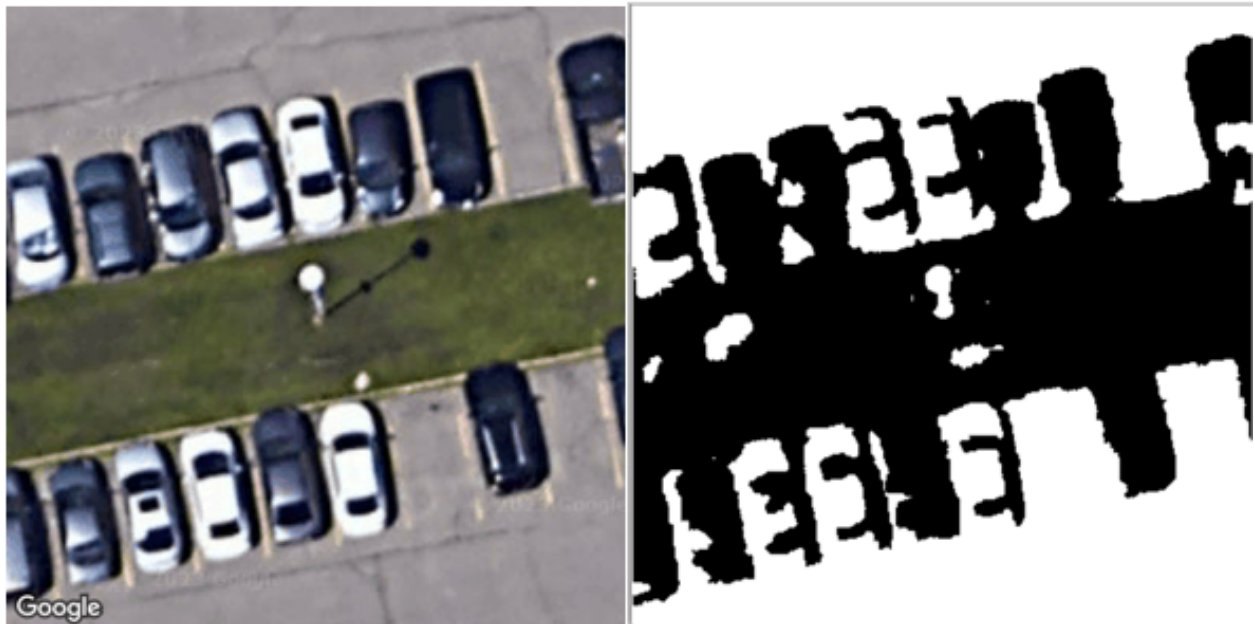
Figure 3: Segmentation Sample: Raw image on left, algorithm segmentation on right (white is parking lot, black is non-parking lot)

Test Case Result ID	UTCR_012
Test Case Reference	UTC_012
Requirements Tested	GEN_001
Procedure	Measure the accuracy of the segmentation algorithm on a satellite imagery dataset of 12.
Expected Result	The segmentation algorithm has an average accuracy of above 80%. Accuracy is calculated as pixels correctly classified divided by the total number of pixels.
Actual Result	The segmentation algorithm has an average accuracy of 73% with a standard deviation of 0.22. Individual results per image are shown in Figure 4.
Result Analysis	Fail, the algorithm is well below the 80% desired. From Figure 4, it can be seen that certain images have much poorer accuracy, such as image 3. The segmented result of image 3 is shown in Figure 5. The lower half of the image is covered by a shadow from the building, producing a much darker ground surface. This then causes the segmenter to misidentify the parking lot.

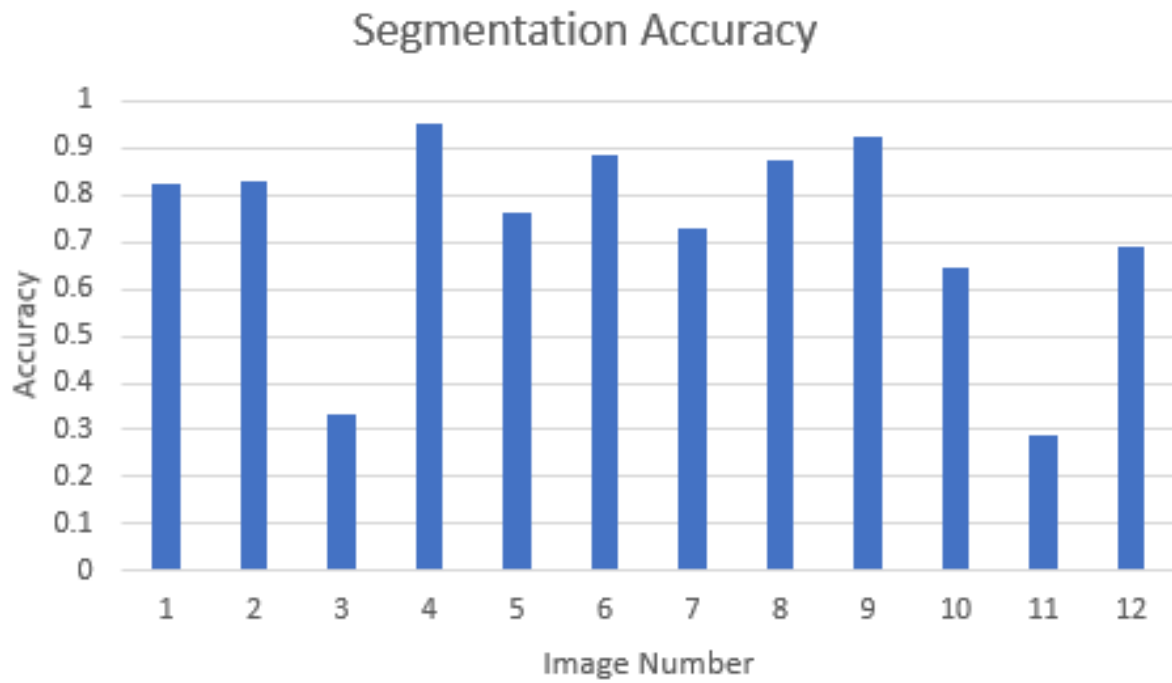
Figure 4: Segmentation Accuracy per Image

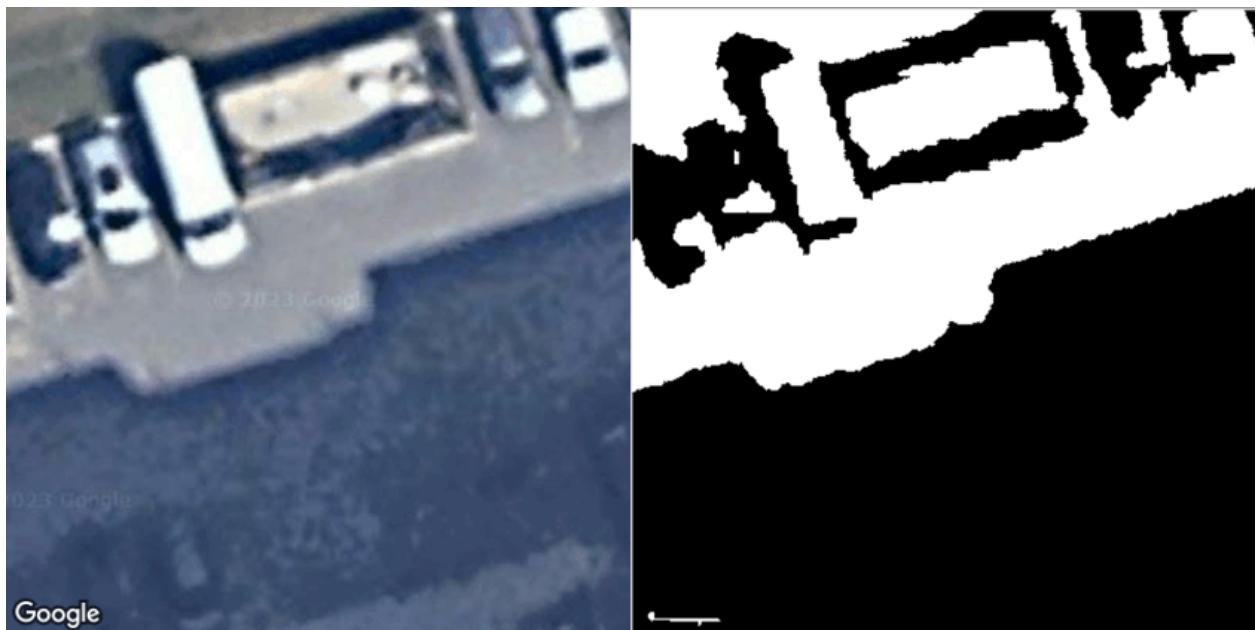
Figure 5: Segmentation Result of Image 3 due to Shadow
