Interior Epoxy Coating vs Bare Pipe: Comparative Analysis of Corrosion Mitigation Strategies in Water Pipelines¹

Abstract— This white paper presents a lifecycle cost analysis of two corrosion mitigation strategies for water pipeline systems: corrosion allowance through increased wall thickness and the application of interior epoxy coatings. The study evaluates the economic and operational performance of both approaches over a 25-year service life, considering capital expenditures (CAPEX), operational expenditures (OPEX).

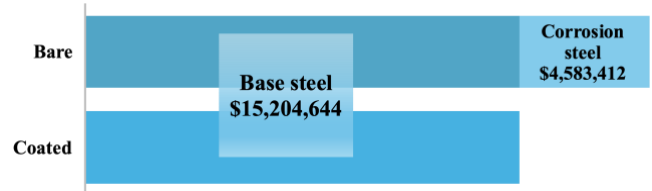
| Item | Bare | Coated | Corrosion Steel |
|---|---|---|---|
| Steel pipe cost | \$21,074,349 | \$15,204,644 | \$4,583,412 |

Extra corrosion steel represents 27.9% of the baseline steel material expenditure.

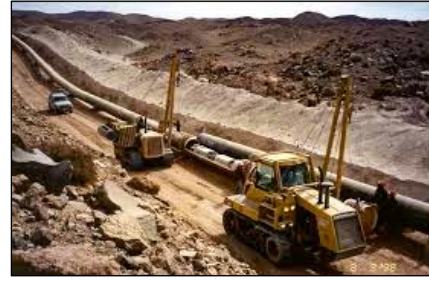
1998 Project, Minera Escondida Monturaqui, Atacama, Chile 18" – 42" Water Pipeline. 7,500 Field Joint Internally Coated with FBE

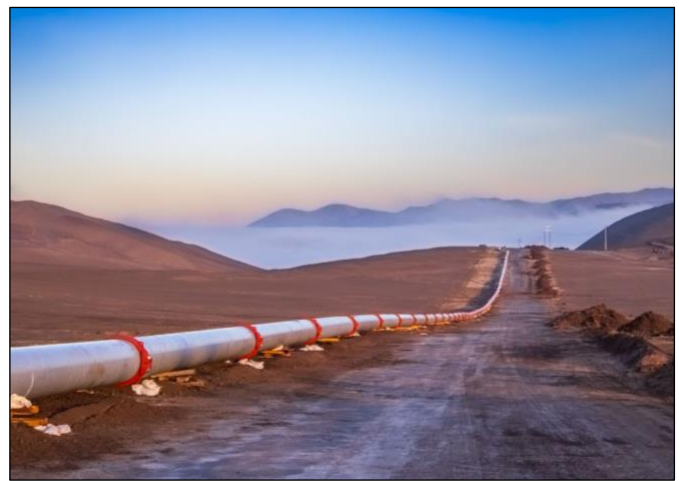
Photo 3. [SQM's TEA project](#), a 32-inch X70 seawater pipeline with interior epoxy-coating was joined using Victaulic's X07 couplings. The need for uncoated ends (cutbacks) and robotic field joint coating was eliminated.

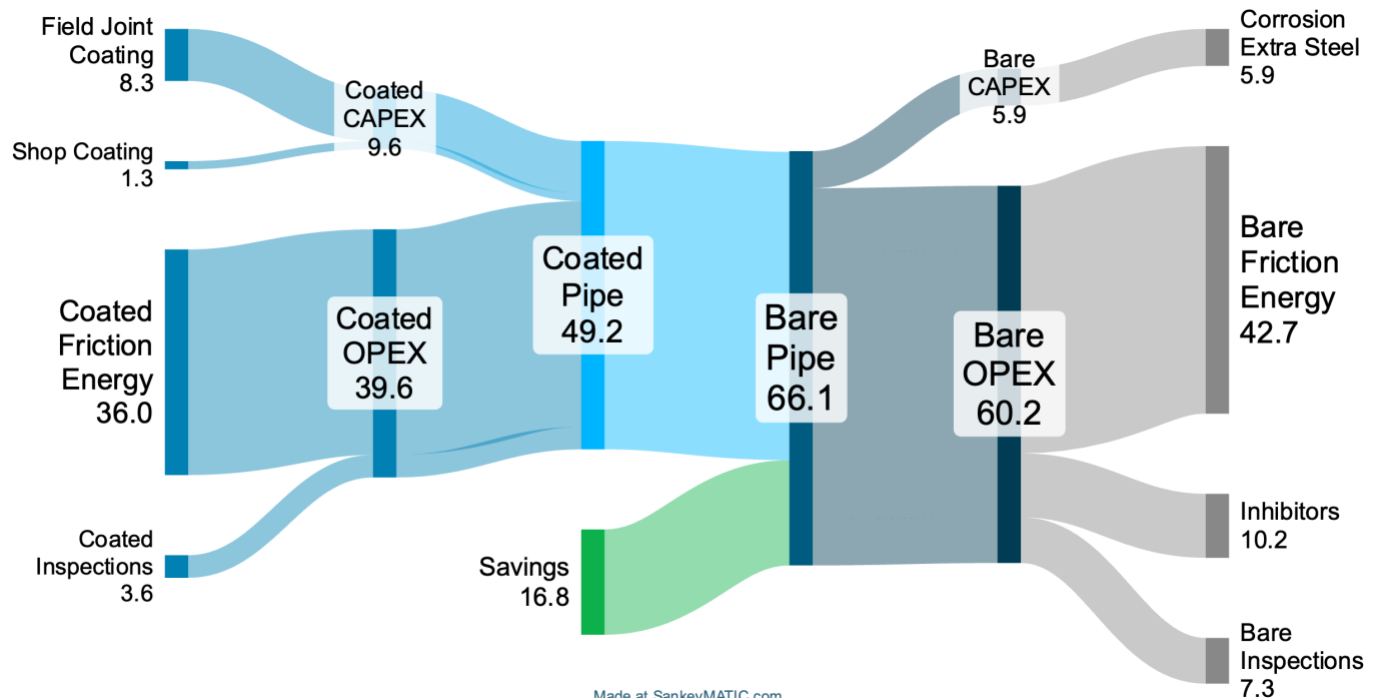
In summary, despite higher initial capital expenditures (CAPEX), internally epoxy-coated pipelines deliver a total lifecycle cost saving of **25.5%** compared to bare steel systems.

The break-even point occurs around year 14 when considering discounted cash flows, underscoring the economic viability and operational superiority of internally coated pipeline solutions.
