REAR COMBINATION LAMP ASSY OVERHAUL

6511F-01

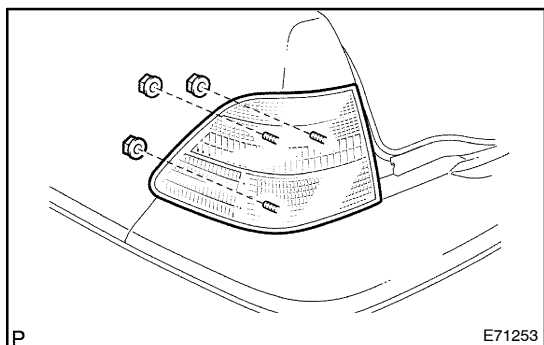
2. REMOVE REAR COMBINATION LAMP ASSY LH

- (a) Disconnect the connectors.
- (b) Remove the 3 nuts and the rear combination lamp assy LH.
