DTC	B1294	IMMOBOLIZER ECU COMMUNICATION STOP
------------	--------------	---

CIRCUIT DESCRIPTION

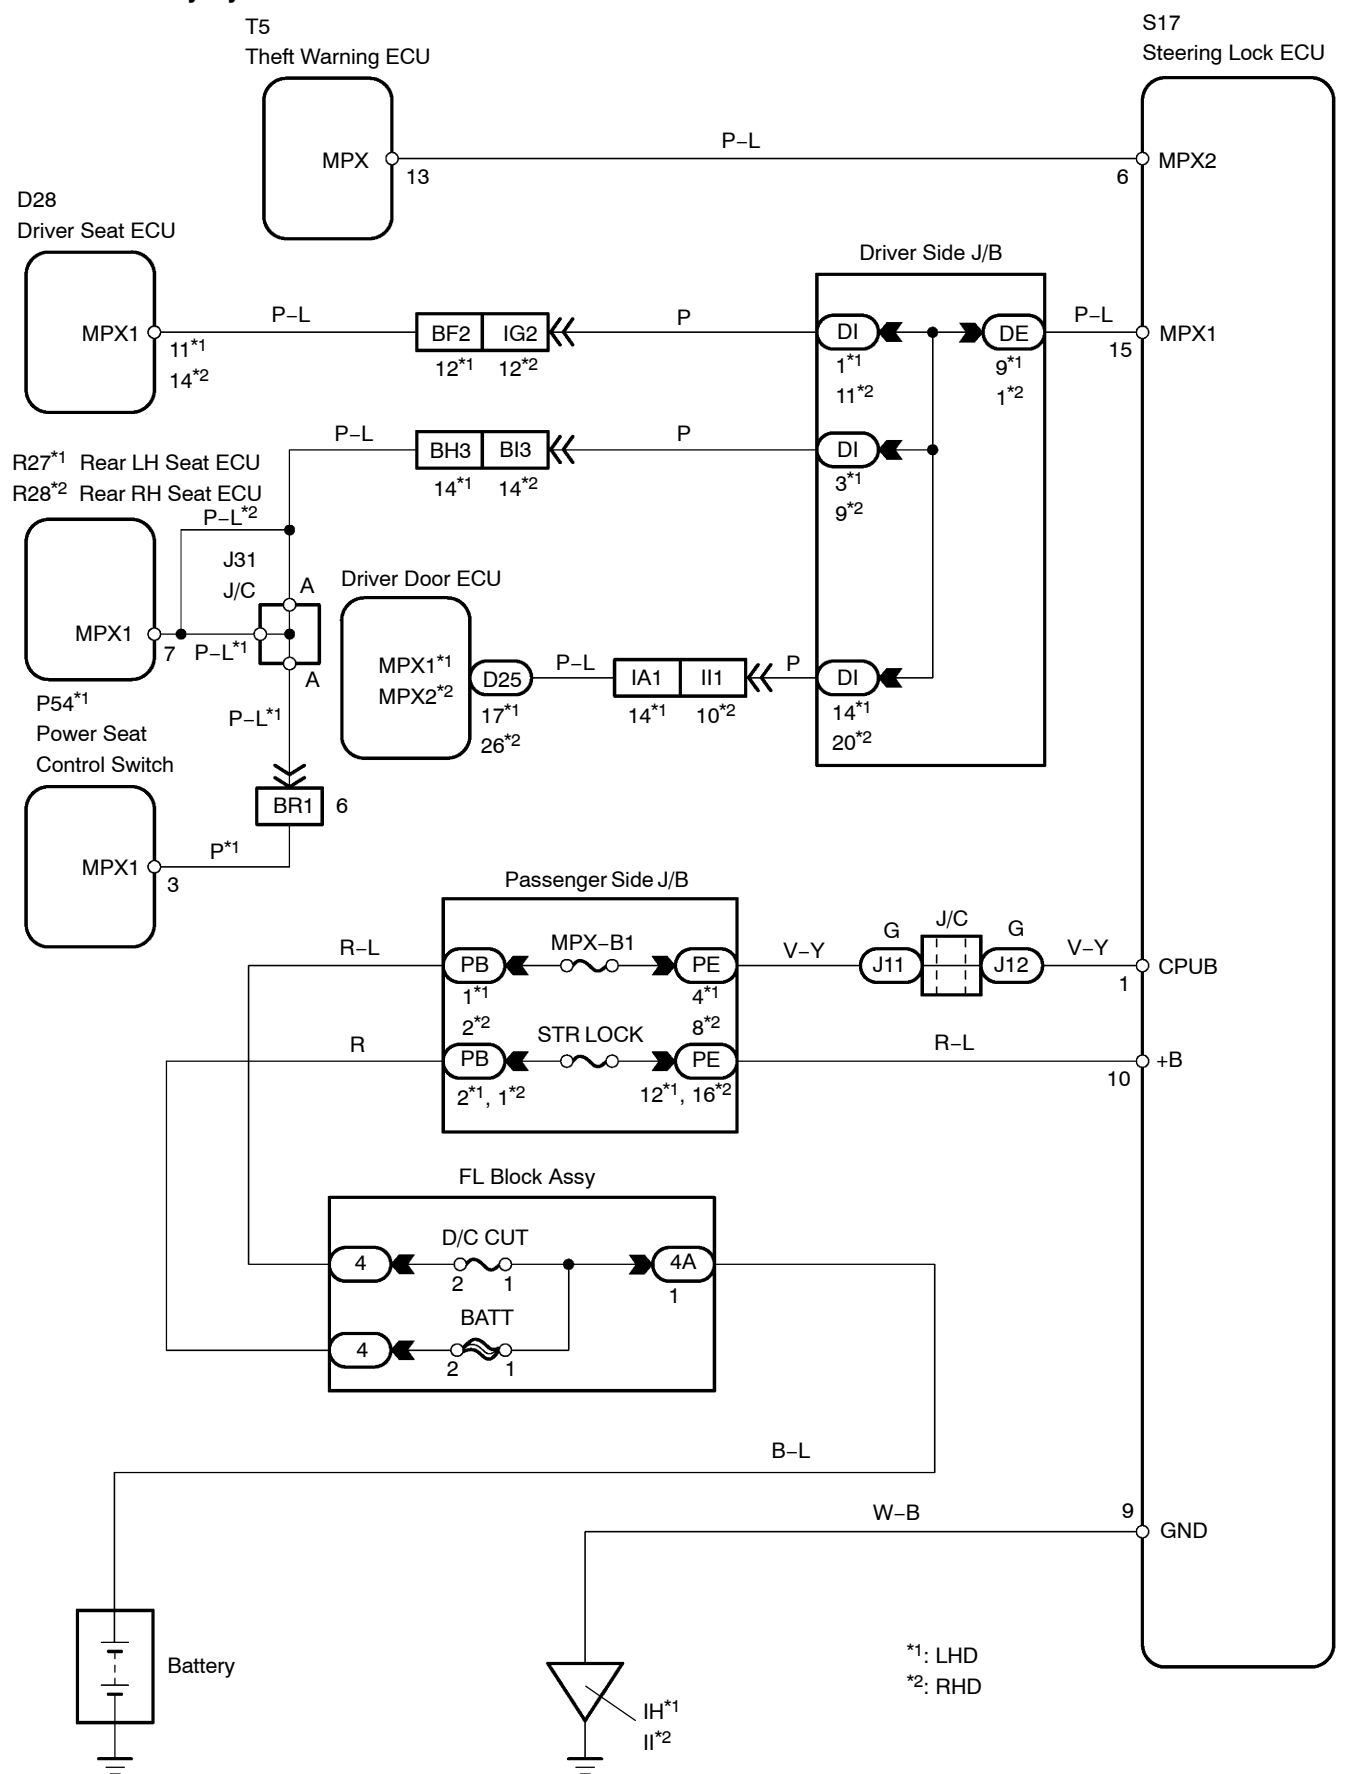
w/ Smart Key System

This DTC is detected when communication between the immobilizer ECU (steering lock ECU*¹ or transponder key ECU*²) and gateway ECU stops more than 10 seconds.

WIRING DIAGRAM

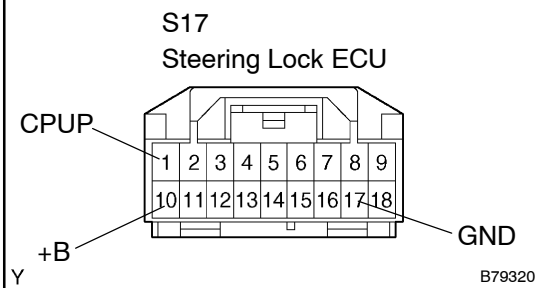
Wire Harness Side

2 CHECK WIRE HARNESS (STEERING LOCK ECU - BODY GROUND)

- (a) Disconnect the S17 ECU connector.
- (b) Measure the voltage and resistance between the wire harness side connector and body ground.

Tester Connection	Specified Condition
S17-1 (CPUB) - Body ground	10 to 14 V
S17-10 (+B) - Body ground	10 to 14 V
S17-9 (GND) - Body ground	Below 1 Ω

REPAIR OR REPLACE HARNESS AND CONNECTOR

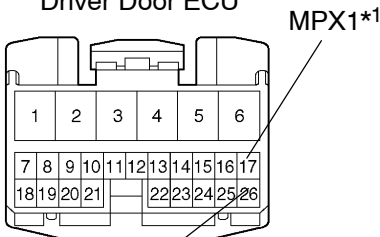
Wire Harness Side

3 CHECK RESISTANCE OF COMMUNICATION LINE

S17
Steering Lock ECU

T5
Theft Warning ECU

D25
Driver Door ECU

- (a) Disconnect the S17 ECU connector.
- (b) Disconnect the T5 ECU connector.
- (c) Disconnect the D25 ECU connector.
- (d) Measure the resistance between the wire harness side connectors.

Tester Connection	Specified Condition
S17-15 (MPX1) – D25-17 (MPX1)	Below 1 Ω
S17-6 (MPX2) – T5-13 (MPX)	Below 1 Ω

Tester Connection	Specified Condition
S17-15 (MPX1) – D25-26 (MPX1)	Below 1 Ω
S17-6 (MPX2) – T5-13 (MPX)	Below 1 Ω

Result	Proceed to
Both are OK	A
One is OK	B
Both are NG	C

REPLACE STEERING LOCK ECU AND
REPAIR OR REPLACE HARNESS AND
CONNECTOR

REPAIR OR REPLACE HARNESS AND
CONNECTOR

REPLACE STEERING LOCK ECU

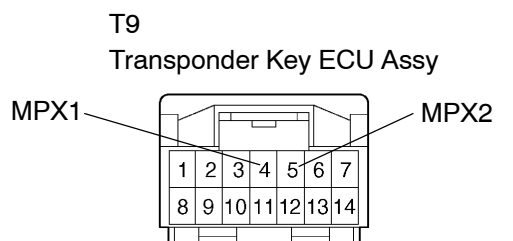
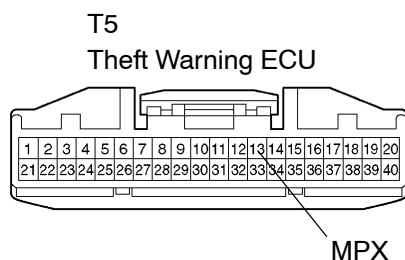
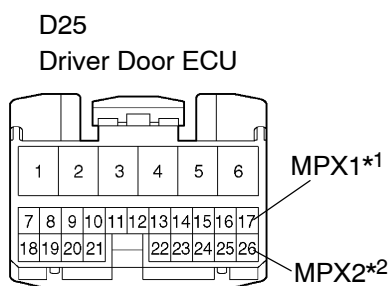
Wire Harness Side

3 CHECK RESISTANCE OF COMMUNICATION LINE

- Disconnect the T9 ECU connector.
- Disconnect the T5 ECU connector.
- Disconnect the D25 ECU connector.
- Measure the resistance between the wire harness side connectors.

Tester Connection	Specified Condition
T9-4 (MPX1) - D25-17 (MPX1)	Below 1 Ω
T9-5 (MPX2) - T5-13 (MPX)	Below 1 Ω

Tester Connection	Specified Condition
T9-4 (MPX1) - D25-26 (MPX2)	Below 1 Ω
T9-5 (MPX2) - T5-13 (MPX)	Below 1 Ω

Result	Proceed to
Both are OK	A
One is OK	B
Both are NG	C

REPLACE TRANSPONDER KEY ECU ASSY AND REPAIR OR REPLACE HARNESS AND CONNECTOR

REPAIR OR REPLACE HARNESS AND CONNECTOR

REPLACE TRANSPONDER KEY ECU ASSY
