DTC	B1865	SHORT IN KNEE AIRBAG (P SIDE) SQUIB CIRCUIT
------------	--------------	--

CIRCUIT DESCRIPTION

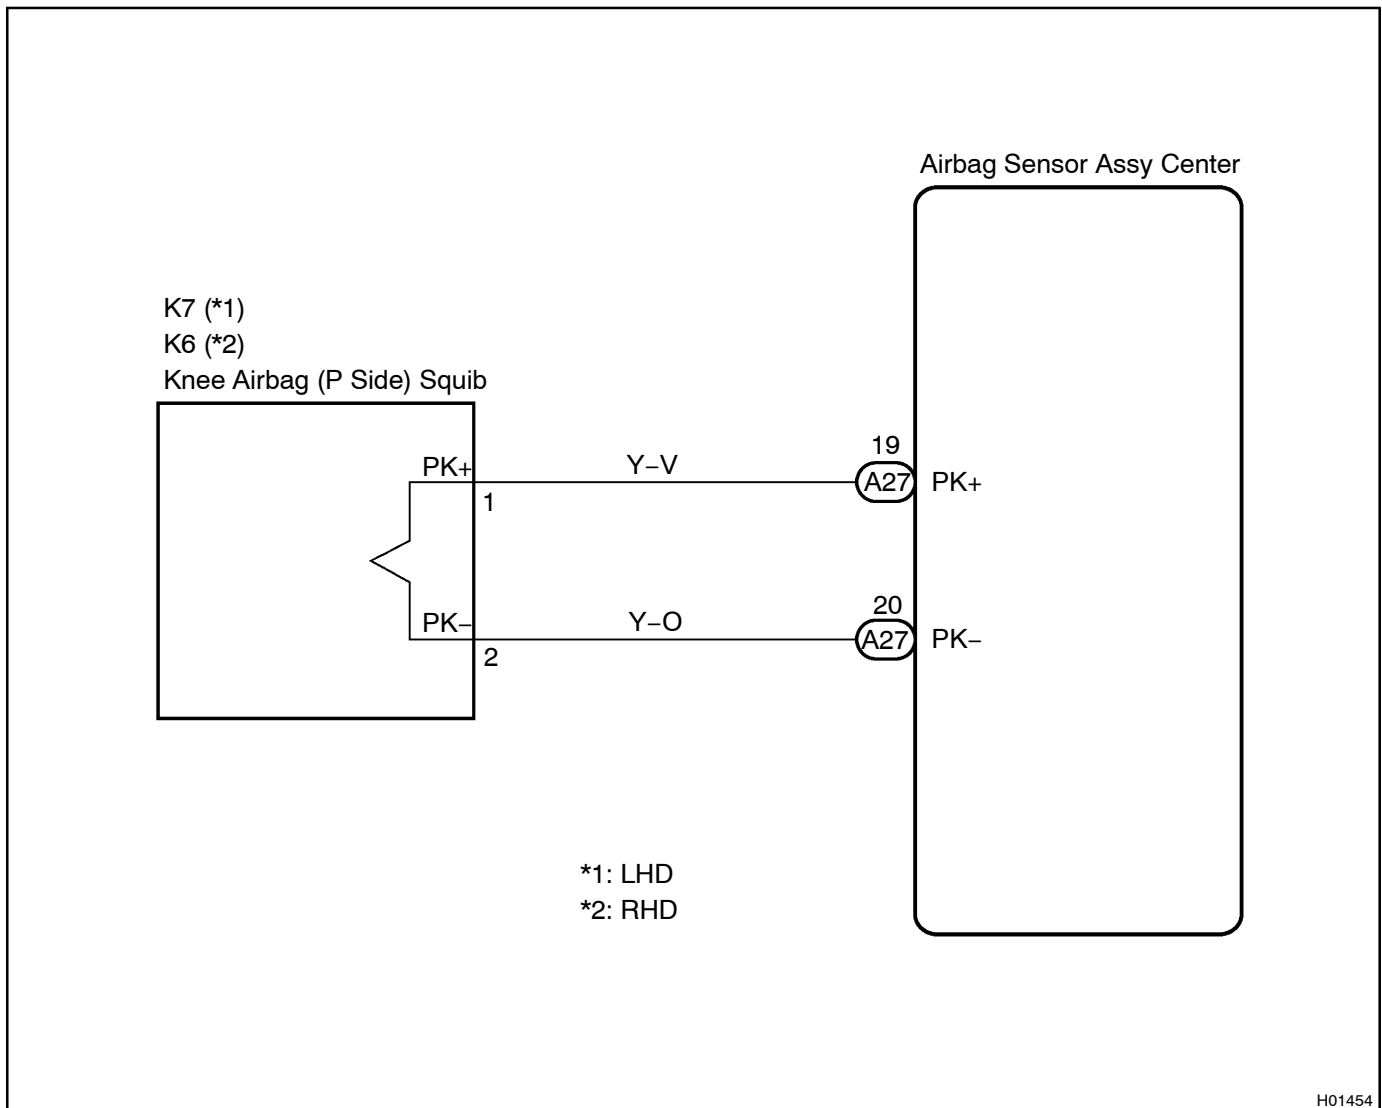
WIRING DIAGRAM

The knee airbag (P side) squib circuit consists of the airbag sensor assy center and the instrument panel airbag assy lower No.2 (LHD) or instrument panel airbag assy lower No.1 (RHD).

The circuit instructs the SRS to deploy when deployment conditions are met.

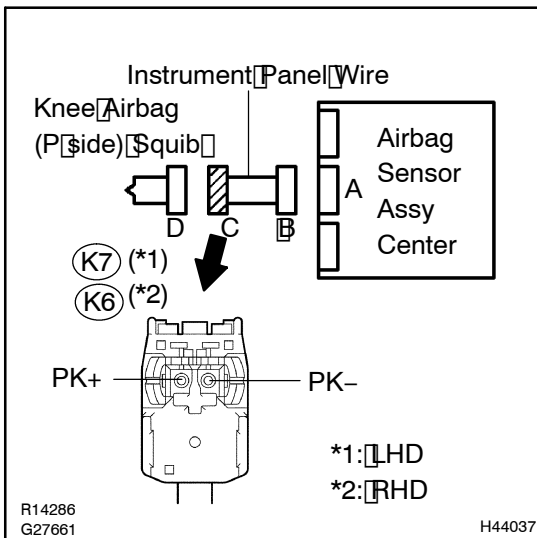
2 CHECK INSTRUMENT PANEL WIRE (KNEE AIRBAG (P\$IDE) SQUIB CIRCUIT)

- Release the activation prevention mechanism built into connector "B" ([see page 05-954](#)).
- Measure the resistance according to the value(s) in the table below.

Tester connection	Condition	Specified condition
K7-1 (PK+) - K7-2 (PK-)	Always	1 MΩ or Higher

Tester connection	Condition	Specified condition
K6-1 (PK+) - K6-2 (PK-)	Always	1 MΩ or Higher

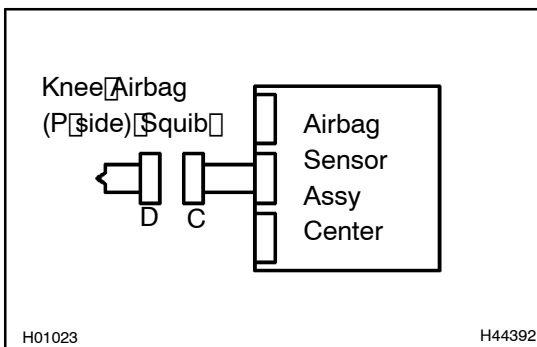
3 CHECK AIR BAG SENSOR ASSY CENTER

- Connect the connectors to the airbag sensor assy center.
- Connect the negative (-) terminal cable to the battery, and wait for at least 2 seconds.
- Turn the ignition switch to the ON position, and wait for at least 60 seconds.
- Clear the DTCs stored in memory ([see page 05-959](#)).
- Turn the ignition switch to the LOCK position.
- Turn the ignition switch to the ON position, and wait for at least 60 seconds.
- Check the DTCs ([see page 05-959](#)).

DTC B1865 is not output.

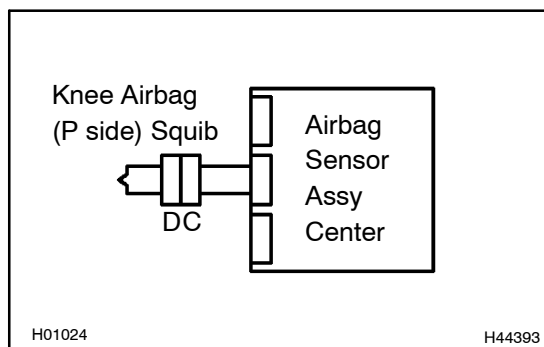
4 CHECK KNEE AIRBAG (P SIDE) SQUIB

- (a) Turn the ignition switch to the LOCK position.
- (b) Disconnect the negative (-) terminal cable from the battery, and wait for at least 90 seconds.
- (c) LHD:
Connect the connector to the instrument panel airbag assy lower No.2.
- (d) RHD:
Connect the connector to the instrument panel airbag assy lower No.1.
- (e) Connect the negative (-) terminal cable to the battery, and wait for at least 2 seconds.
- (f) Turn the ignition switch to the ON position, and wait for at least 60 seconds.
- (g) Clear the DTCs stored in memory (see page 05-959).
- (h) Turn the ignition switch to the LOCK position.
- (i) Turn the ignition switch to the ON position, and wait for at least 60 seconds.
- (j) Check the DTCs (see page 05-959).

OK	DTC B1865 is not output.	A
NG (LHD)	DTC B1865 is output.	B
NG (RHD)	DTC B1865 is output.	C
