DIAGNOSIS SYSTEM

1. DESCRIPTION

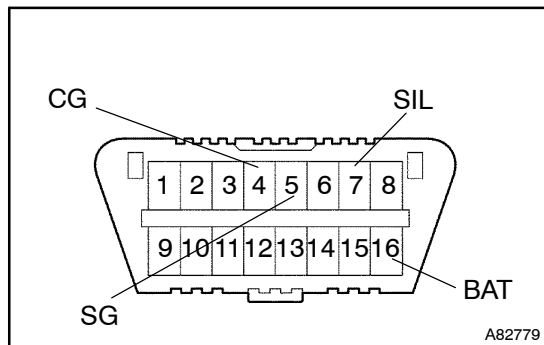
- (a) The driver side J/B ECU controls the function of the seat belt warning system on the vehicle. Data of the seat belt warning system can be read in the Data Link Connector 3 (DLC3) of the vehicle. When the system seems to be malfunctioning, use the intelligent tester II to check for malfunctions and perform repairs.

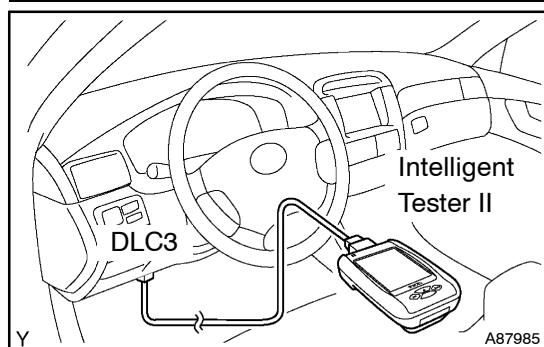
2. CHECK DLC3

The vehicle's ECU uses the ISO 15765-4 for communication protocol. The terminal arrangement of the DLC3 complies with ISO 15031-03 and matches the ISO 15765-4 format.

Symbol	Terminal No.	Name	Reference terminal	Result	Condition
SIL	7	Bus "+" line	5 – Signal ground	Pulse generation	During transmission
CG	4	Chassis ground	Body ground	1 Ω or less	Always
SG	5	Signal ground	Body ground	1 Ω or less	Always
BAT	16	Battery positive	Body ground	9 to 14 V	Always

Connect the cable of the intelligent tester II to the DLC3, turn the ignition switch ON and attempt to use the intelligent tester II. If the screen displays UNABLE TO CONNECT TO VEHICLE, a problem exists in the vehicle side or the tester side.

- If the communication is normal when the tool is connected to another vehicle, inspect the DLC3 on the original vehicle.
- If the communication is still impossible when the tool is connected to another vehicle, the problem is probably in the tool itself. Consult the Service Department listed in the tool's instruction manual.
