## INSPECTION

### 1. PRETENSIONER IS NOT ACTIVATED

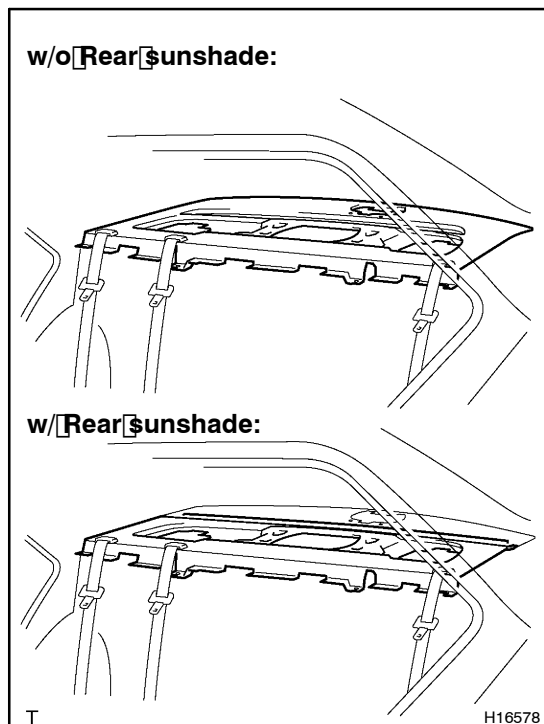
(b) Perform a visual check which includes the following items with the rear seat outer belt removed from the vehicle.

- Check for cuts and cracks in, or marked discoloration on the package tray trim panel.
- Check for cuts and cracks in wire harness, and for chipping in connectors.

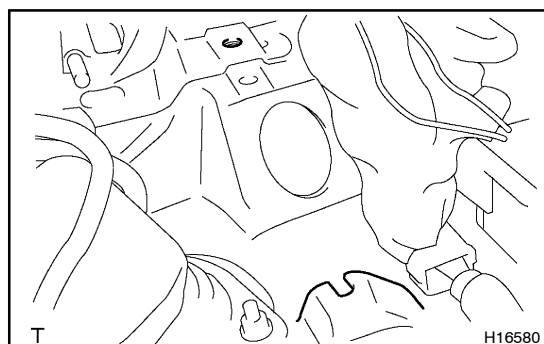
- Check for deformation of the package tray panel.

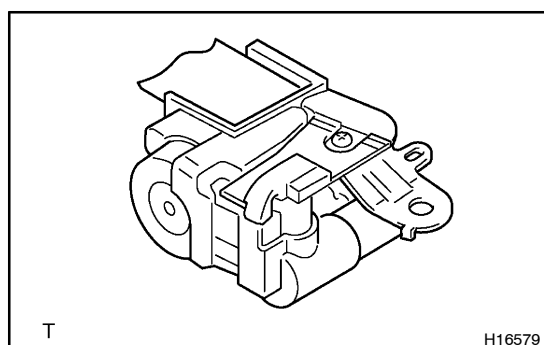
- Check for cuts and minute cracks in wire harness or marked discoloration on the rear seat outer belt.

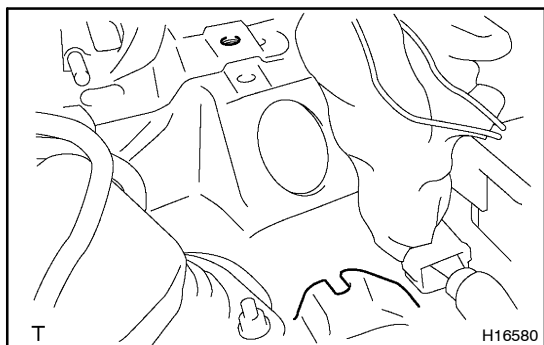
- (b) Perform a visual check which includes the following items with the rear seat outer belt removed from the vehicle.
- Check for deformation of the package tray panel.
  - Check for damage on the connector and wire harness.
