DTC	B1197/75	Short in Rear P/T Squib (LH) Circuit (to Ground)
-----	----------	--

CIRCUIT DESCRIPTION

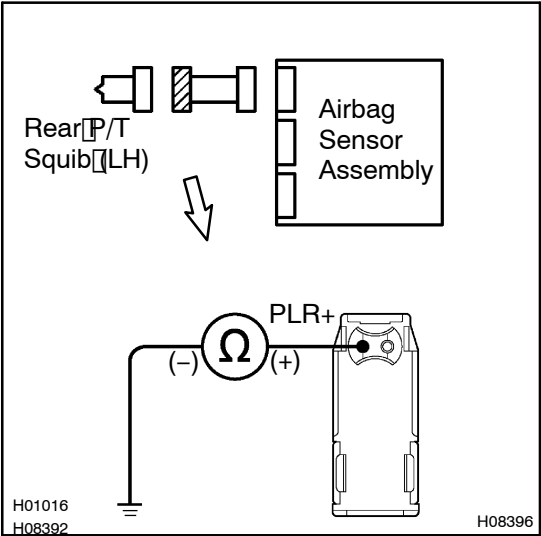
2	Check rear P/T squib (LH) circuit.
---	------------------------------------

CHECK:
For the connector (on the rear seat belt pretensioner side) between the rear seat belt pretensioner (LH) and the airbag sensor assembly, measure the resistance between PLR+ and body ground.

OK:
Resistance: 1 MΩ or Higher

NG
Repair or replace harness or connector between rear seat belt pretensioner (LH) and airbag sensor assembly.

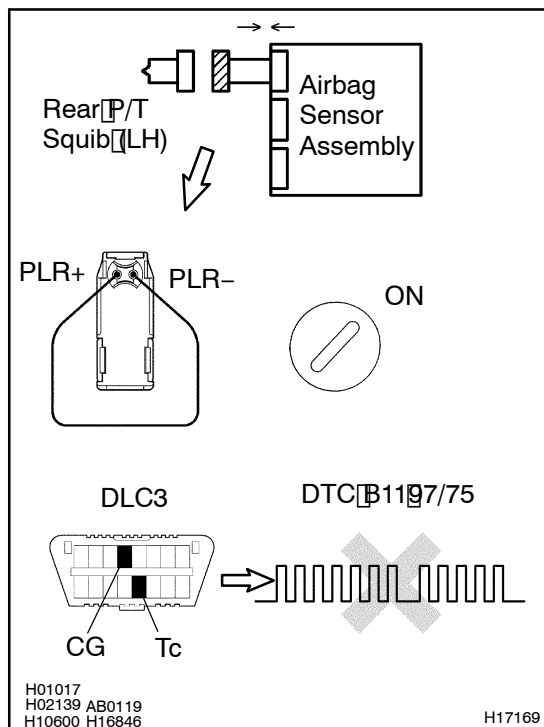
3 Check airbag sensor assembly.

- Connect the connector to the airbag sensor assembly.
- Using a service wire, connect PLR+ and PLR- of the connector (on the rear seat belt pretensioner side) between the rear seat belt pretensioner (LH) and the airbag sensor assembly.
- Connect negative (-) terminal cable to the battery, and wait at least for 2 seconds.

- Turn the ignition switch to ON and wait at least for 20 seconds.
- Clear the DTC stored in memory (See step 5 on [page DI-484](#)).
- Turn the ignition switch to LOCK, and wait at least for 20 seconds.
- Turn the ignition switch to ON, and wait at least for 20 seconds.
- Check the DTC (See [page DI-484](#)).

DTC B1197/75 is not output.

Replace airbag sensor assembly.

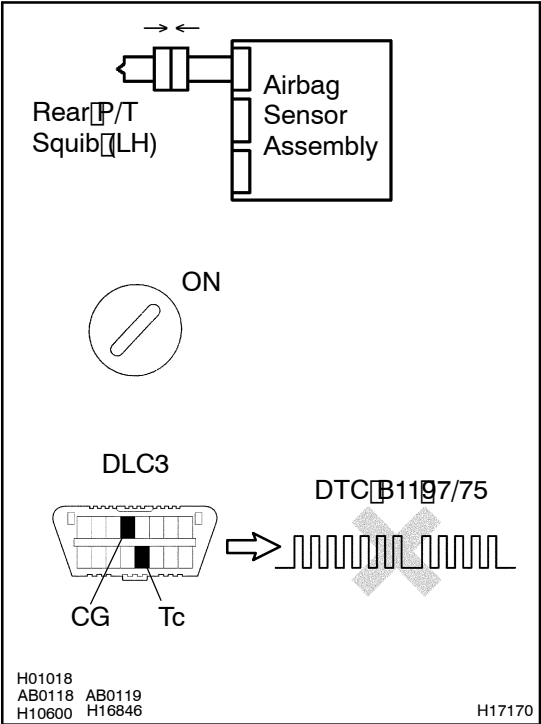
4 Check rear P/T squib (LH).

- Turn the ignition switch to LOCK.
- Disconnect negative (-) terminal cable from the battery, and wait at least for 90 seconds.
- Connect the rear seat belt pretensioner (LH) connector.
- Connect negative (-) terminal cable to the battery, and wait at least for 2 seconds.

- Turn the ignition switch to ON, and wait at least for 20 seconds.
- Clear the DTC stored in memory (See step 5 on [page DI-484](#)).
- Turn the ignition switch to LOCK, and wait at least for 20 seconds.
- Turn the ignition switch to ON, and wait at least for 20 seconds.
- Check the DTC (See [page DI-484](#)).

DTC B1197/75 is not output.

Replace rear seat belt pretensioner (LH).
