STEREO COMPONENT AMPLIFIER ASSY REPLACEMENT

67146-01

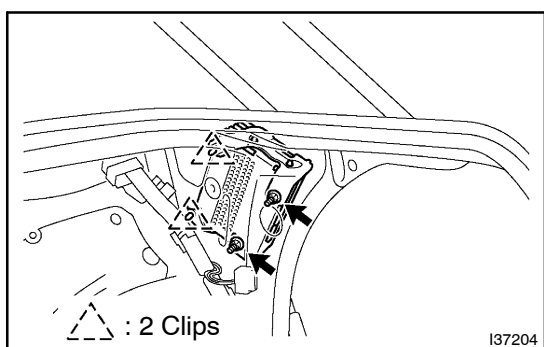
- COMPONENTS: [SEE PAGE 75-44.](#)
 - LOCATION: [SEE PAGE 67-2.](#)
 - Installation is in the reverse order of removal.
1. REMOVE LUGGAGE COMPARTMENT FLOOR MAT ([SEE PAGE 75-47](#))
 2. REMOVE DECK TRIM SIDE BOARD RH ([SEE PAGE 75-47](#))
 3. REMOVE REAR FLOOR FINISH PLATE ([SEE PAGE 75-47](#))
 4. SEPARATE LUGGAGE COMPARTMENT TRIM COVER FRONT ([SEE PAGE 75-47](#))
 5. REMOVE LUGGAGE COMPARTMENT TRIM COVER ASSY RH ([SEE PAGE 75-47](#))
 6. REMOVE TELEVISION CAMERA ECU (W/ TELEVISION CAMERA) ([SEE PAGE 67-15](#))

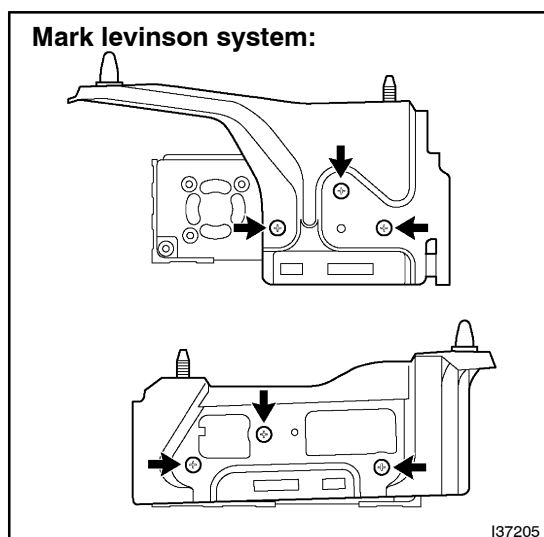
7. REMOVE STEREO COMPONENT AMPLIFIER ASSY W/BACKET

- (a) Disconnect the connector.
- (b) Remove the 2 nuts.
- (c) Disengage the 2 clips and remove the stereo component amplifier assy with bracket.

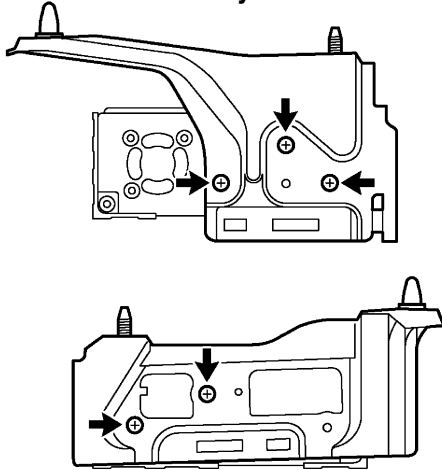
I37192

Non-mark levinson system:

- (b) Non-mark levinson system:
Remove the 5 screws and 2 brackets.
