Norman Craftsmanship

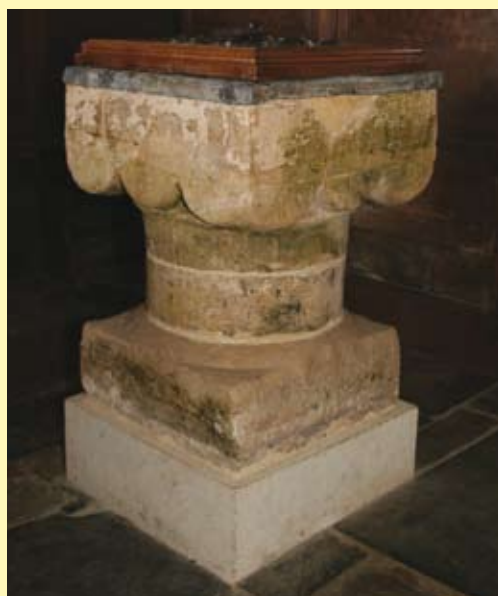
Figure A *Winsford font. The Norman fonts at Brushford, Hawkridge, Molland, Twitchen, West Anstey, Winsford, and Withypool vary in shape and design. They were carved from large blocks of stone and most carry cable or chevron patterns. The square ones may be later but the precise sequence is unknown.*
