## Figure 16

### Sixteenth Floor Plan

255 Riverside Drive,  
Windsor, Ontario

Designated Substances Survey

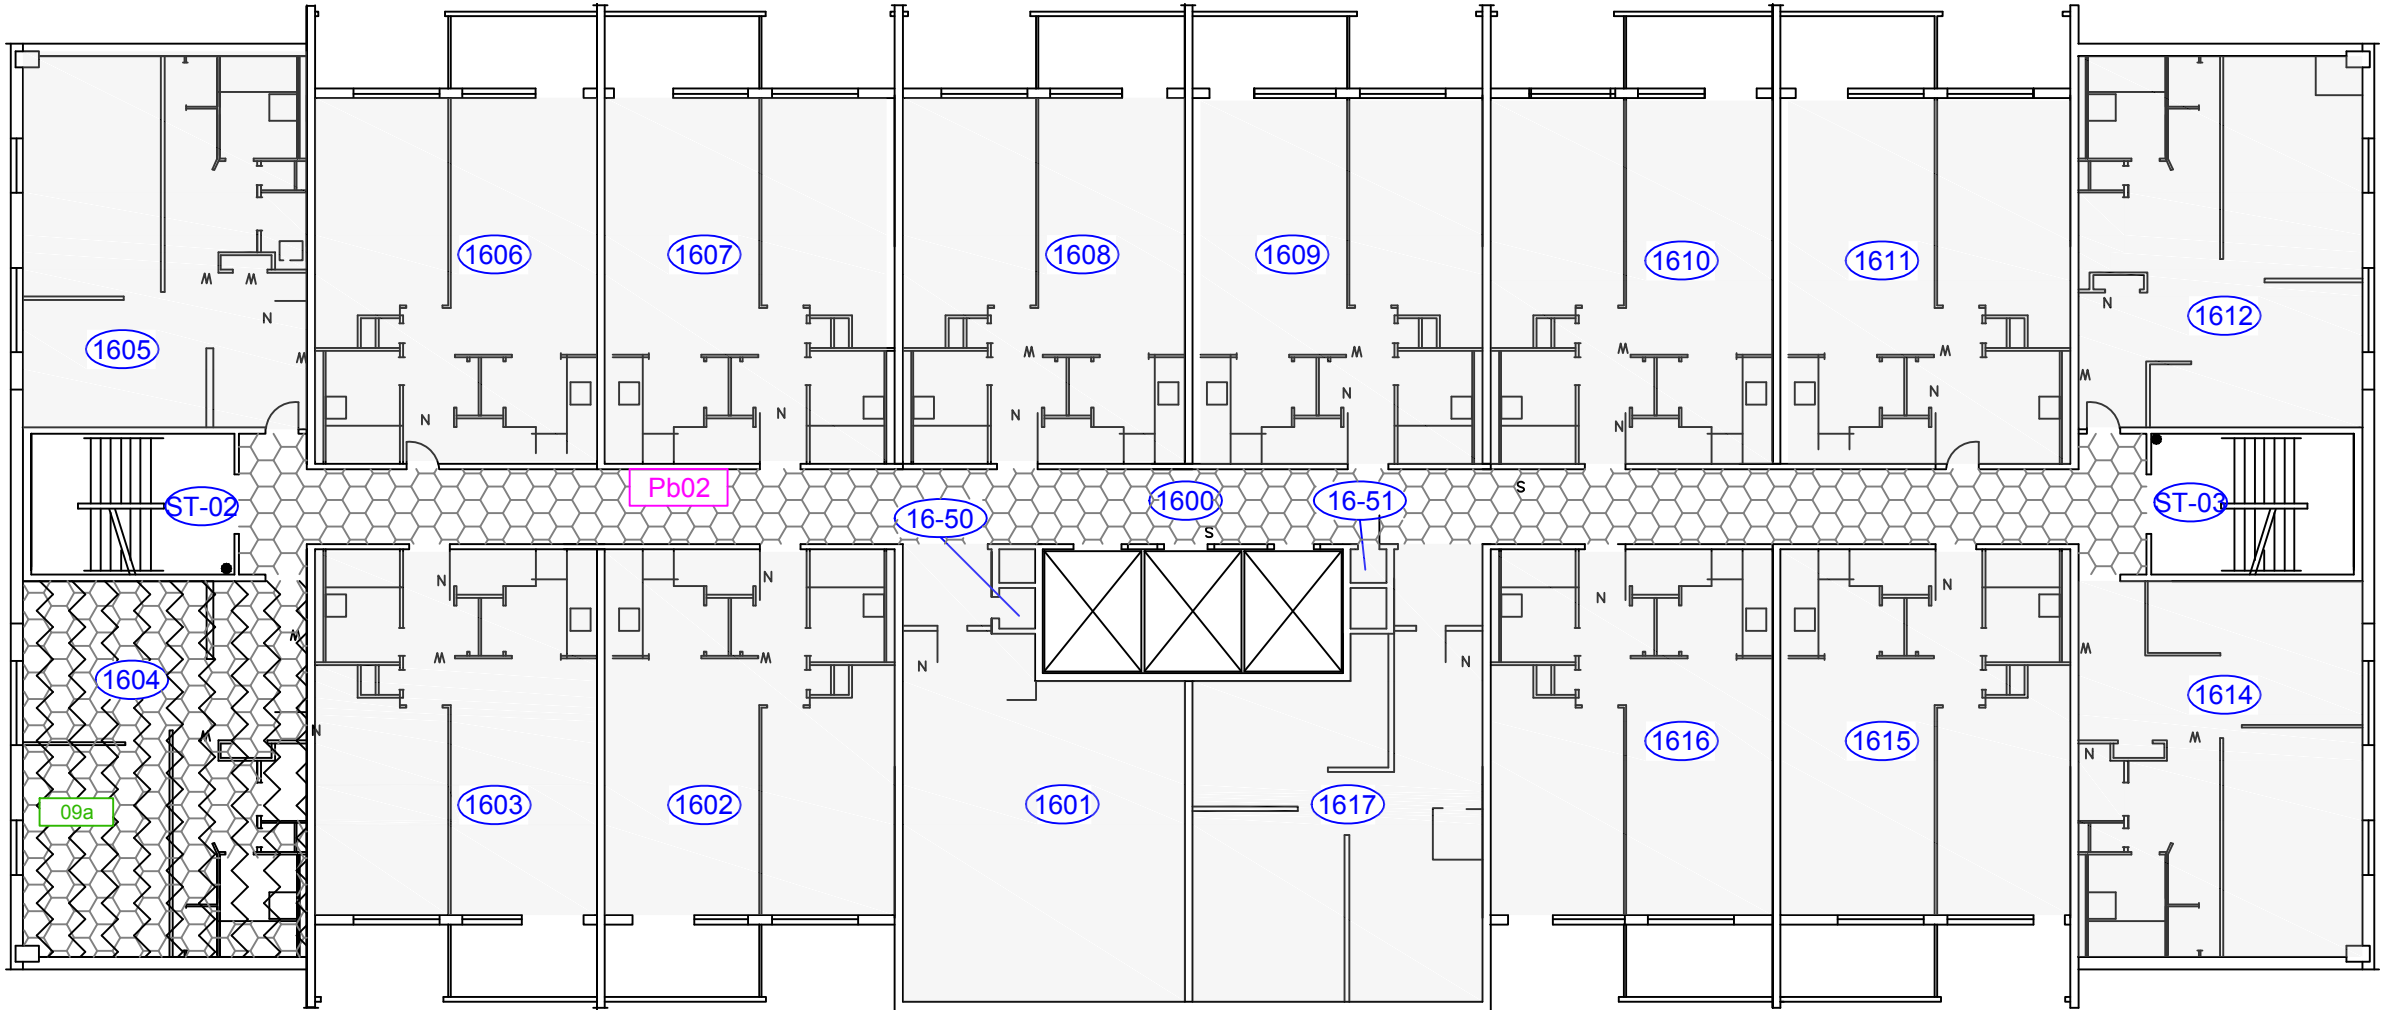
Asbestos-Containing Vinyl Floor Tiles & Mastic  
(Non-Friable)

Asbestos-Containing Texture Finish  
(Friable)

Asbestos-Containing Mastic  
(Non-Friable)

Asbestos-containing vinyl floor tile mastic may be present in  
other location not identified on this drawing
