REPORTABLE INCIDENT REPORT

**Delphi TVS Technologies Ltd,
Oragadam**

Department	: Heat Treatment
Process / Activity	: DFP6 Hydraulic Head movement by Material Handling Trolley (From HT to DFP6)
Injured person	: Kalaiselvan A
CC.No	: RS10171
Date & Shift	: 03.08.2024 & 3rd shift
Incident Time	: 1.25 AM

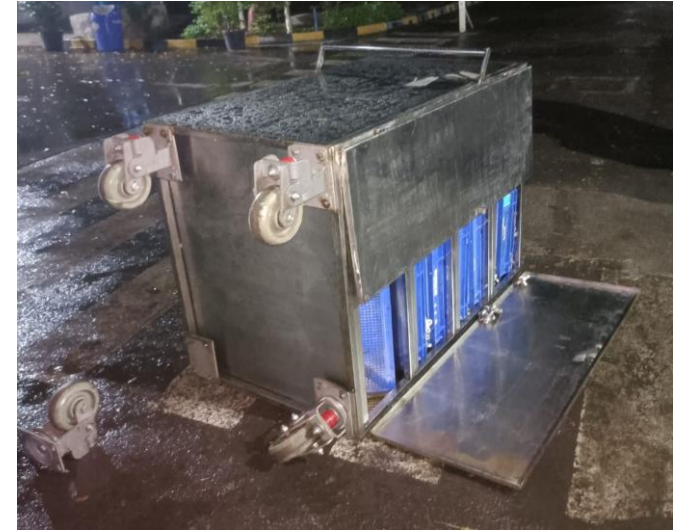
Component loaded trolley fell down while moving it

DFP6 hydraulic Head components loaded trolley collapsed and fell on his right leg while movement

Sl.No	Cause of Accident	Corrective Action	Resp	Target Date
1	No system to ensure for condtion monitoring and maintenance of Material Handling trolley	A comprehensive SOP to be made for Material Handling Trollies on Safe usage, monitoring and maintenance	R.Gopu	10.08.2024
		FLM for Material Handling Trollies to be introduced	R.Gopu	10.08.2024
		PM for Material Handling Trollies to be done	D.Muthukumar	
2	Component loaded trolleys with the huge capacity were handled manually	Criteria to be defined for movement of the material handling trollies based on Size and total weight (including parts) to decide the material handling by a)Manual movement and b)Material Handling Equipment (Forklift,Stacker,etc..)	R.Gopu	17.08.2024

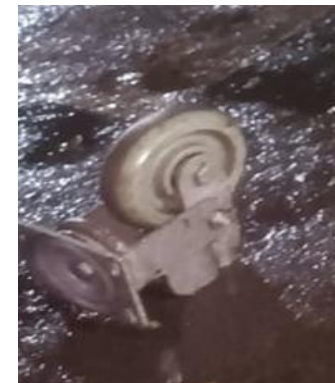
Detached trolley wheel

One of the wheel (rear end left) in the trolley got detached

Bolt Nuts securing the Trolley wheel with base plate were in loose condition

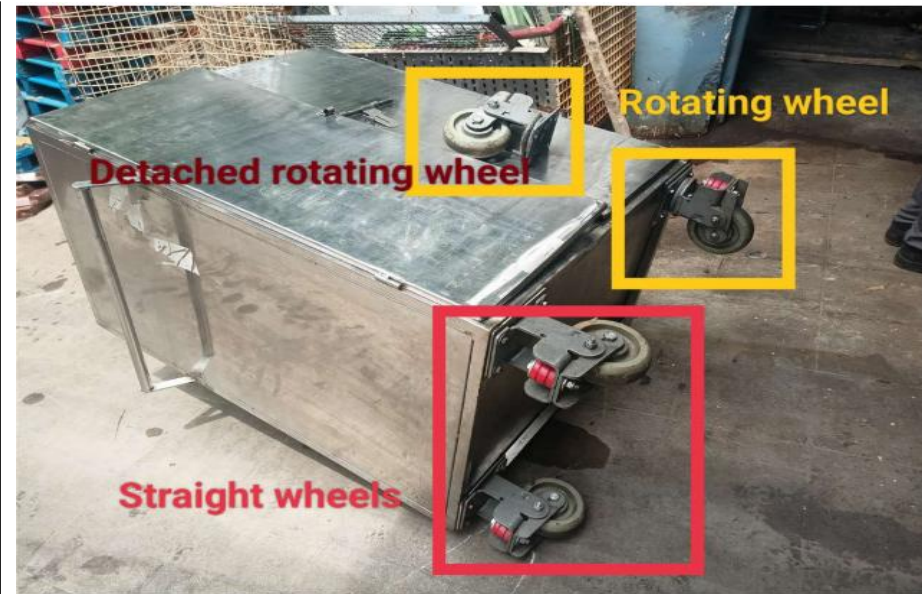
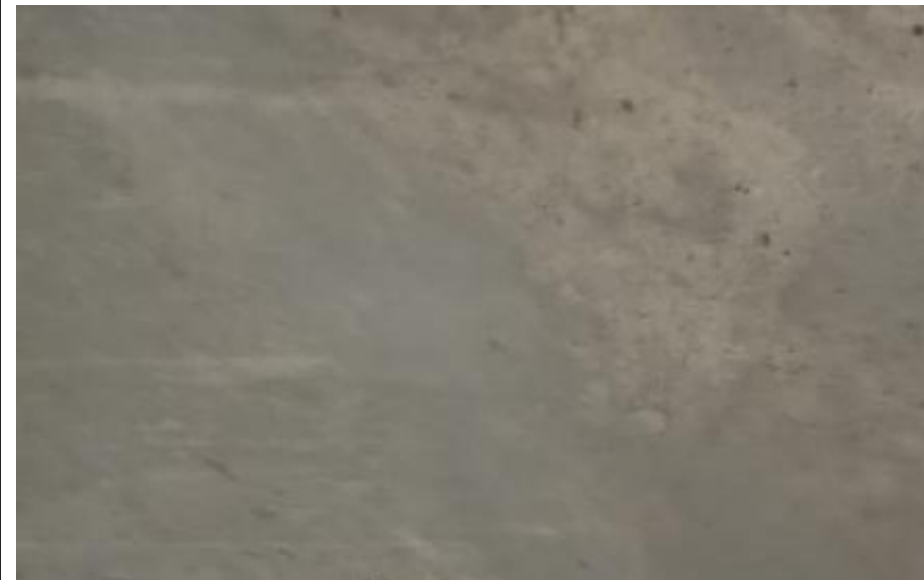
- 1) No Nuts (securing the wheel bolts with base plate) were observed.
- 2) Rotating wheels had been fixed in the rear end side of the trolley. (Should be at the front end side where handle is provided)
- 3) Material Handling Trolley with full load was moved manually by pushing the trolley by a single person.
- 4) Un even surfaces in the Road

Sl.No	Cause of Accident	Corrective Action	Resp	Target Date
3	Trolley is stuck on the road because of the uneven road surface during its movement	Separate RCC flooring with smooth finishing to be provided in road only for trolley movement on both side of the road	TVS	
4	No incoming inspection is done for material handling trolleys before handing over to user department	1. Incoming inspection to be done for all new material handling trolleys and storage facilities before handing over to user department(Along with FPD/EHS) 2. Handing over check sheet to be prepared and followed	N.Sairam	
5	Lack of Safety Awareness - Victim pushing the component loaded trolley	Awareness should be given to all trainees on how to handle the trolleys. "Always pull the trolley, do not push it.	M.Rajesh	17.08.2024
