## TEST REPORT

No. : GZMR220802602301

Sample Name : MOBILE PHONE CASE(NIMASO)  
Product or Lot No. : EOM-007  
Manufacturer : SHENZHEN YIOUMAI TECHNOLOGY CO.,LTD  
Other Information : PRODUCTION DATE:20220810

Test Item: Drop Test

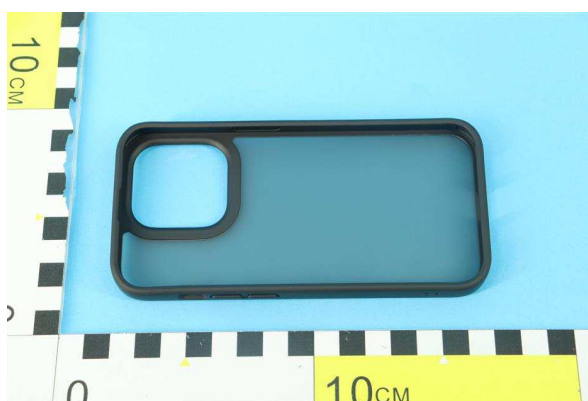
Original sample A

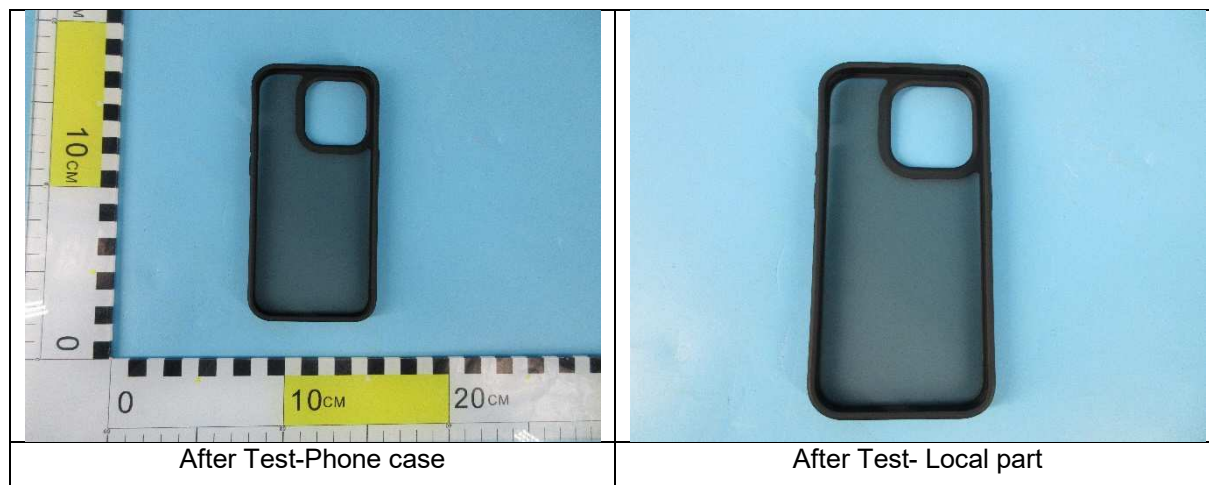
Test Photo:

Sample	Result	Client's requirement	Conclusion
A	No visual damage	No visual damage	Pass

Drop Height: 122cm

Drop Plane: Steel plate

Drop Times: Drop on each face, edge and corner; a total of 26 drops
