Closure works

Interactive professional course

Henk Jan Verhagen

Keywords: coastal engineering, closure dams, closure works

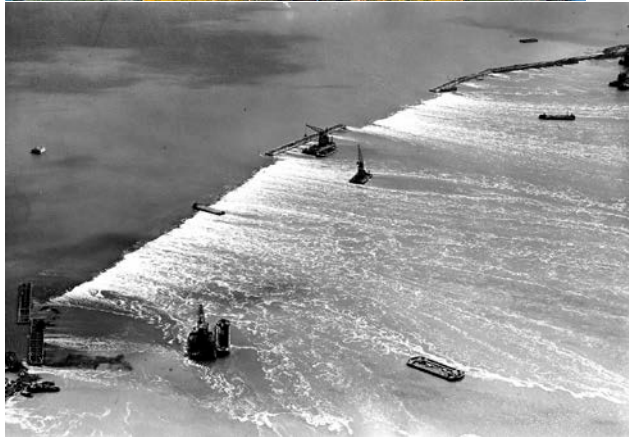
After the storm surge of 1953 many dikes in the Netherlands were breached. Especially in the tidal area closing is a complicated job. But also non-tidal breaches in rivers are sometimes a problem, especially when the surrounding land is lower than the normal water level in the river. This was for example the case during the floods of Yangtze river in 1998.

Photo: closure of the Schelphoek-breach in 1953, KLM-Aerocarto

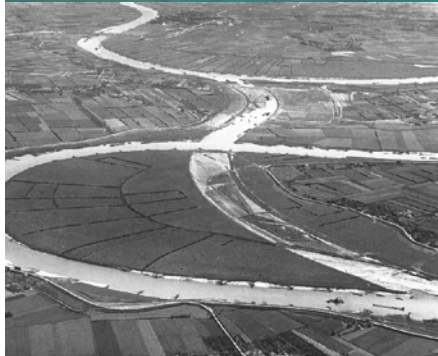
Because of the meandering effect of rivers the total length of a river may increase considerably. This has quite some drawback on river discharge, river management and navigation. A shortcut through the meander is then often a good solution, but this also means that the remaining meander has to be closed.

Photo: cutting off river meander in the Maas river, the Netherlands, photo KLM

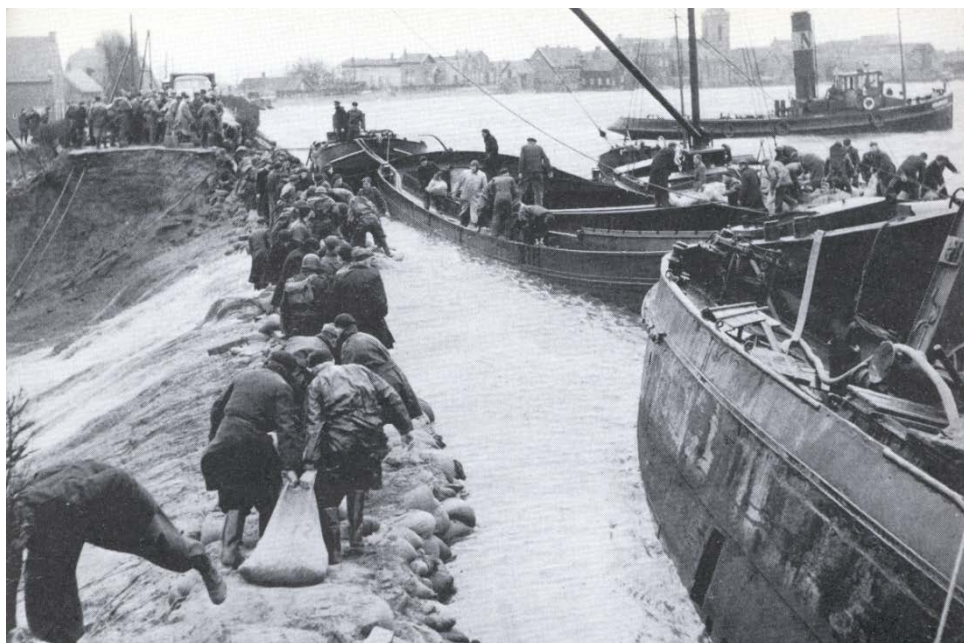
Figure 2.7 Closure dike breach Ouderkerk aan den IJssel 1953

An example of a successful emergency closure was the blocking of the dike breach near Ouderkerk aan den IJssel (Holland) during the major storm flood in February 1953. A relatively small breach cut the dike, which secured a vast, densely populated area of Holland, north of Rotterdam. Several hours later on the same night, a small vessel was taken and put onto the remainder of the outer slope of the dike, with neither any erosion protection nor any re-profiling of the gap to fit the vessel's shape. Piping under the vessel and around stem and stern could easily have scoured another gap. Then, the vessel would have broken and been pushed away, leaving a very large gap. However, the piping was blocked by using tarpaulins ballasted with sandbags (see Figure 2.7). The closure was a success and this central area of Holland remained dry.

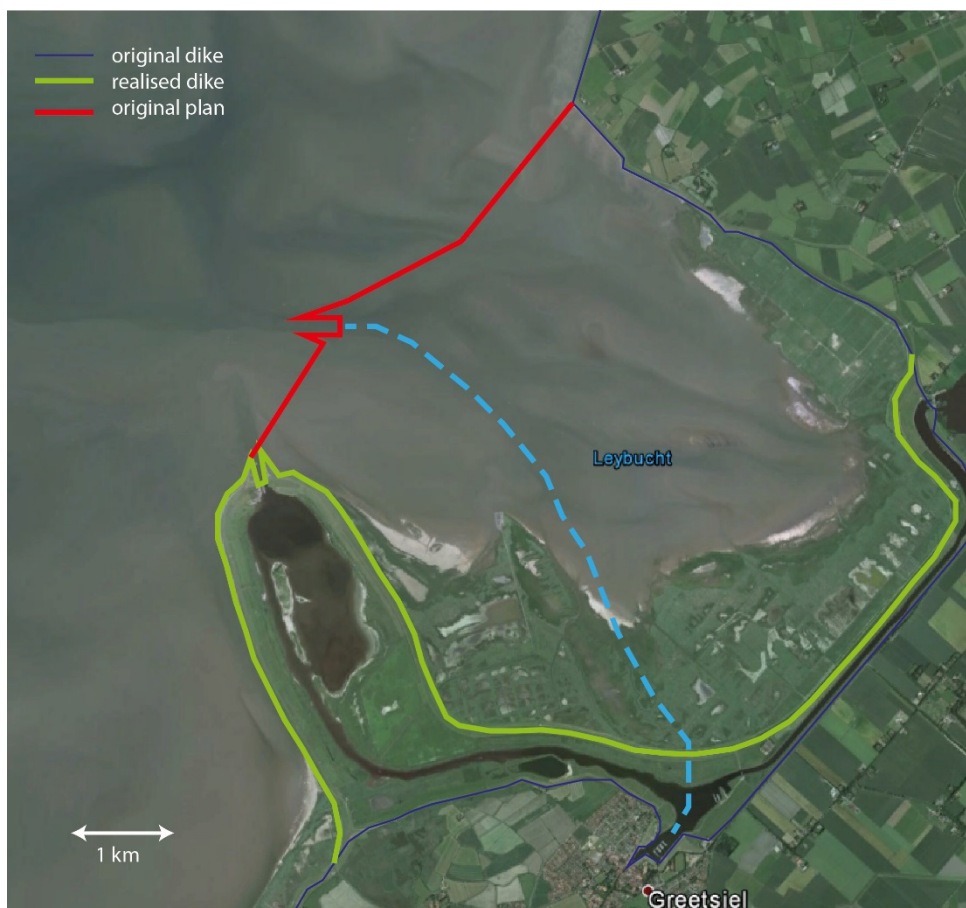
Figure 2.11 Plans and realisation of the closure of the Leybucht in Germany (chart basis Google Earth)

Around 1975 enhanced world views regarding ecological importance altered the design of closures. Because of this in the north of Germany a number of closures were completed in a different way than planned. For example it was planned to dam the full Leybucht near Greetsiel, but eventually only a small part was closed, just sufficient to guarantee safety and water management requirements.
