# Monitoring ephemeral headwater streams: a paired-sensor approach

Rashaad Bhamjee\*, John B. Lindsay<sup>†</sup> & Jaclyn Cockburn<sup>‡</sup>

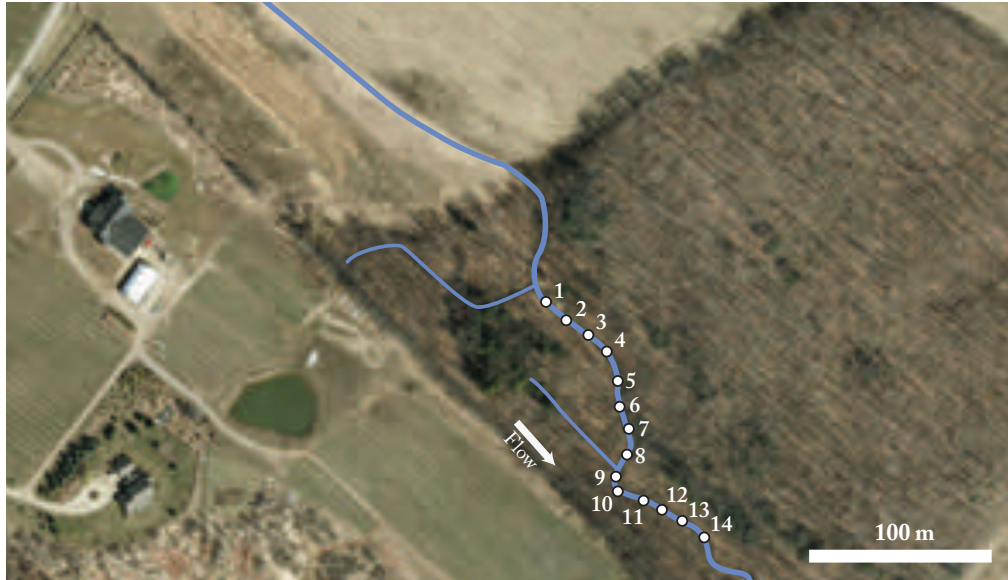
Figure 2: Site 1 study area including the positioning of the sensor pairs.

Field-based sensor performance and evaluation was undertaken at two field sites in southern Ontario. Each site contained at least one ephemeral channel. Site 1 (43.7580 N, 79.9392 W) was located in a predominantly agricultural area in southern Ontario, west of the town of Cheltenham (Figure 2). The study-reach of ephemeral channel was located in a forest adjacent to active corn fields and an apple orchard. The stream originates in the surrounding fields and is bounded

by a riparian buffer where it bisects the field. In the forested section, the active stream is greatly incised in the banks and has a mix of bed-surface sediment conditions. At the head of the study-reach there were large cobbles and boulders across the width of the channel, however the bed-surface exhibited noticeable sediment fining downstream. The lower reaches of the channel had less rocks on the bed-surface and appeared sandier. Grain-size analysis showed that in the 30 cm below the bed, there was more longitudinal consistency along the study-reach. The channel was on average 53.7% sand, 12.1% silt and clay, with the remainder being grains larger than sand. The site had an average organic matter content of about 5.1% with a standard deviation of 1.3% along the entire study reach. The channel flattens and widens toward the mouth, with an approximate average channel width of 2.5 m, however, flow tends to be concentrated in a far narrower area. The forest is composed of large, mainly deciduous, trees with minimal understory. This lack of understory resulted in leaf litter accumulation in the autumn months and increased the debris load in the channel. The channel empties into the Credit River near Cheltenham, Ontario.

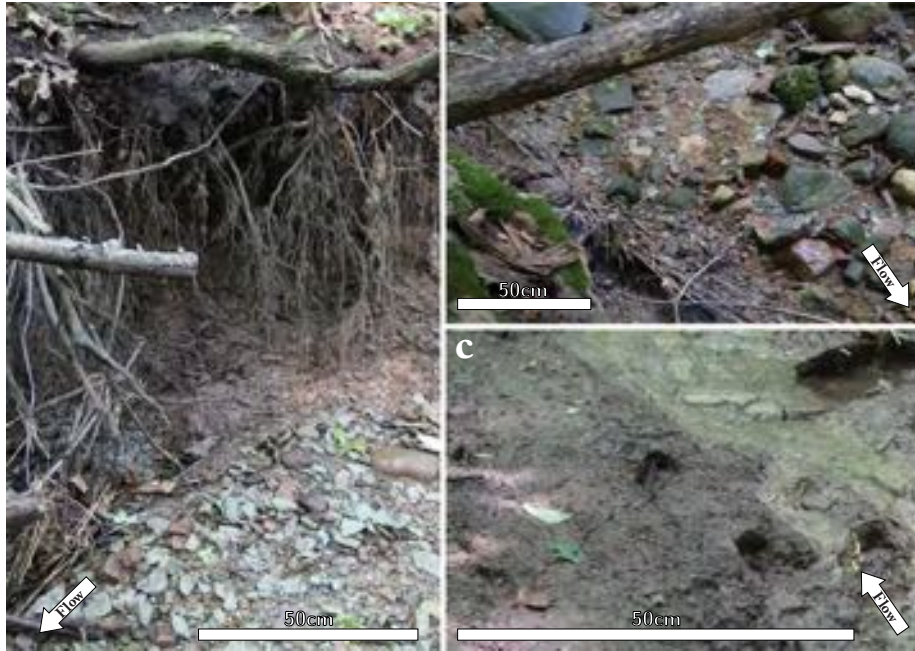
Figure 4: Photos of channel surface characteristics at Site 1. a) the upper parts of the channel were deeply incised and contain lots of pebble-sized grains on the bed-surface. b) the lower reaches of the channel had a relative absence of larger grains on the surface. c) in the mid-to-upper reaches, there was a mix of pebbles, cobbles, and boulder sized grains on the bed-surface, which lead to potential siting issues. Site 2 exhibits similar channel surface characteristics, with the downstream area similar to c), and the upstream area similar to b). There were no channel surfaces similar to a) at Site 2.
