Precise Aerial Measurement Report

4621 North 42nd Street, Omaha, NE 68111

Report: 60346214

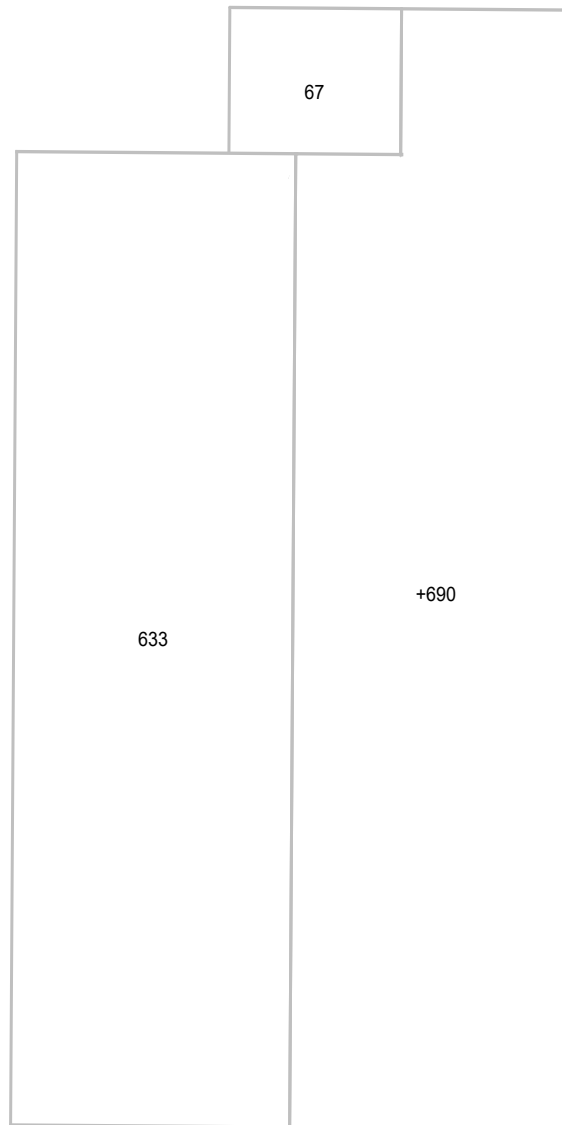
AREA DIAGRAM

Total Area = 1,391 sq ft, with 3 facets.

Note: This diagram shows the square feet of each roof facet (rounded to the nearest Foot). The total area in square feet, at the top of this page, is based on the non-rounded values of each roof facet (rounded to the nearest square foot after being totaled).
