## Data Center Airflow Management Retrofit

Technology Case Study Bulletin:  
September 2010

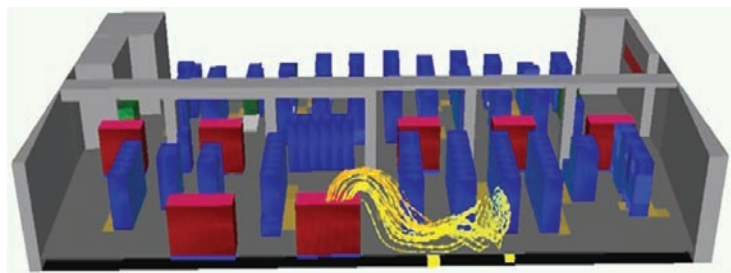
Figure 1

Figure 1: Data center CFD model of return airflow short circuit (Courtesy: ANCIS)

Data center operators can benefit from airflow visualization models created by using computational fluid dynamics (CFD). Understanding airflow within data centers is complicated because under-floor air distribution and unguided pathways often result in unintended turbulences and vortices. These turbulences and vortices limit cooling capacity and waste energy. A CFD model of the data center can help identify detrimental airflow short-circuits, mixing, imbalances, and hotspots. Examples of CFD modeling at LBNL are provided in Figures 1 and 2.

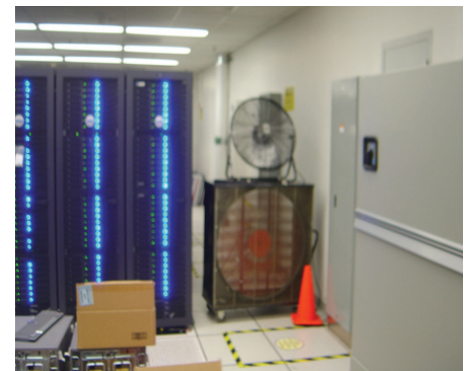
Figure 3: Before retrofit auxiliary fans cool hot spots

At LBNL, many common airflow problems existed that were exacerbated by airflow deficiencies particular to this 40-year old data center. Existing perforated tiles were inefficiently arranged, causing airflow from under-floor outlets to be misdirected. In addition, low volume flow rates were noted in certain sections of the data center resulting in hotspots (see Figure 3). Notably, supply tile outlet size (known as tile free-hole area) and location optimization was enhanced by using wireless temperature monitoring devices<sup>1</sup> and associated visualization software. In this data center, hot air short circuiting through the racks was widespread. To limit this situation, LBNL installed server rack blanking-plates and recommends using side-panels. In addition, LBNL used brush-type seals around cabling to mitigate this air-leak pathway. The combination of air management best practices implemented at LBNL improved airflow and under-floor air pressure.

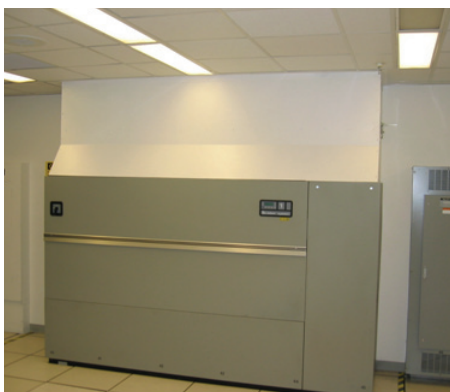
Figure 4: Return duct from plenum to CRAC unit

- Ceiling plenum became return airflow pathway.
- Extended CRAC intakes into new overhead hot-air return plenum.
  - Duct CRAC units to ceiling plenum (see Figure 4).
- Redirected supplementary cooling to under floor.
  - Relocated existing overhead supply to under-floor plenum (see Figures 5 and 6).
- Installed isolation curtains.
  - Added strip curtains to hot aisles (see Figure 7).

Airflow short-circuits were eliminated by adding ductwork at the top of each CRAC unit to connect to the newly configured hot-air return plenum in the data center's ceiling.

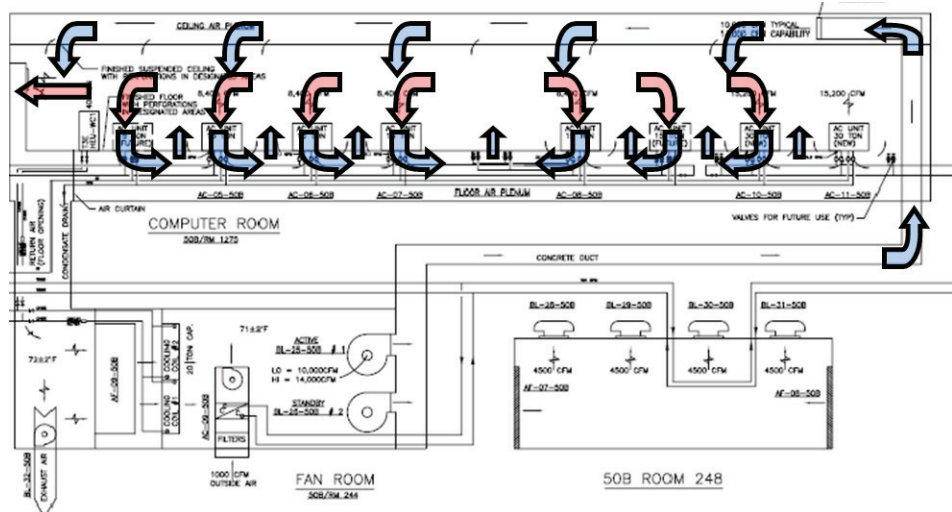
Figure 5: Airflow before retrofit (red arrows=hot; blue arrows=cold)

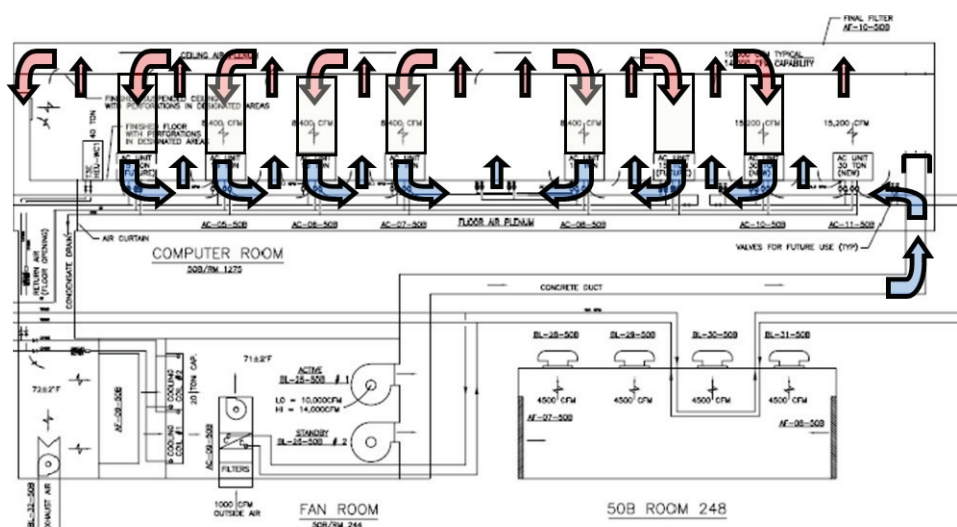
Figure 6: Revised airflow with return plenum (red arrows=hot; blue arrows=cold)

Cold and hot airflow mixing was significantly reduced by redirecting cooling air from an existing overhead supply system to the under-floor cooling plenum already in use by the CRAC units. Strip curtains improved isolation of cold and hot airstreams.

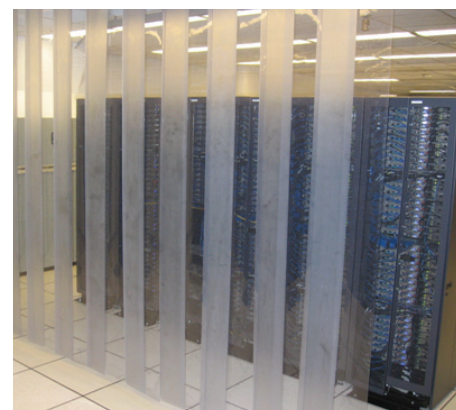
Figure 7: Isolation air curtains with fusible links

- Converted false ceiling to hot-air plenum.
  - Added strip curtains to hot aisles (see Figure 7).

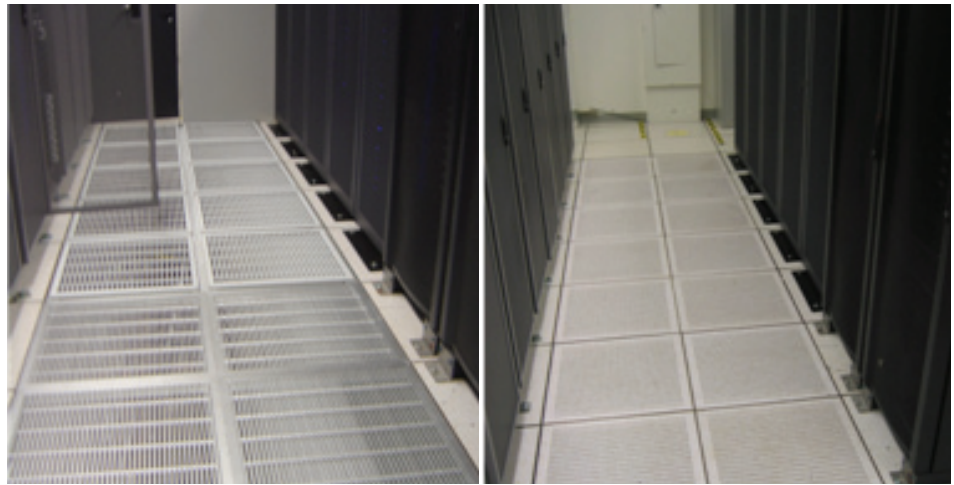
Figure 8: Floor tiles; before and after retrofit

Under-floor air distribution was examined and optimized for pressure and flow distribution. Installation of many wireless temperature and pressure sensors aided the optimization process (refer to DOE Wireless Sensors Improve Data Center Efficiency Technology Case Study Bulletin). The following improvements were made to the tile configuration (see Figure 8):

- 27 perforated floor tiles removed.
- 30 floor tiles converted from high- to low-flow.
- 4 floor tiles converted from low- to high-flow.

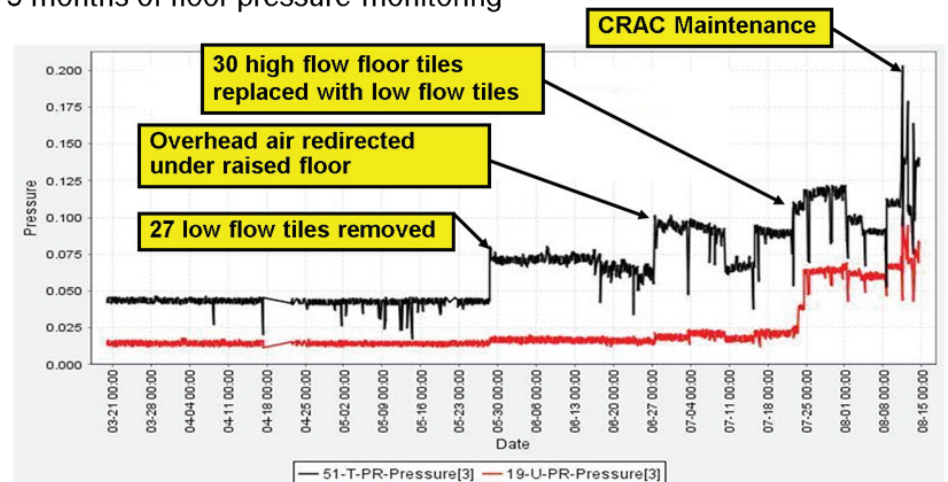
## 5 months of floor pressure monitoring

Figure 9 shows a five-month history of improved under-floor airflow. Note the significant performance improvement

resulting from CRAC maintenance that included tightening loose supply fan belts.

Regular preventative maintenance, inspection, and tune-ups are highly effective in reducing energy waste in data centers. A sizeable increase in airflow resulted from basic maintenance. In particular, LBNL facilities personnel found CRAC fan belts to be loose and slipping.
