APOLLO 11 MISSION REPORT
SUPPLEMENT 10

COMMUNICATIONS SYSTEM PERFORMANCE

SUPPLEMENTAL REPORT ON
COMMUNICATIONS SYSTEM PERFORMANCE
DURING THE APOLLO 11 MISSION

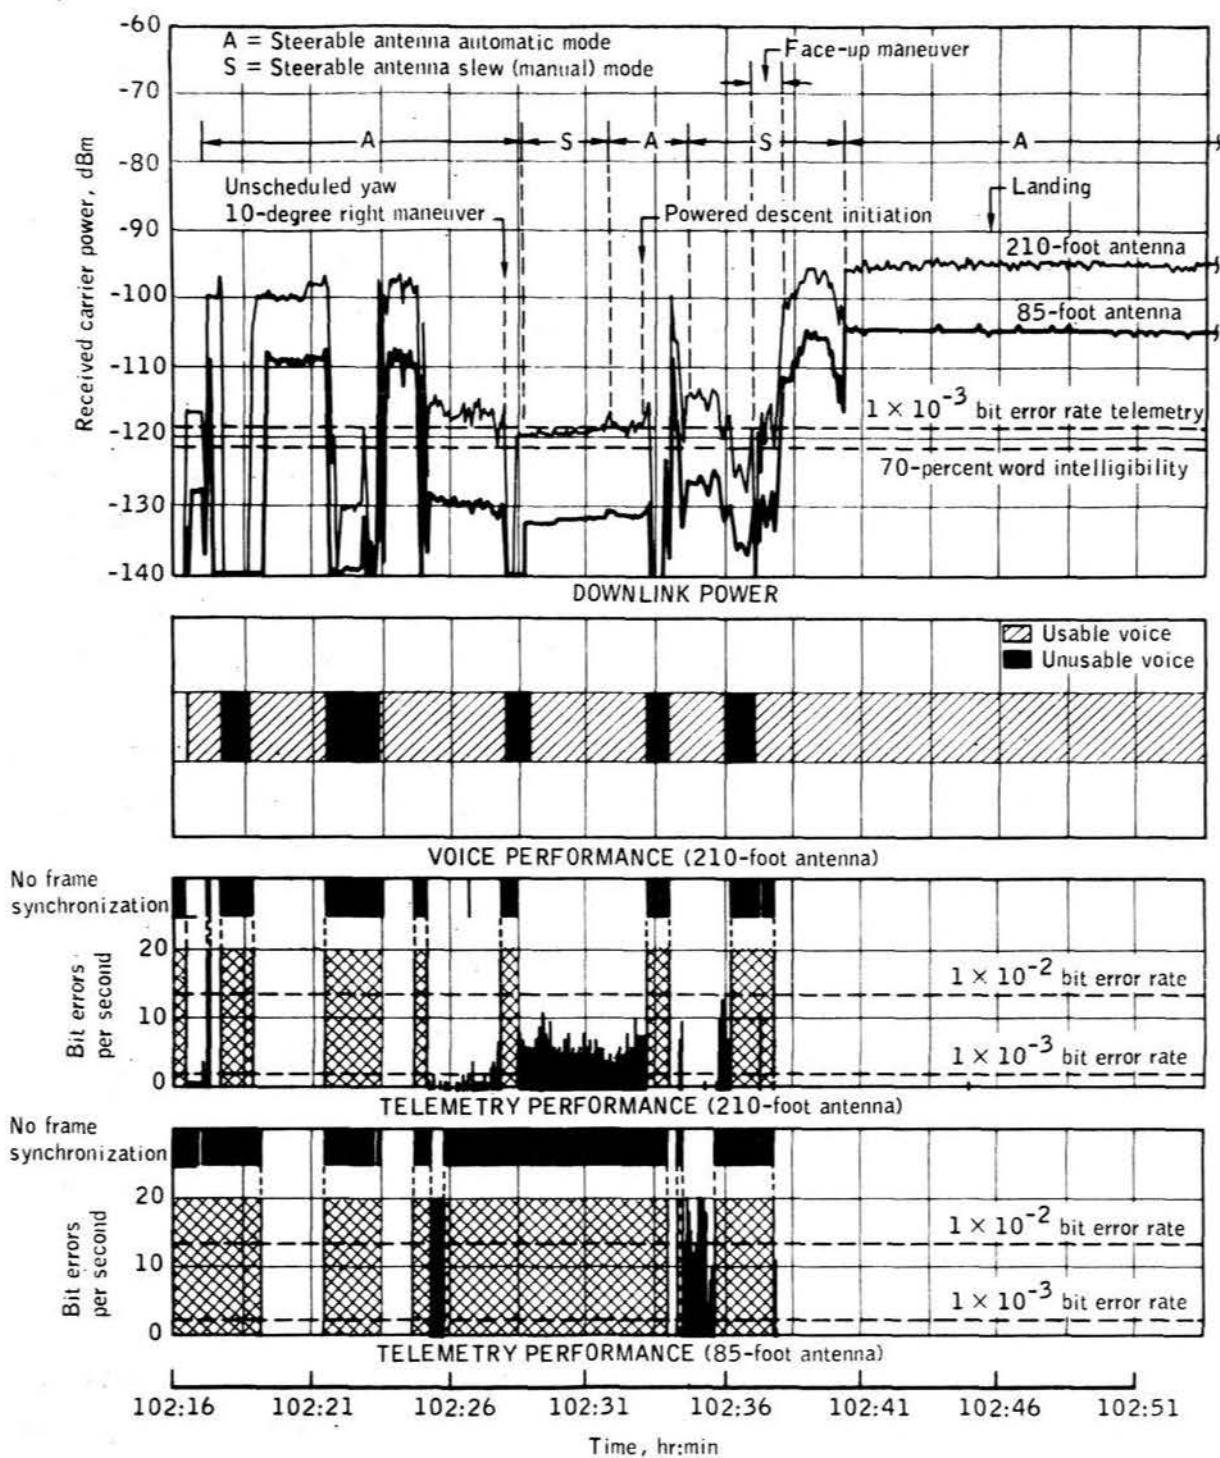
Figure 2-1 Communications System (downlink) Performance During Final Descent

During powered descent (See Figure 2-1), the performance of the downlink voice and telemetry channel was degraded by low received carrier power. The long periods of loss of PCM synchronization on data received at the 85-foot antenna station distinctly illustrated the advantage of scheduling the descent maneuver during coverage by the 210-foot antenna at the Goldstone station.

Between acquisition of the lunar module signal at 102:16:30 and the pitch down maneuver during powered descent, valid steerable antenna auto-track could not be achieved (received uplink and downlink carrier powers were 4 to 6 dB below predicted values) and several losses of phase-lock were experienced. Prior to 102:27:22, the line-of sight from the steerable antenna to the earth was obstructed by a lunar module reaction control system thrust deflector. Therefore, the antenna was more susceptible to multipath transmissions off the lunar module and/or the lunar surface. The sharp losses of phase lock were probably caused by the buildup of oscillations in steerable antenna motion as the frequencies of the incidental amplitude and phase modulation approached multiples of the antenna switching frequency (50 Hz). After the unscheduled yaw maneuver at 102:27:22, which was unsuccessful in establishing communications, automatic tracking with the correct spacecraft pointing angles was attempted at 102:40:20. Communications were maintained from this time until lunar landing.

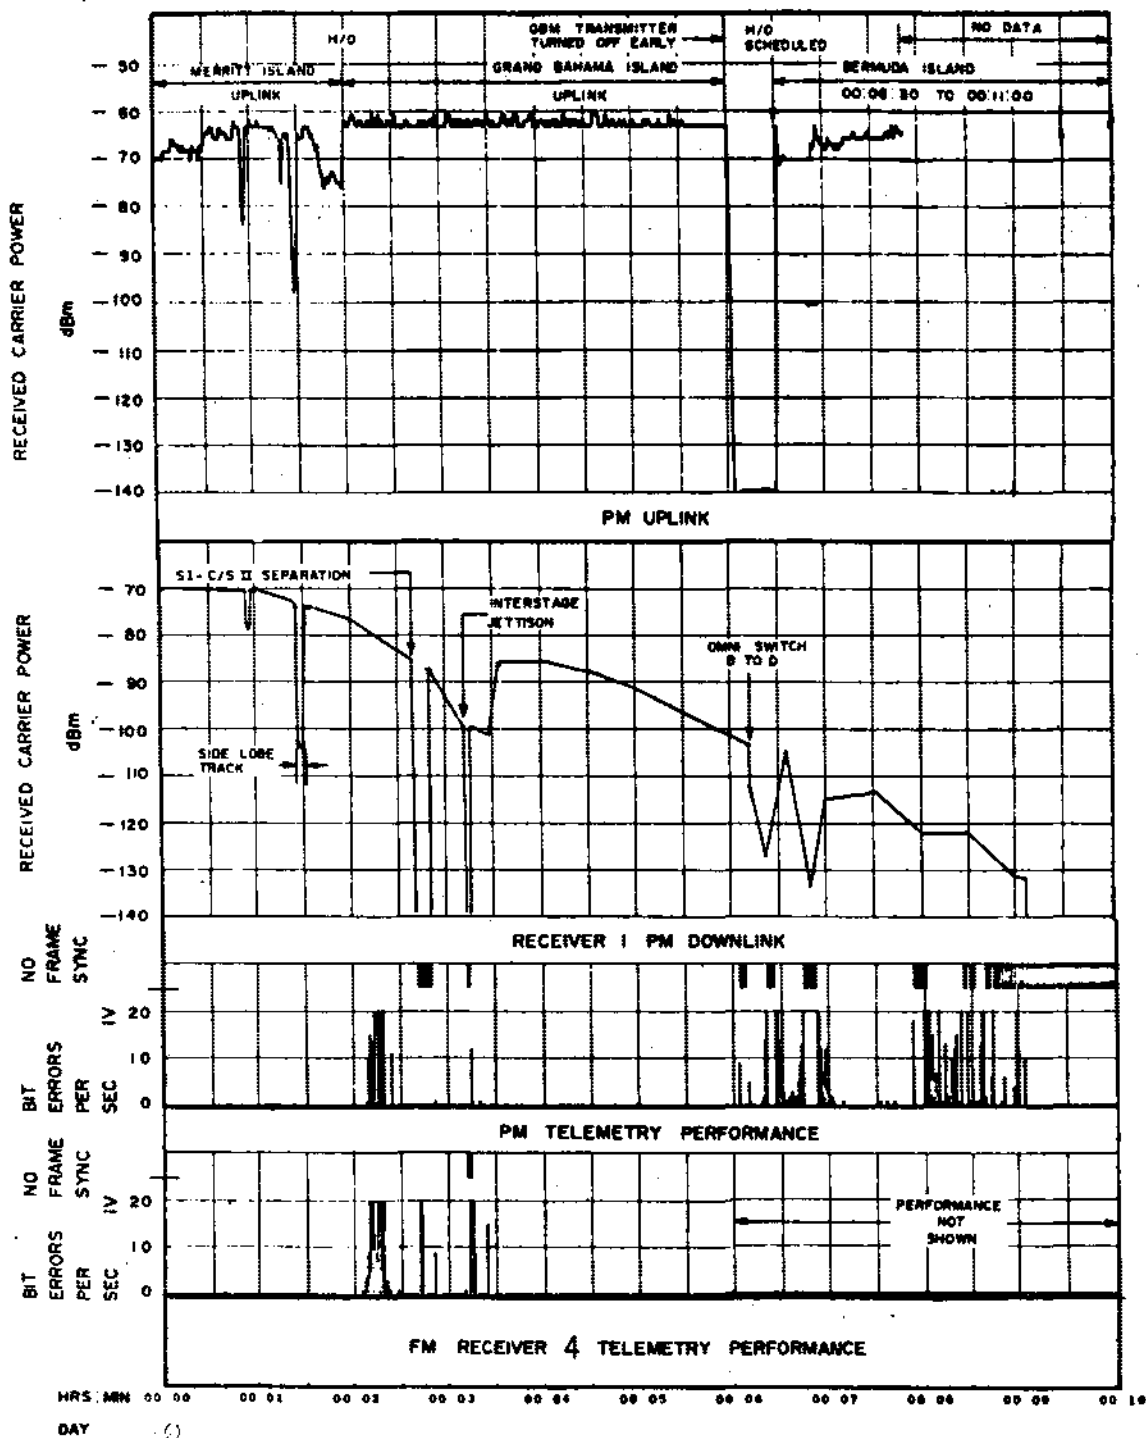
During Merritt Island's coverage of the launch phase, both phase modulation (PM) and frequency modulation (FM) receivers were used to demodulate the telemetry in an attempt to reduce the data losses during the Saturn

Although the number of dropouts is the same for the FM and PM receiver cases, it is noted that more data are provided from the FM receiver. This is attributed to the fact that the FM receiver does not have to maintain or re-establish phase lock as in the PM receiver case. It is to be noted, however, that during periods when the PM receiver is in lock, the PM data quality is better than that obtained from the FM receiver. Therefore, after the initial four to five minutes when this type of PM dropouts is not normally experienced, the telemetry data from the PM receiver should be utilized.

The data losses during Saturn IC/Saturn II separation and interstage jettison were caused by flame attenuation, booster shadowing, and rapid phase perturbations due to transmission through the plume. As shown in Figure 3-1, these losses can be reduced during the first four-to-five-minutes of the launch phase, through the utilization of a frequency

modulation receiver as a source for the telemetry data. Through a comparison of telemetry performance from the frequency modulation and phase modulation receivers, shorter time periods of data dropouts are observed in the FM receiver telemetry performance as compared to the PM receiver case. Although the number of dropouts is the same for the FM and PM receiver cases, it is noted that more data are provided from the FM receiver. This is attributed to the fact that the FM receiver does not have to maintain or reestablish phase lock as in the PM receiver case. It is to be noted, however, that during periods when the PM receiver is in lock, the PM data quality is better than that obtained from the FM receiver. Therefore, after the initial four to five minutes when this type of PM dropouts is not normally experienced, the telemetry data from the PM receiver should be utilized.

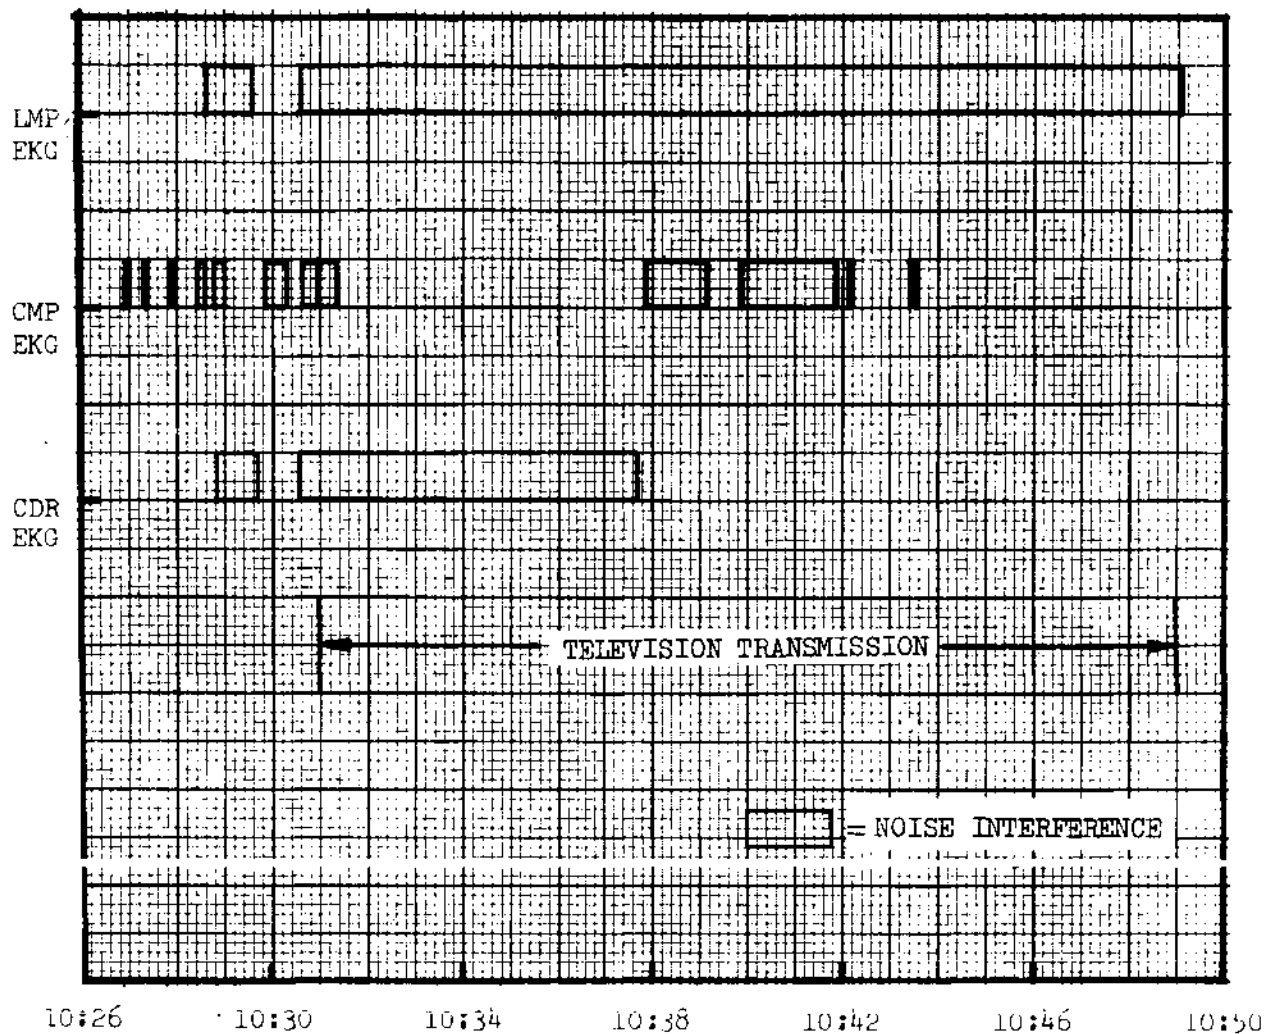
Figure 3-3 Command And Service Module Electrocardiogram Data Noise Timeline

During the second television transmission from the command module, noise spikes were on the electrocardiogram (EKG) data transmitted to the Goldstone station. The characteristics of the noise indicated that the noise spikes were probably caused by electromagnetic interference from the television equipment within the command module.

It appears that interference by the television equipment may have caused

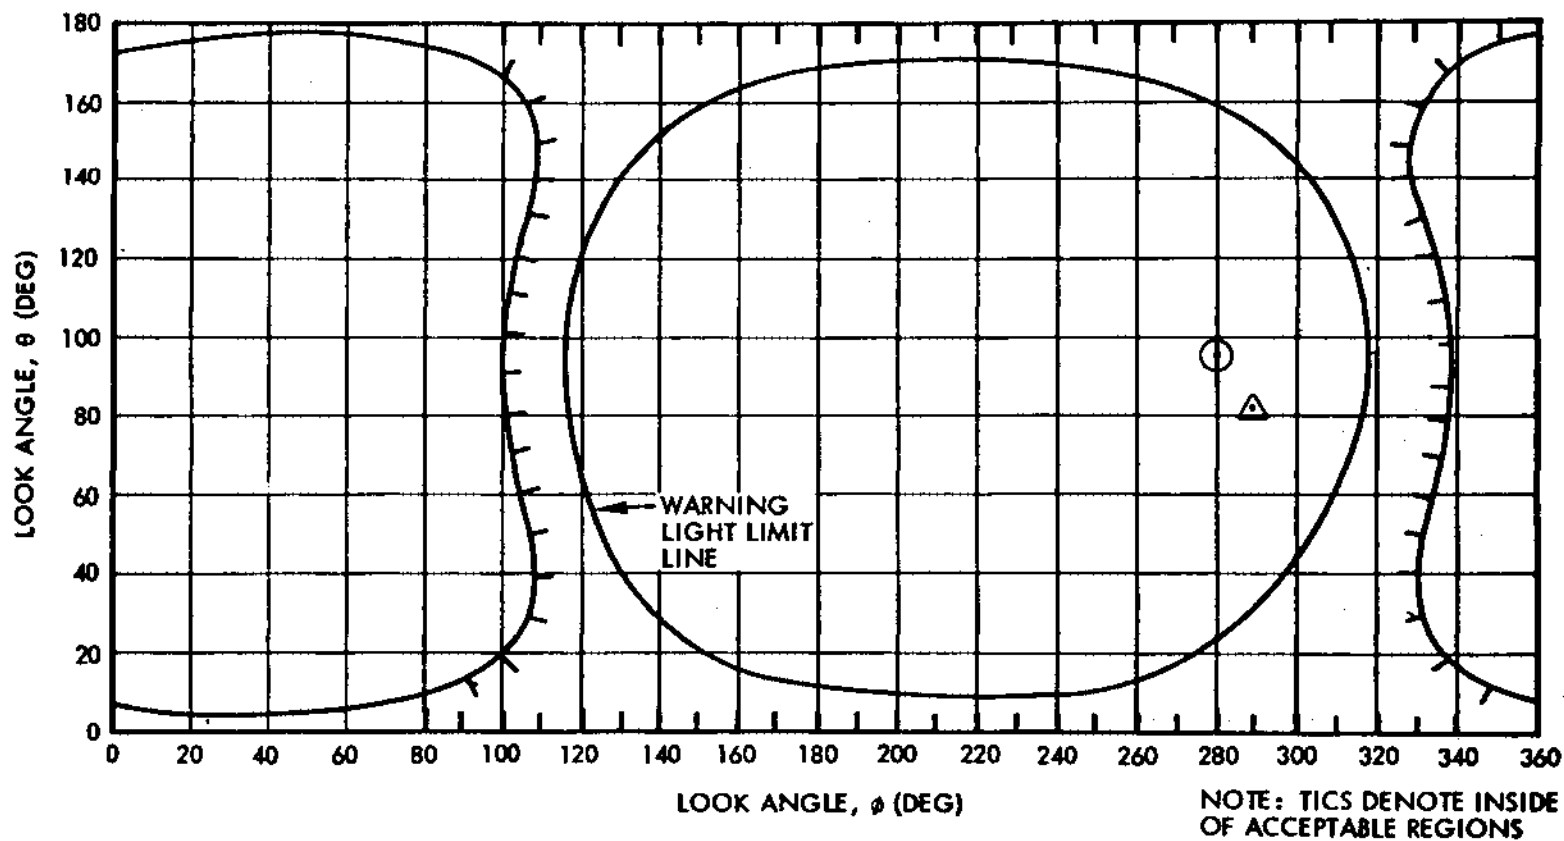
Figure 3-5 Spacecraft To Site Look Angles During Late Acquisition, Lunar Orbit 9

- ⊙ Predicted Look Angles at Acquisition of Signal
- △ Look Angles After Acquisition of Signal

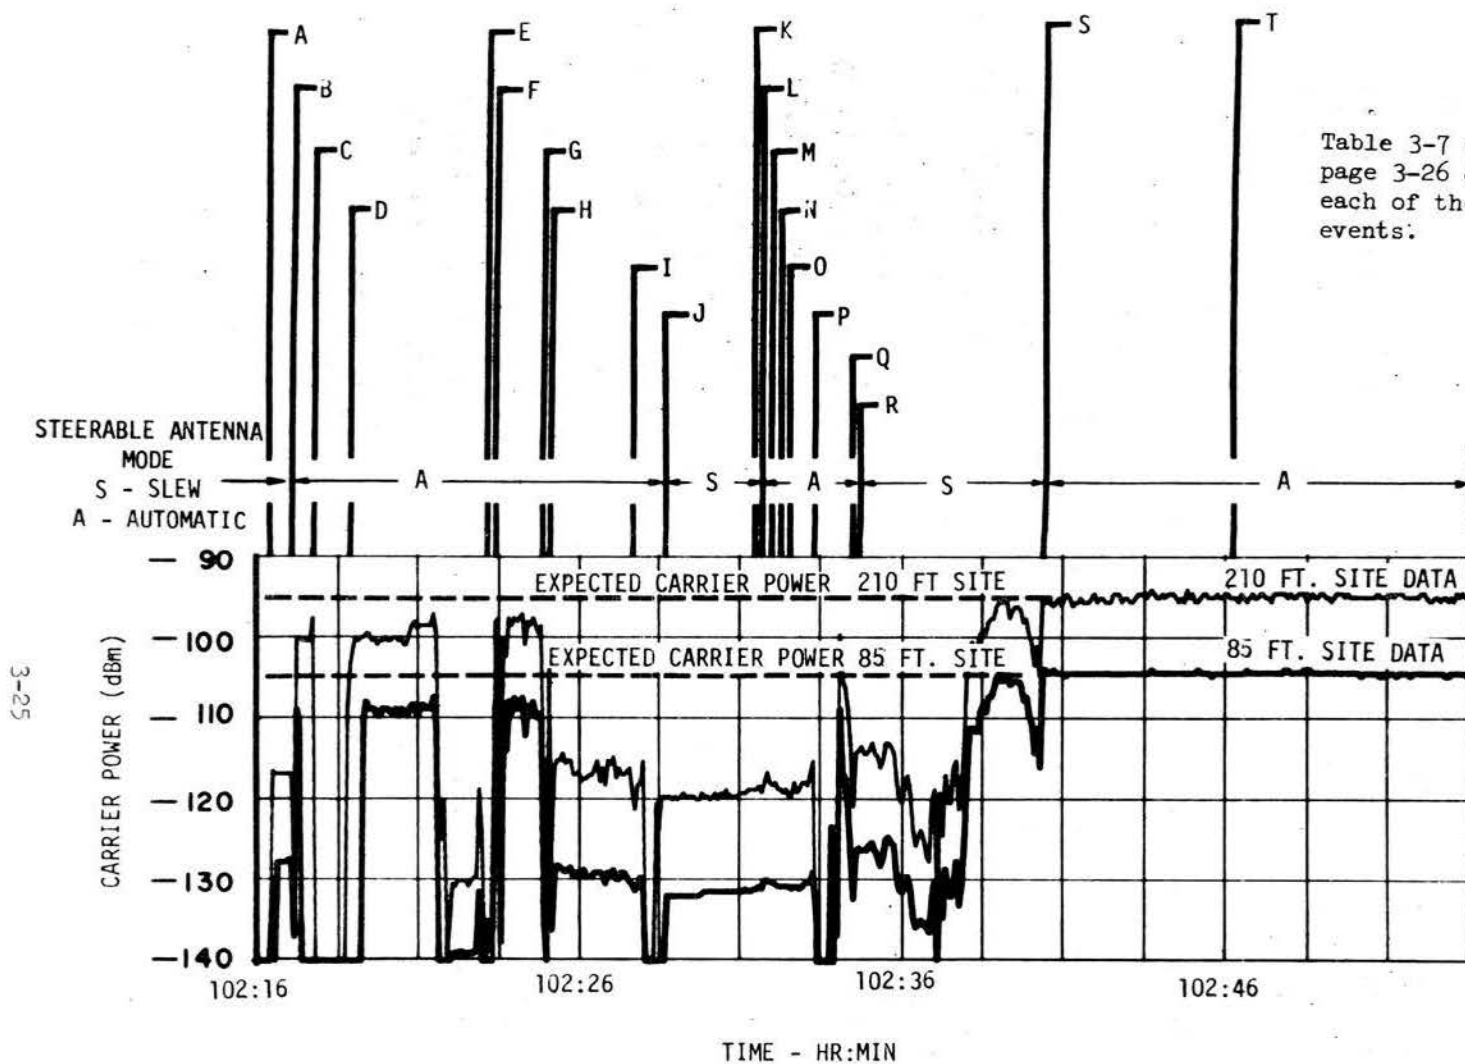
Figure 3-7 Received Downlink Carrier Power, Goldstone, Descent Phase (Apollo 11)

From the scheduled acquisition time of 102:16:30 until 102:34:05, several sharp losses of phase lock were observed. Figure 3-7 presents the downlink received carrier power recorded at the Goldstone wing site. The losses of phase lock were probably caused by a buildup of approximately 1 Hz oscillations in the steerable antenna motion (See Figure 3-8) as the frequencies of multipath from the lunar module and/or lunar surface approached multiples of the steerable antenna switching frequency. The oscillations occurred at approximately the same time that the predicted lunar surface multipath fade frequency approached a multiple of the antenna electronics switching frequency. As shown in Figure 10, some of these oscillations were of sufficient amplitude to cause loss of phase lock while other oscillations built up and decreased without loss of phase lock.

Table 3-7 on
page 3-26 describes
each of the indicated
events:

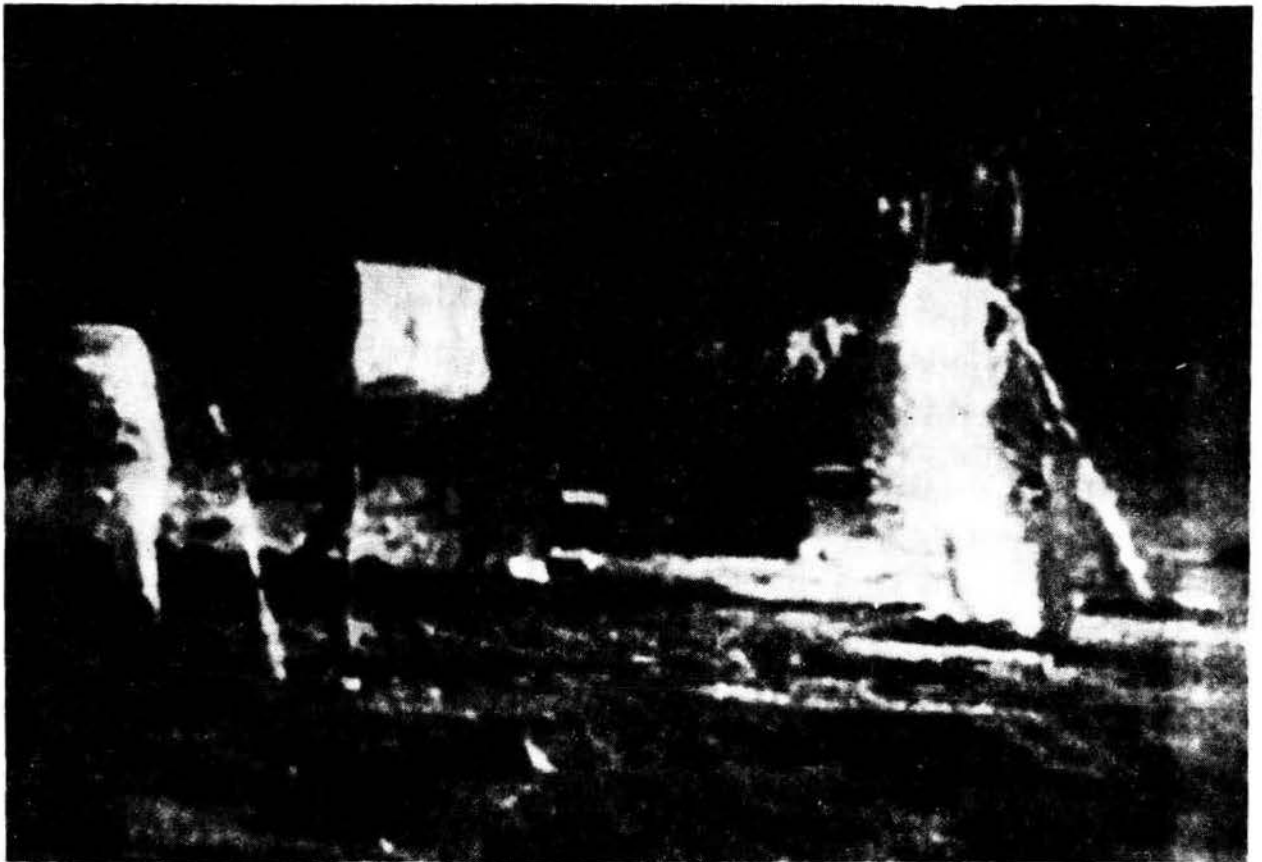
Figure 3-10 Television Picture, Mars 210-Foot Antenna Site,
Extravehicular Activity

The television signal recorded from the Mars site from approximately 110:18:00 to 110:28:00 had an overall signal-to-noise ratio of 16 dB. The picture quality was good. Horizontal jitter was noticed in the post-mission evaluation of the Mars television picture similar to that observed in the picture obtained from the Honeysuckle station. From 111:18:00 to 111:32:00, the television signal recorded at the Mars site had the same picture quality and characteristics as the previous time period and the overall signal-to-noise ratio was 17 dB.

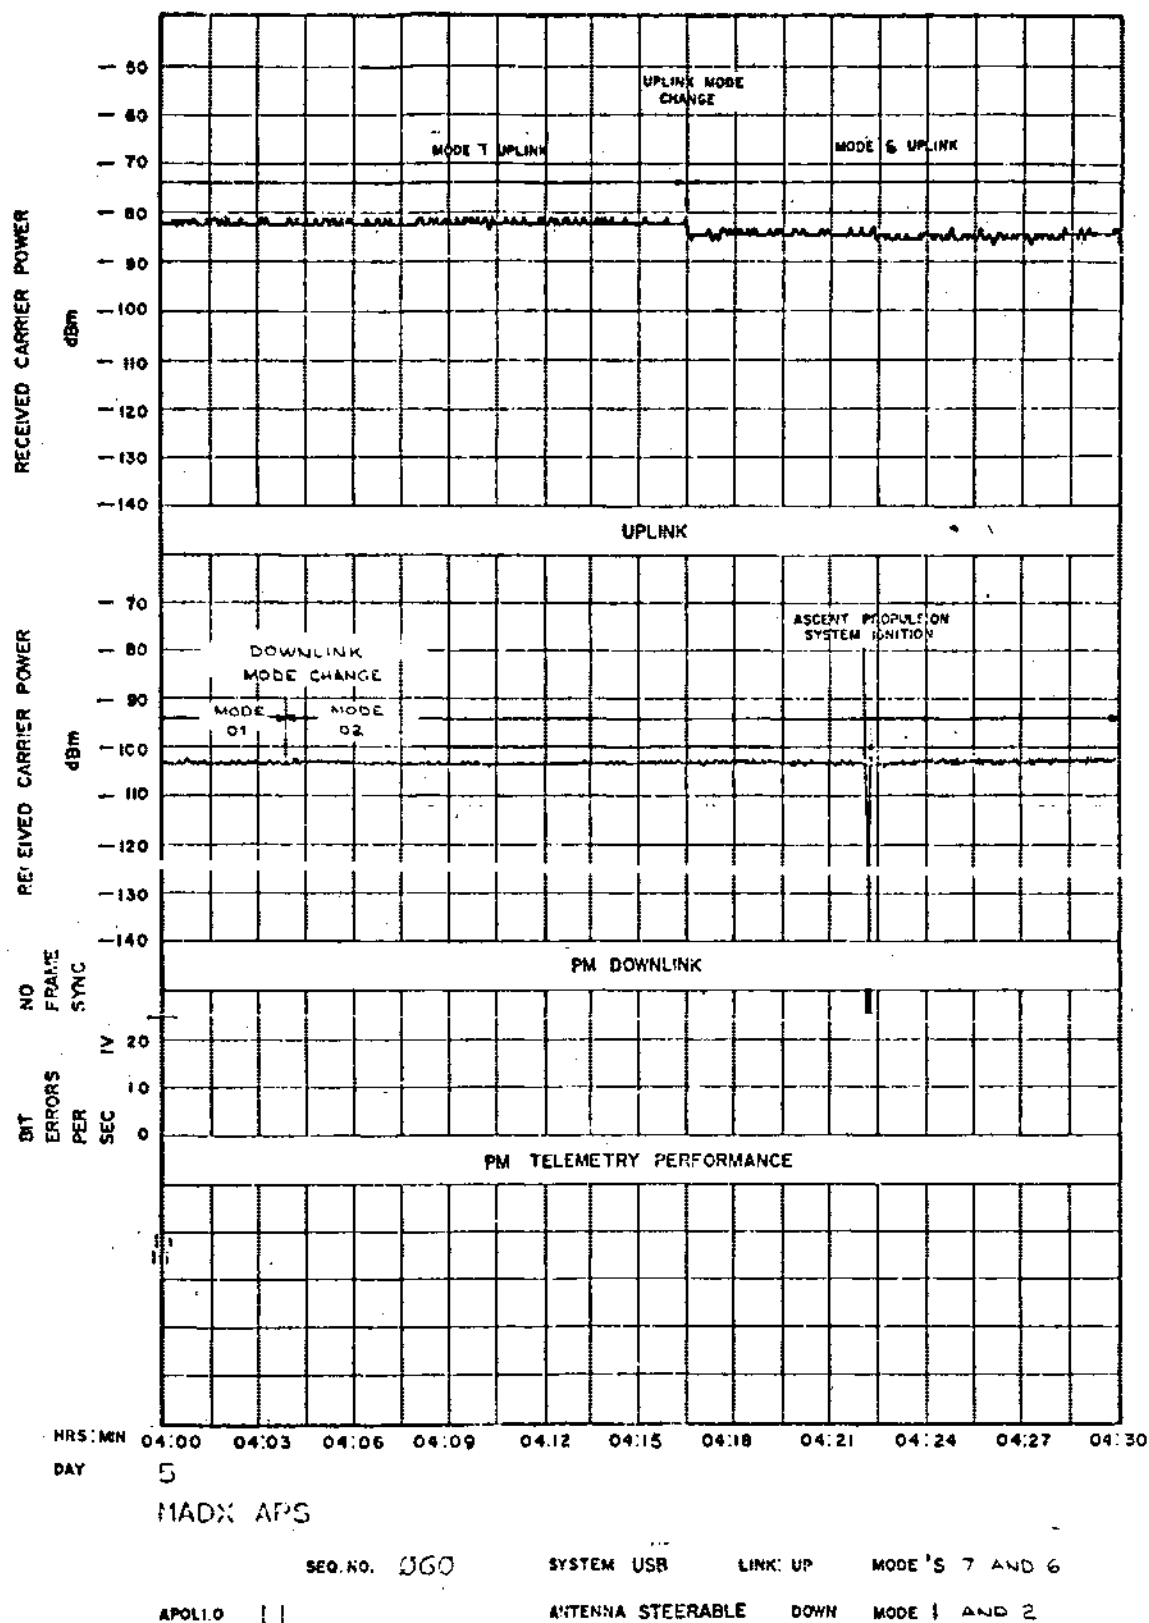
Figure 3-13 S-band Communications Performance, Lunar Ascent Propulsion System Burn, Madrid Wing Site

At 124:04:00, 16 minutes prior to the lunar module liftoff, an abrupt 7 dB decrease was observed in the S-band downlink received carrier power at the Madrid wing site. Postmission analysis revealed no downlink received carrier power change at the secondary receiver, receiver 6, but receiver 5 which was remoting the downlink received carrier power from the lunar module showed a change in automatic gain control voltage

equivalent to 7 dB carrier power decrease. This was apparently due to an instrumentation or receiver problem and was not an actual decrease in received carrier power within receiver 5. No degradation of communications performance was observed.

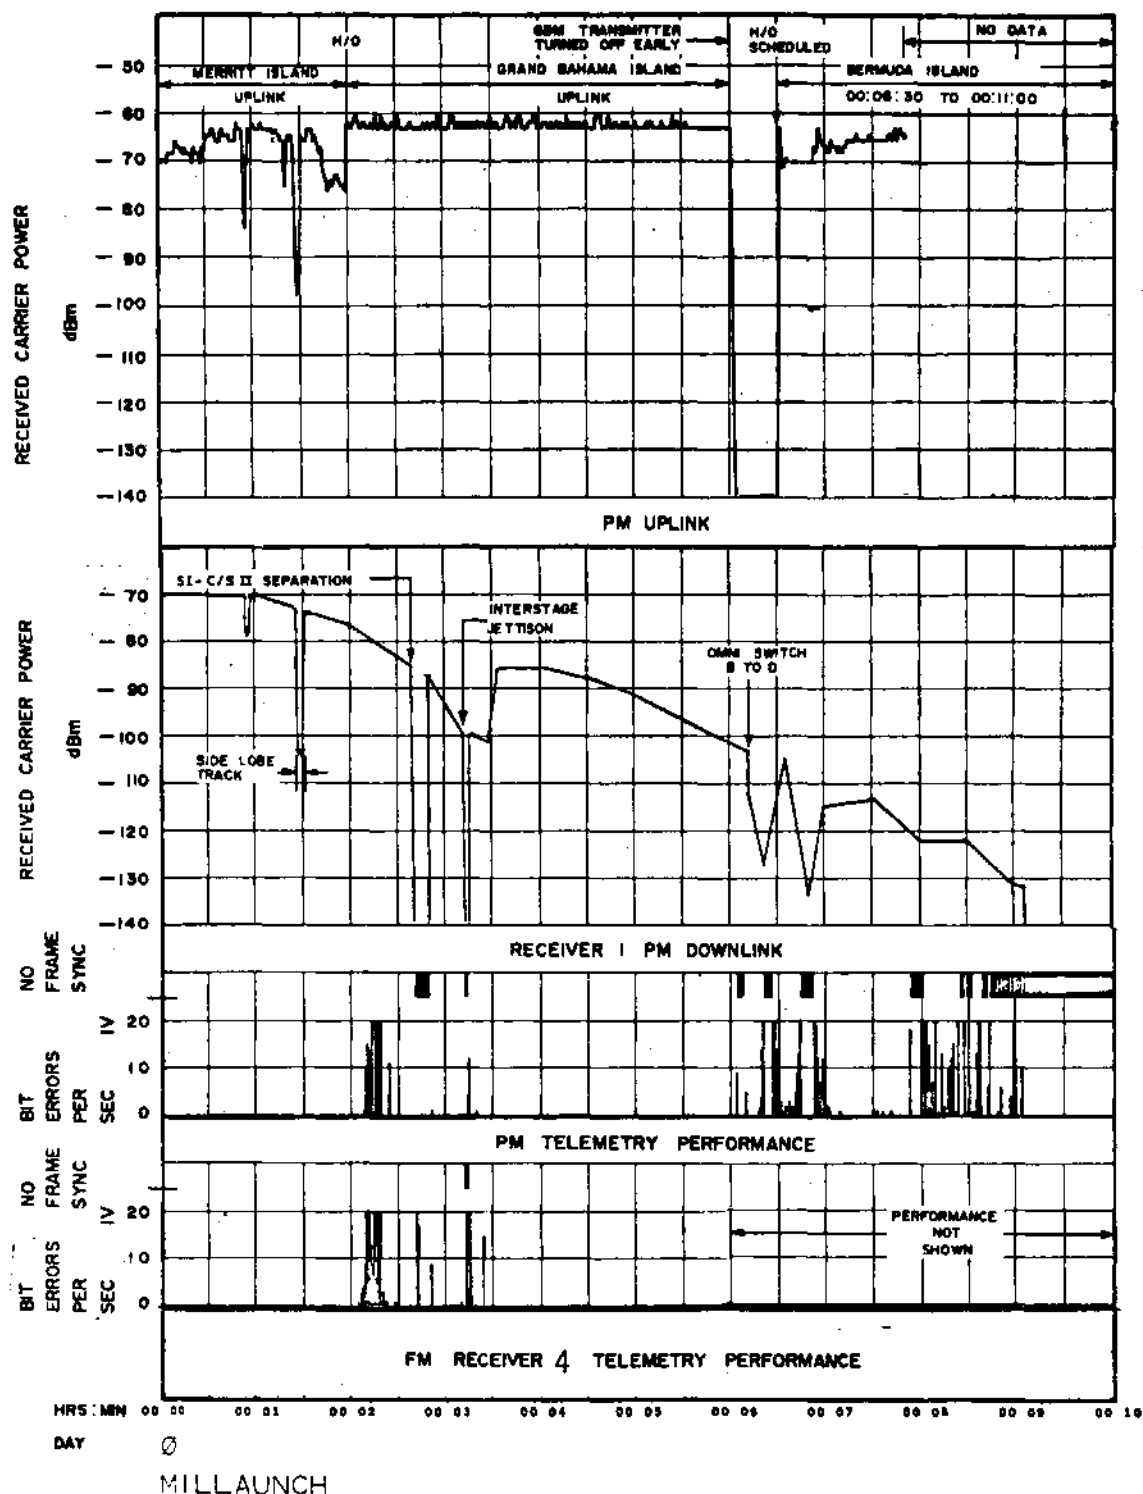
Figure A-1 Merritt Island Station S-band Communications Coverage During Launch

In comparing the communications performance of the Apollo 9, 10, and 11 launches, there was greater coverage with progressively fewer data losses from one launch to the next. Figure A-2 compares the PM and FM receiver performance for these missions. During the Apollo 9 launch, the telemetry data through the PM receiver from 00:02:00 to 00:04:00 was out of frame synchronization for approximately 30 seconds. During the Apollo 10 mission loss of frame synchronization was slightly less than 30 seconds and less than 15 seconds during Apollo 11. However, a higher bit error rate existed for a longer period during Apollo 11 than during Apollo 9 or 10 for the telemetry from the PM receiver.

The Apollo 8 predictions (Figure B-4) did not closely agree with the measured downlink received carrier power after 00:03:00. From Figure A-1, the spacecraft look angle, theta, for Apollo 8 was equal to or greater than 176 degrees beginning at 00:03:00. In this region the Saturn V shadowing of the omni B antenna degraded the RF signal level.

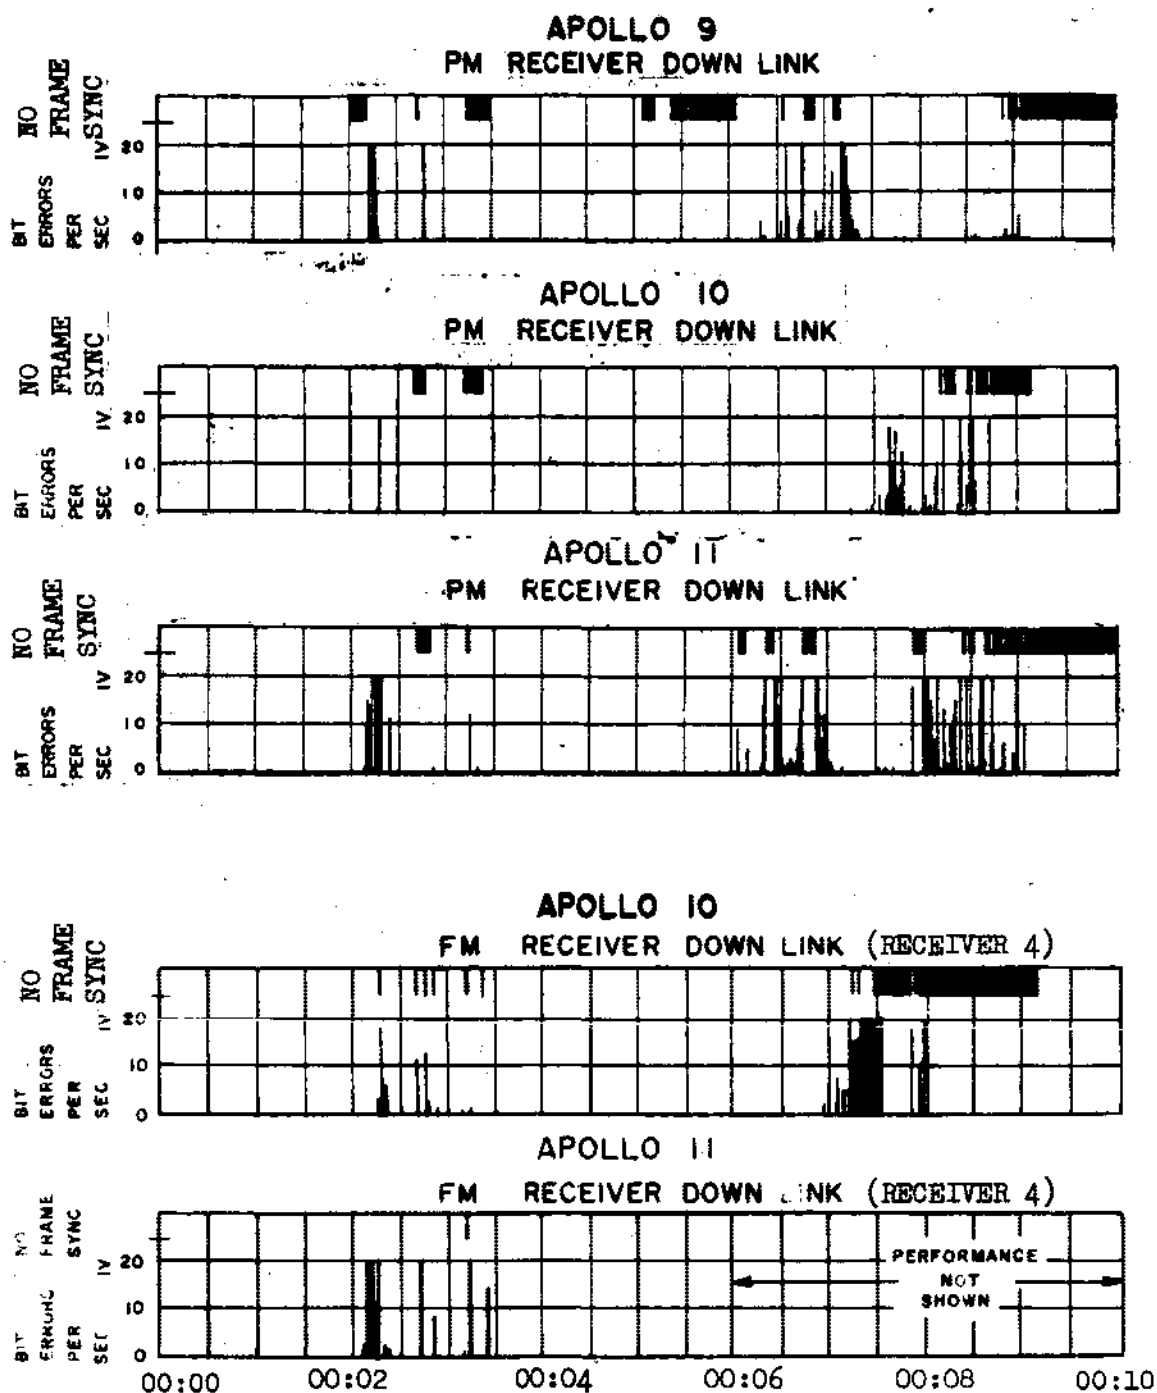
Figure A-2 PM and FM Receiver Performance Comparison

The telemetry data from the FM receiver contained a higher bit error rate during the Apollo 11 mission than during the Apollo 10 mission from 00:02:00 and 00:04:00. However, there were only two 1-second out-of-lock conditions for the Apollo 11 telemetry; whereas, during Apollo 10, five out-of-lock conditions, each lasting from one to four seconds occurred during that period. It appears that a high bit error rate must be accepted while maintaining frame synchronization with the FM receiver. Even though the FM receiver will threshold 4 to 6 dB

sooner than the PM receiver, the signal levels during launch are well above threshold. The overall performance for these three missions shows that the use of the FM receiver offers considerable performance improvement over the use of the PM receiver during the first 5 minutes after launch.

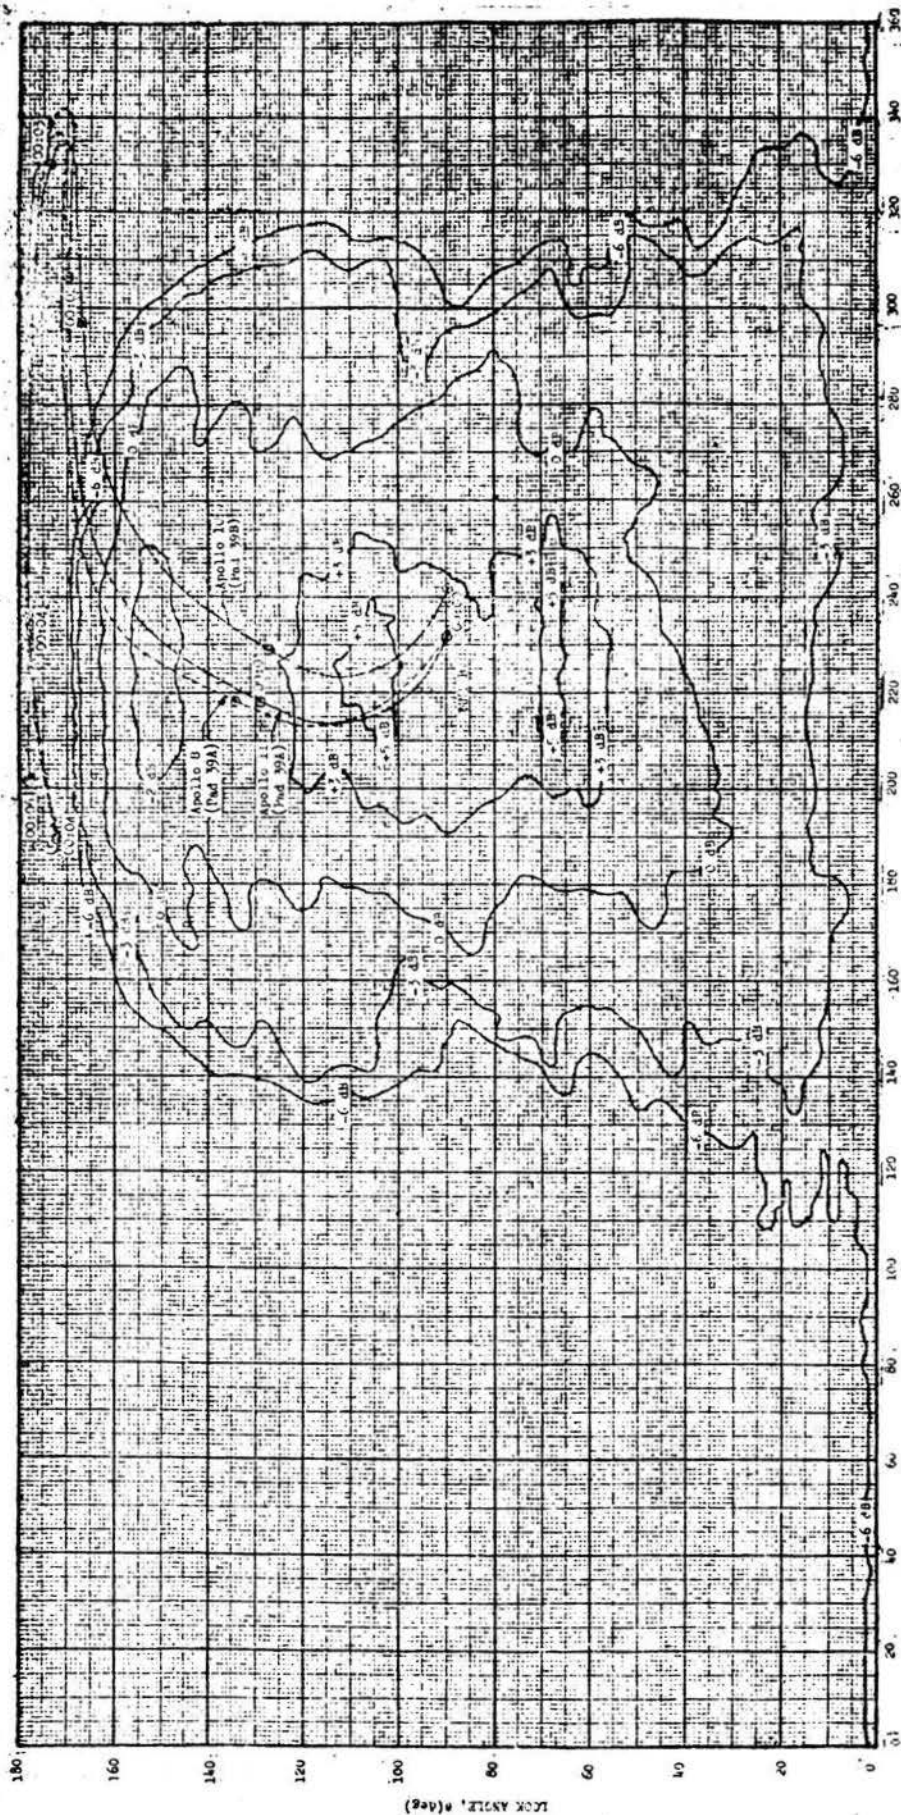
Figure B-1 Command and Service Module Omni B Antenna Gain for Apollo 8, 10, and 11

Figure B-1 presents a plot of omni B antenna gain as a function of look angles, theta and phi. Theta is the smallest angle from the X-body axis of the spacecraft to the line of sight vector to the ground station. Phi is the angle measured from the minus Z-body axis positively about the X-body axis to the vector projection in the Y-Z plane. Each mission launch phase look angles are plotted and time correlated (see References 11 and 12). Therefore, the omni B antenna gain can be computed as a function of mission time.

The launch trajectory for Apollo 10 from launch pad 39B resulted in better look angles to the Merritt Island station in terms of omni B antenna gain than either Apollo 8 or 11. Apollo 8 and 11 were launched from pad 39A and have similar launch trajectories. However, on Apollo 8 the look angle theta remained in the Saturn V omni shadowing region, theta equal to or greater than 176 degrees, from 00:03:00 through 00:06:00.

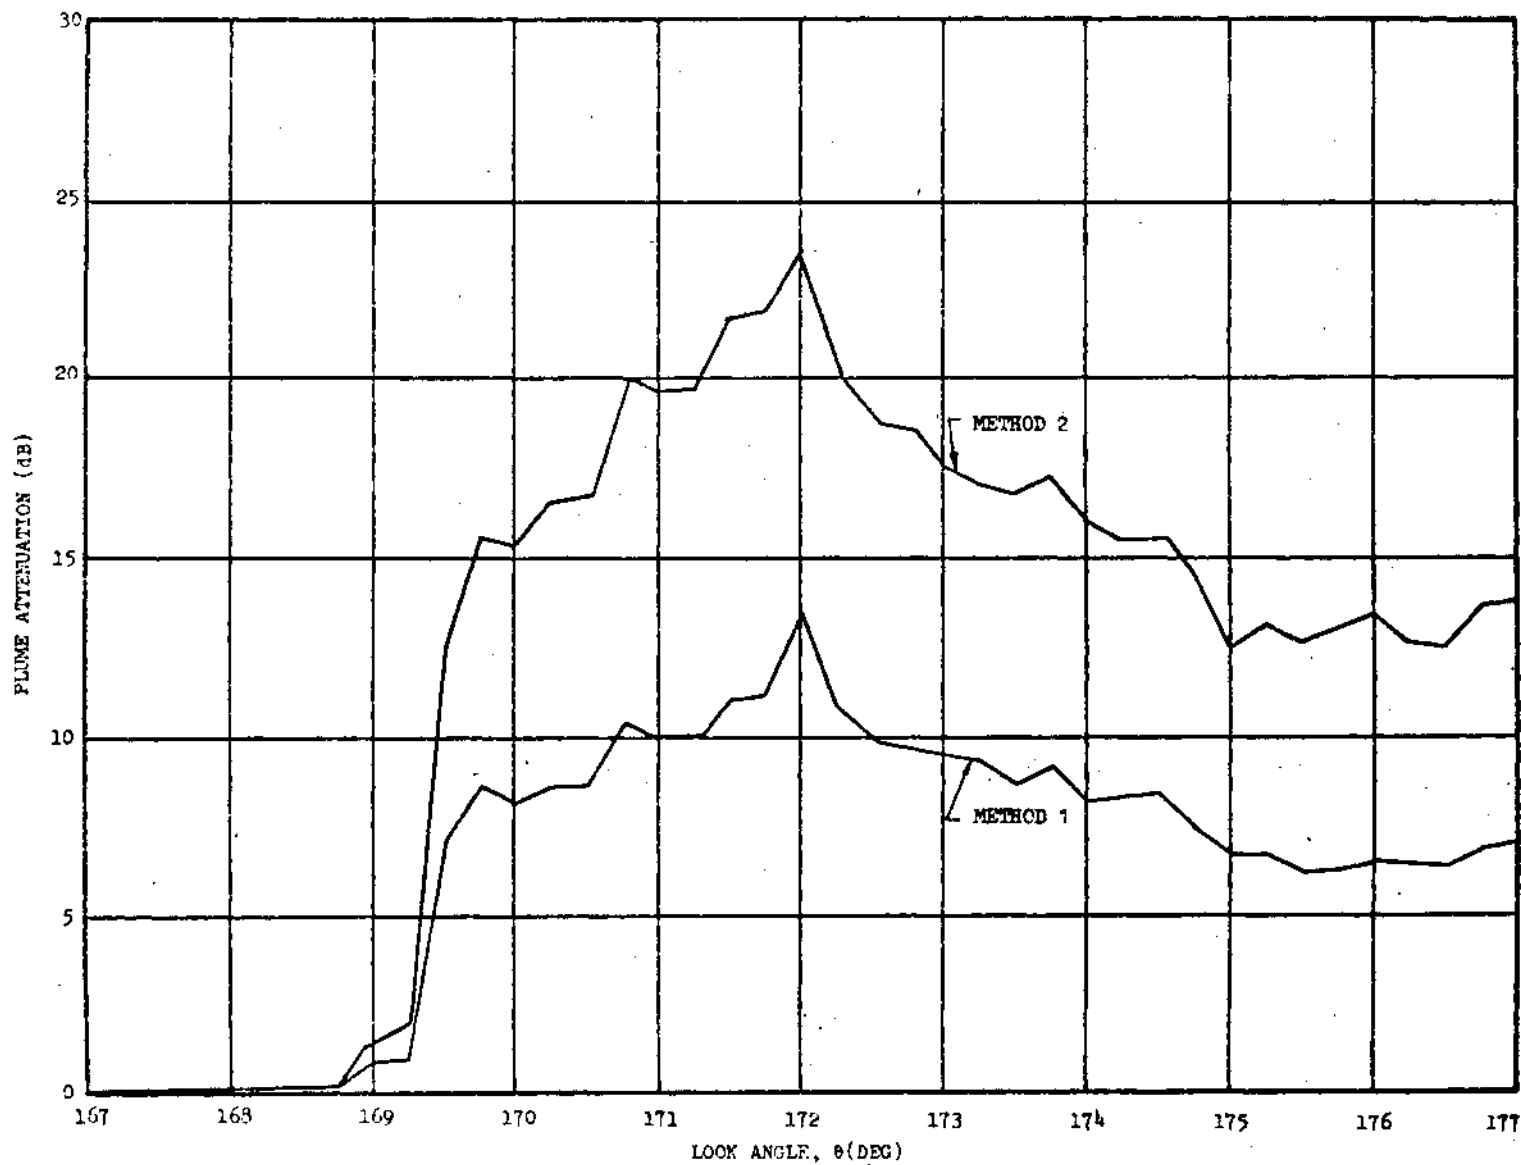
Figure B-2 Saturn V Exhaust Plume Attenuation

Figure B-2 presents plots of Saturn V exhaust plume attenuation as a function of look angle, θ . The exhaust plume is symmetrical about the minus X-body axis; therefore, the exhaust plume attenuation is independent of the look angle, ϕ . Method 1 of computing the exhaust plume attenuation was derived by Dr. J. C. Chang of Lockheed Electronics Company and considers only the conduction current in the plume plasma (see Reference 5). Method 2 derived by Dr. Chang considers not only the conduction current in the plasma, but also includes the displacement current introduced by the equivalent electron dipole moment. Both methods of computing the exhaust plume attenuation are used in this report to predict the downlink received carrier power. The exhaust plume attenuation data presented in Figure A-2 are computed to only 177 degrees because after 176 degrees the main attenuation effect is omni antenna shadowing by the Saturn V. The exhaust plume considered by Dr. Chang and used in this report is for the Saturn IC first stage. The Saturn IC and Saturn II separation occurs at approximately 00:02:30.

In conclusion, while the exhaust plume does degrade the RF performance, the most important factor in signal degradation is the omni shadowing by

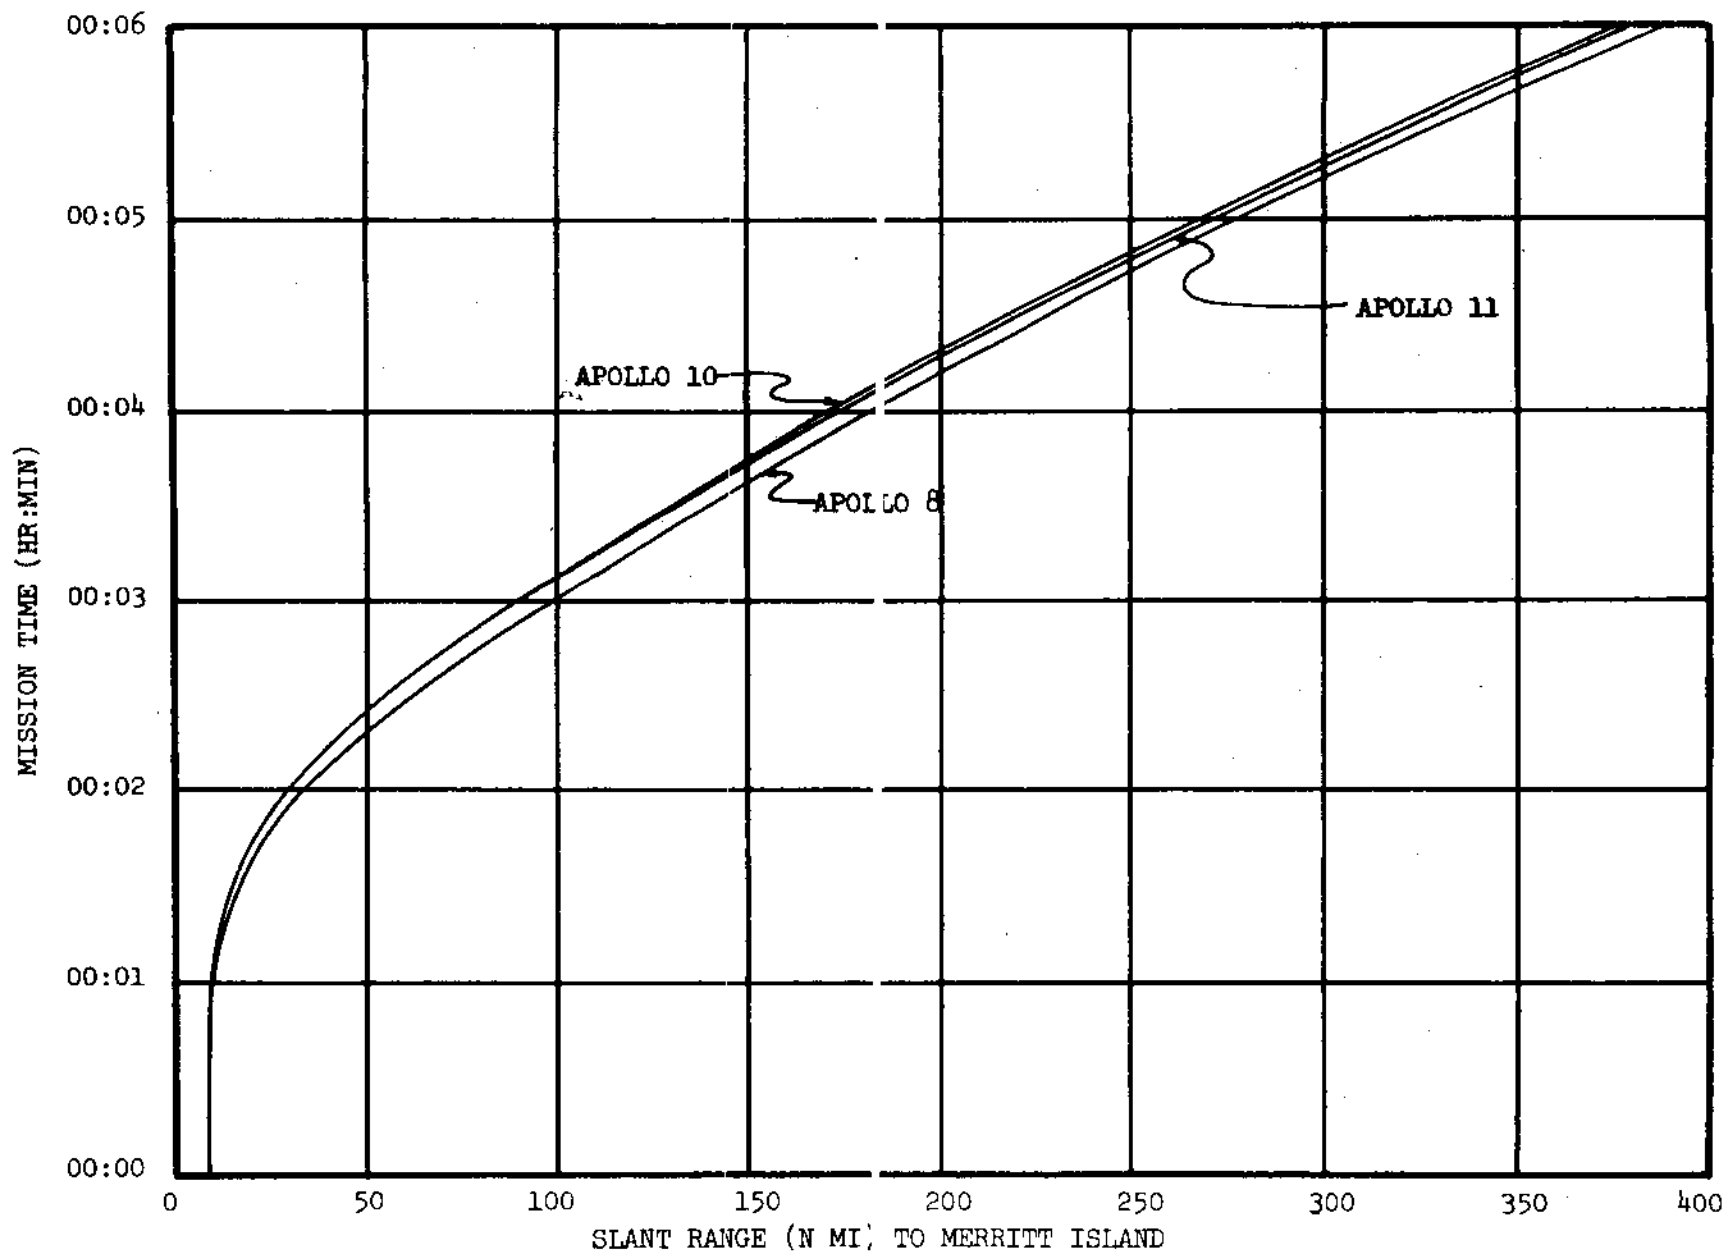
Figure B-3 Apollo 8, 10, and 11 Slant Range Comparison During Launch

Figure B-3 is a plot of slant range from the spacecraft to the Merritt Island station as a function of mission time. It can be seen that there is very little difference in slant range for the respective missions.
