APOLLO 11 MISSION REPORT
SUPPLEMENT 10

COMMUNICATIONS SYSTEM PERFORMANCE

SUPPLEMENTAL REPORT ON
COMMUNICATIONS SYSTEM PERFORMANCE
DURING THE APOLLO 11 MISSION

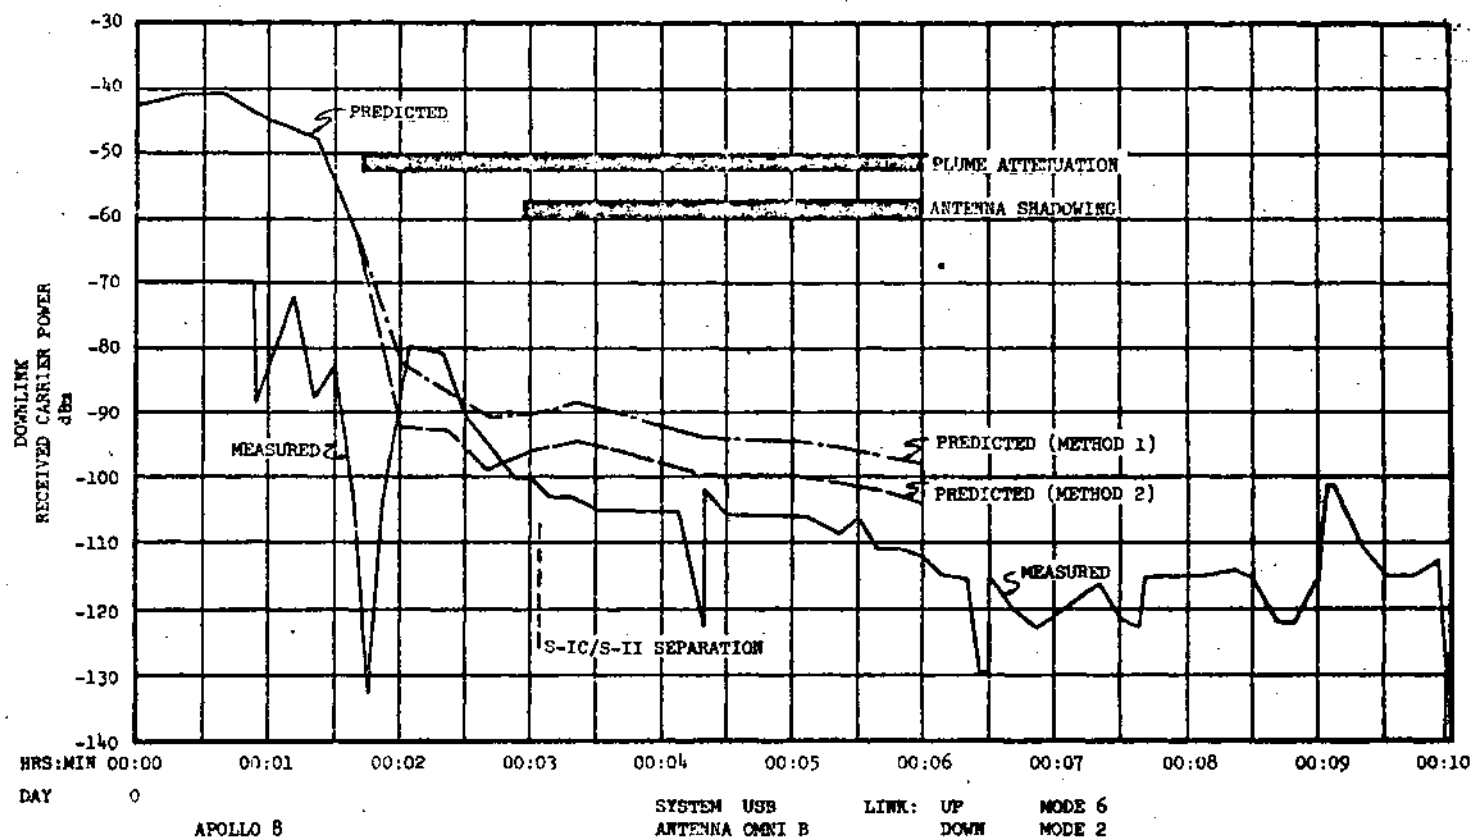
Figure B-4 Downlink Received Power Levels During Apollo 8 Launch

Figures B-4, B-5, and B-6 present a comparison between the predicted and the measured downlink received carrier power levels for Apollo 8, 10, and 11 respectively. The measured values are truncated at an upper level of -70 dBm by the Automatic Data Evaluation program used to plot the measured data.

The Apollo 8 predictions (Figure B-4) did not closely agree with the measured downlink received carrier power after 00:03:00. From Figure A-1, the spacecraft look angle, theta, for Apollo 8 was equal to or greater than 176 degrees beginning at 00:03:00. In this region the Saturn V shadowing of the omni B antenna degraded the RF signal level.

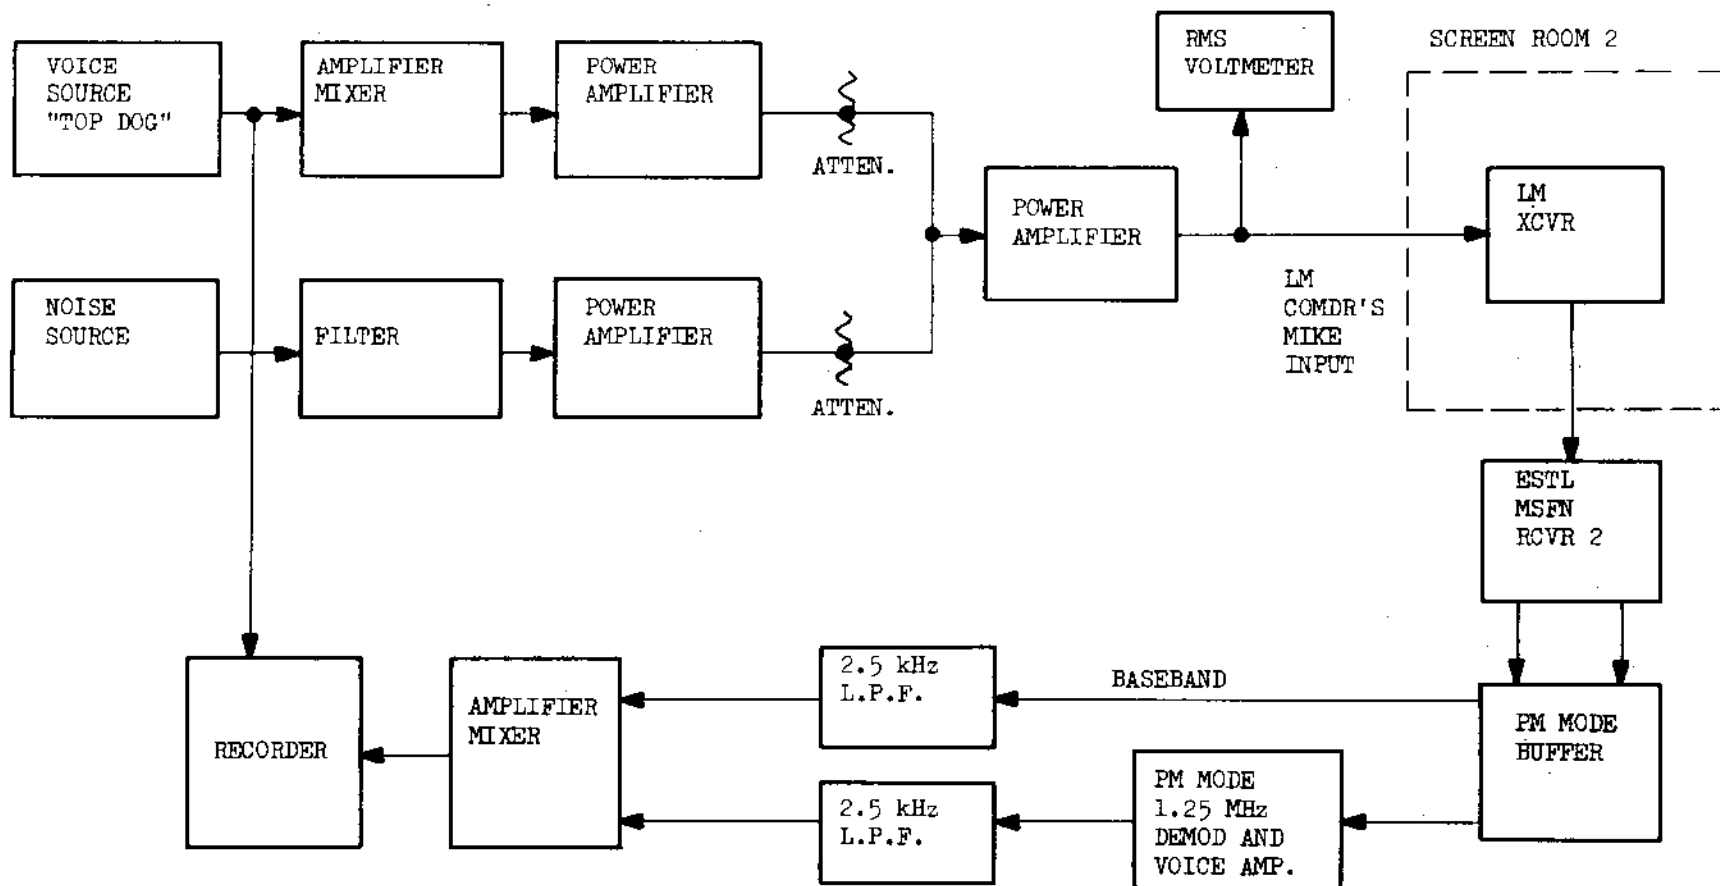
Figure D-1 Electronic Systems Test Laboratory (ESTL) Test Configuration

A Manned Space Flight Network station using a cooled parametric amplifier results in approximately a 10 dB improvement in sensitivity when compared to the Electronic Systems Test Laboratory configuration. Therefore, for signal combination 1 a correction factor of approximately 15.7 dB exists between the total received power as referenced in the laboratory to the received carrier power as obtained from station data. Also, for periods of no voice modulation for signal combination 4, a correction factor of approximately 13.8 dB exists between the laboratory data and station data.
