Status of MACRO PMT pressure tests at SAB

Logan Lebanowski, Shih-Kai Lin

2010 November 18

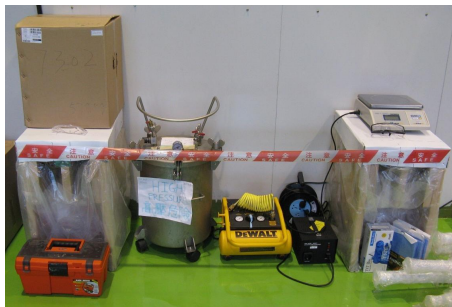
As of November 18, we have passed 97 of 108 tested MACRO PMTs

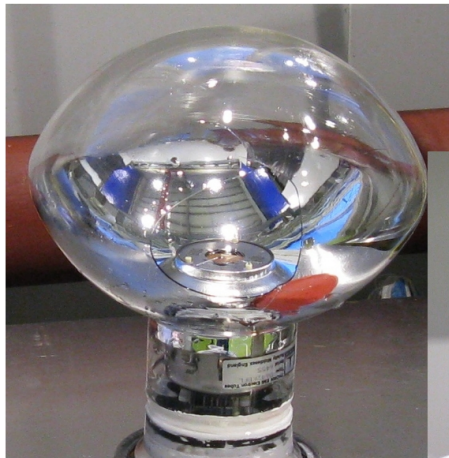
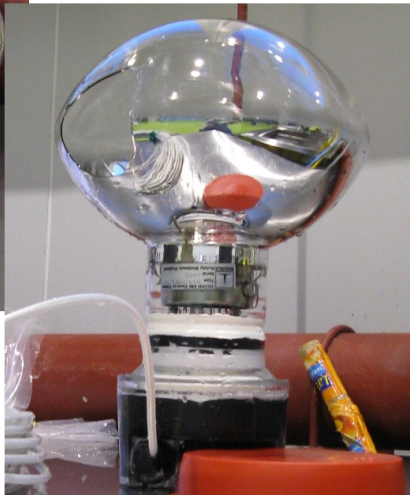
photos: PMT 6455

SN	mass(g)	pressure (psig)	test time (h:m)	result
8927	3046.5 [†]	13.0	16:42	PASS ²
7113	3042.5 [†]	11.9	7:49	PASS ¹
6908	589.0	12.0	15:00	PASS ¹
7727	583.5	12.0	8:13	PASS ¹
7224	614.0	12.0	16:18	PASS ²
6300	608.0	12.0	46:47	PASS ²
7660	593.5	12.0	8:18	PASS ¹
6587	570.5	12.0	15:00	PASS ¹
6455	558.5	12.2	<8:21	FAIL ³
7739	594.0	12.1	15:20	PASS ¹
7037	576.5	12.1	7:10	PASS ¹

³ PMT was broken. (see photos in the next page)

SN	reason of failure
8430	crack and hole on photocathode
7046	imploded
6545	imploded
6455	broken
