Identifying Issues Related to Domestic Plumbing, Corrective and Preventive Measures :A Case Study

K.A.D.S. Karunaratna

Kasun Nandapala

Abstract—Plumbing-related issues (Blockages, Leakages, and damages etc.) after construction are common in any type of buildings. Mostly it leads to damage the building structure, water waste, safety issues of users and as unexpected high maintenance cost etc. This study focuses on proposing corrective and preventive measures for common issues in plumbing and sanitary related. As a case study, three site locations that have plumbing problems have been selected in the Western South Department of Buildings, Survey Department, and Foreign Ministry Quarters. The most common issues have been identified by a technical inspection in the above three locations and using the analysis of financial cost usage for past 5 years of time. The main issues highlighted are leaks and damage to pipe fittings, pipes, sanitary fittings, and blockages in waste lines. It was established through a questionnaire that problems with most caused by poor maintenance. Then, corrective and preventive measures have been identified for these issues. Corrective measures have been pr

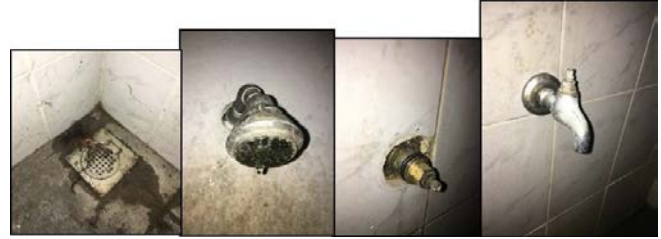
Fig. 1. Blockages, Leakages and Damages

As mentioned above, a visual site inspection survey was carried out to identify the extent of plumbing-related issues in the selected buildings. Figure 1 and Figure 2 exhibit some of the observed issues. Additionally, a list of issues has been prepared at each of the three locations and is presented in Table II.

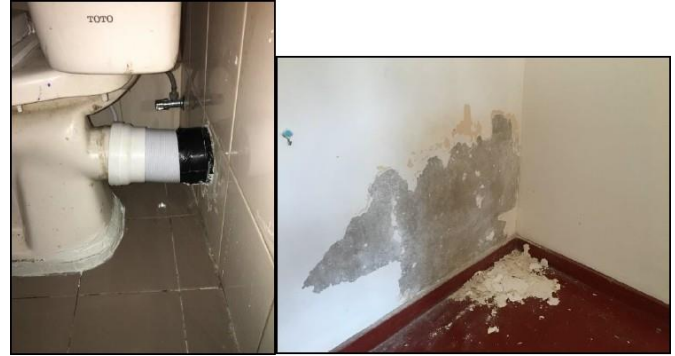
Fig. 2. Leakages
