198 - Untwist CW fault - NM72 NM82 V82 Mk1-5

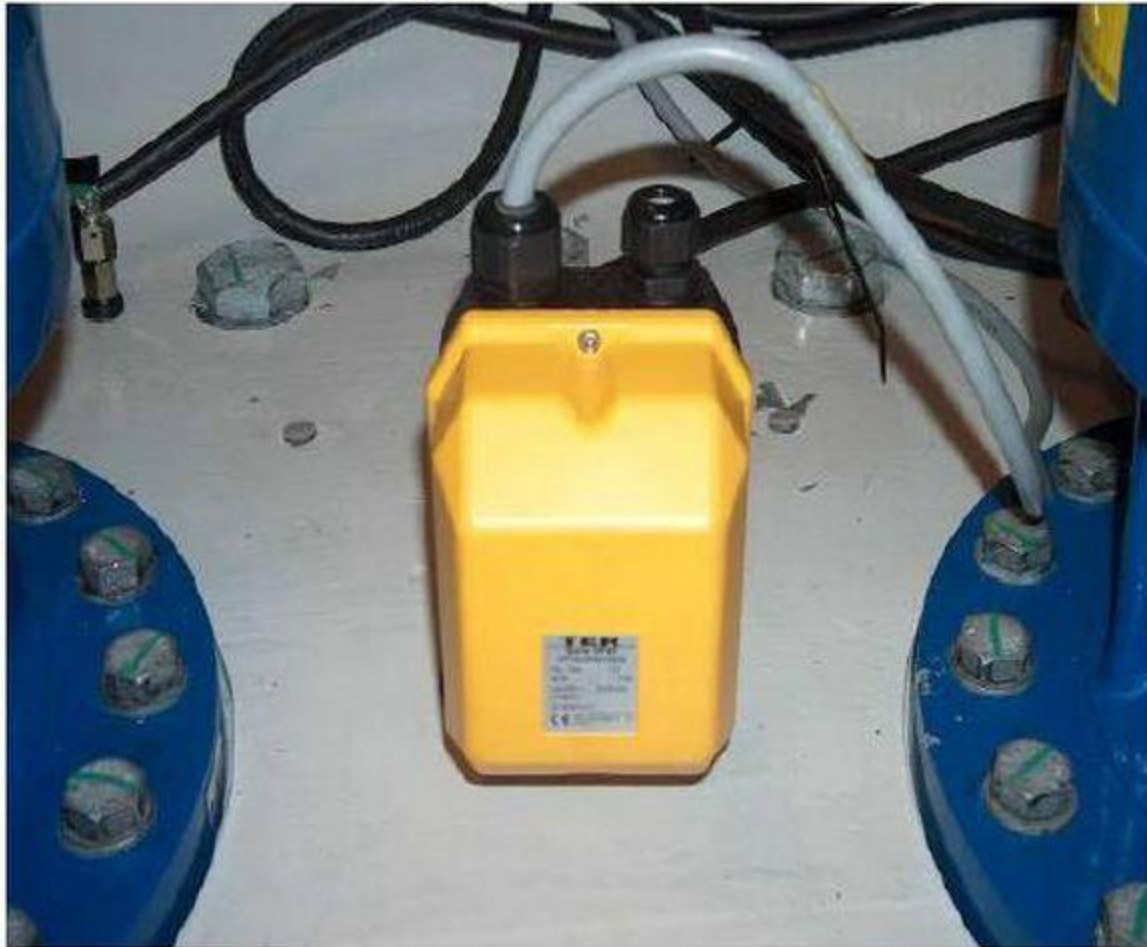
Check the yaw box settings and perform cam adjustment. Refer to [0000-9925](#) Commissioning Instruction Section 5.14.3.

Adjusting the Yaw Twist Box per SWI [0004-4426](#).

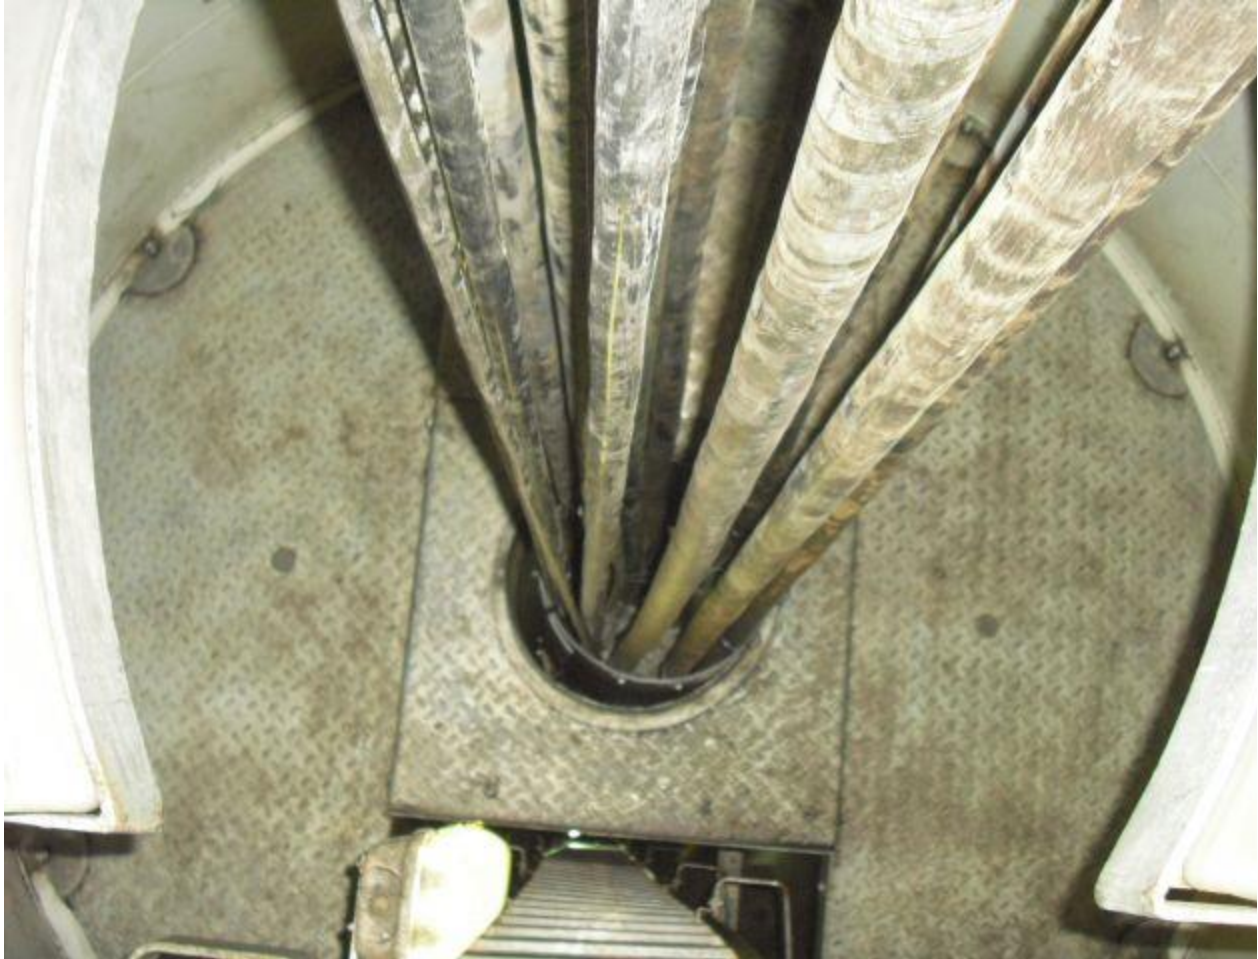
Check the power cable when the nacelle has rotated to the maximum cable twist. If required, manually operate the yaw system and return the nacelle to zero manually.

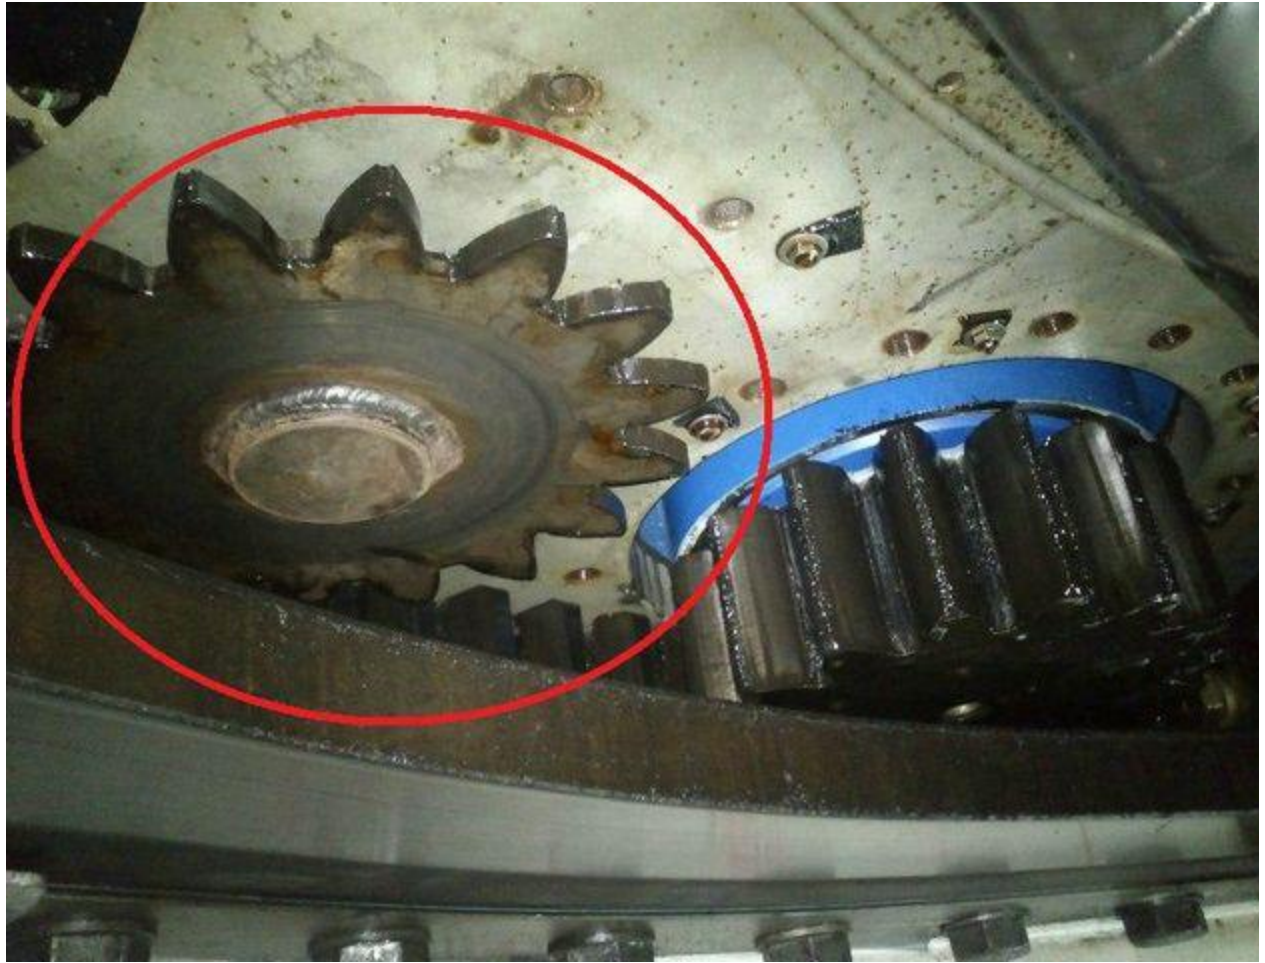
Check the yaw reader wheel which is connected in the yaw box

Check the teeth in the remaining yaw gear pinion wheels for any damage.

Replace the damaged yaw reader wheel
Does this solve the problem?
