Check the shaft brake switch and circuit connection

Property of Vestas Wind Systems A/S. This drawing must not be passed on to any person, nor be copied or otherwise made use of without our approval.		Date	Initials	Function	+AN12 Plant Outline		
	Designed	070628	FLT	Project title	Plant Outline V82-1.65MW 1 Speed Mk5 50Hz		
	Approved	070628	FLT	Comments	Customer: Vestas Wind Systems A/S		
	Revised	070628	INI	Rev.	Drawing no.	934702	Cont. sheet 045 Sheet 044

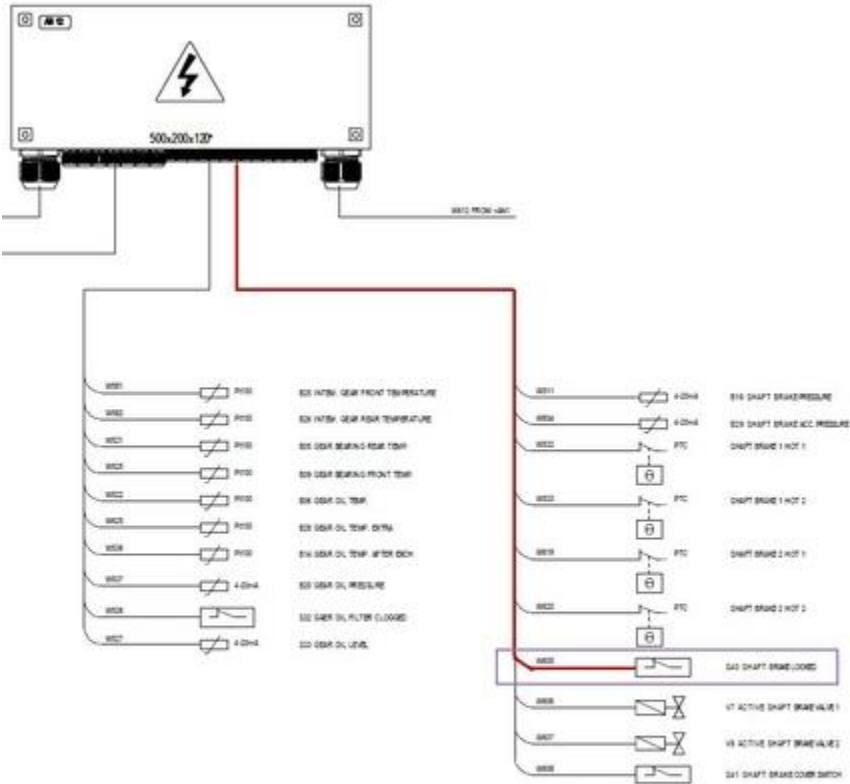
- Explanation
Check the Cable termination tightness and re-tighten, if found loose connection;

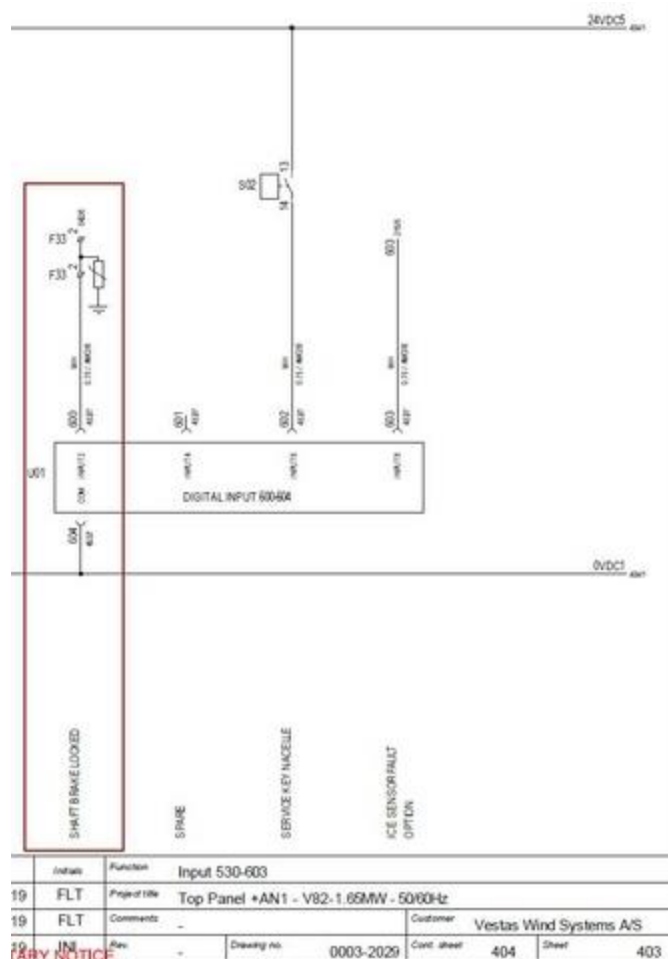
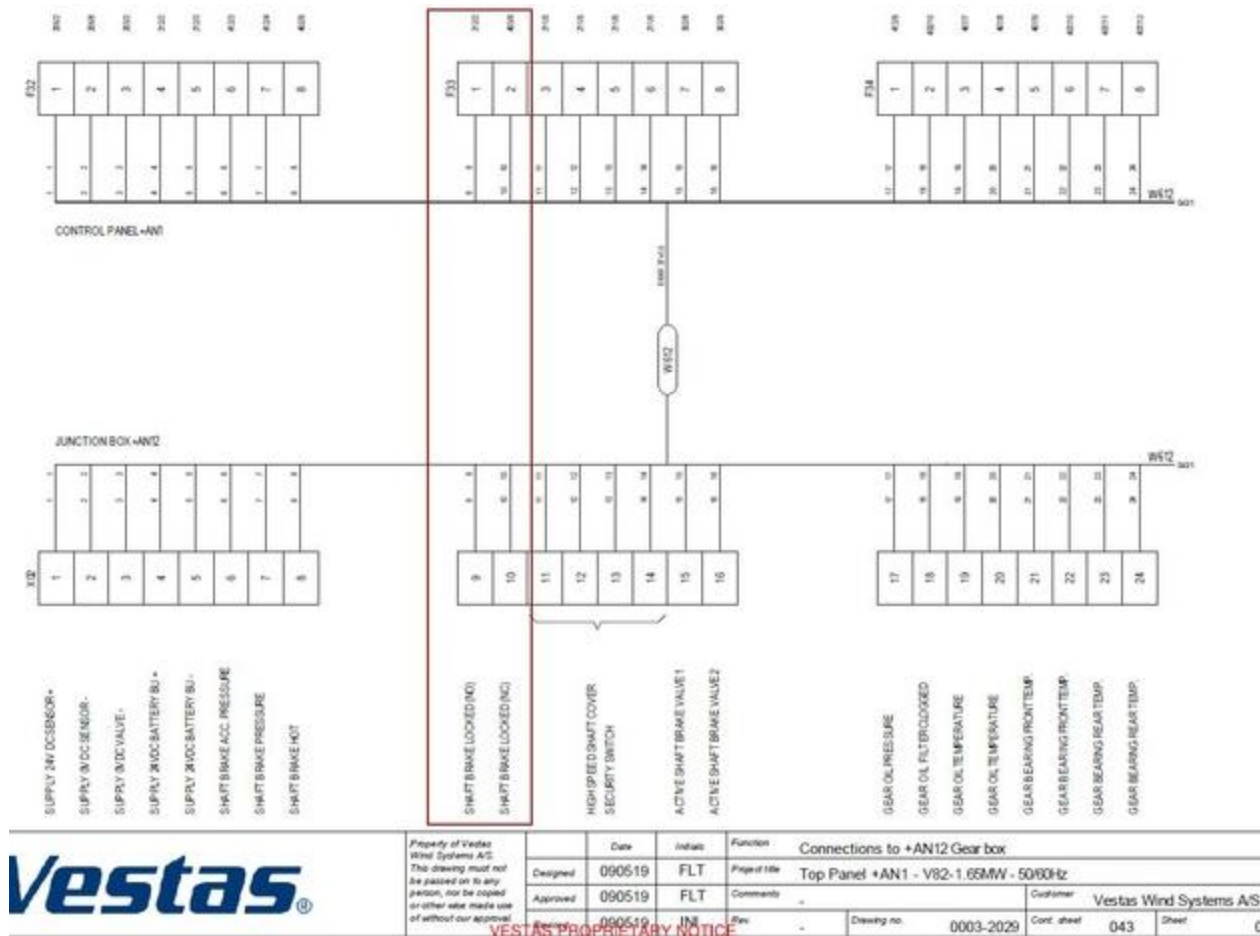
Check the Operation of S40 Switch and replace, if not operating as intended.

Activate the spring mechanism and check the continuity between 13 -14 and 21-22

Check and Replace the switch

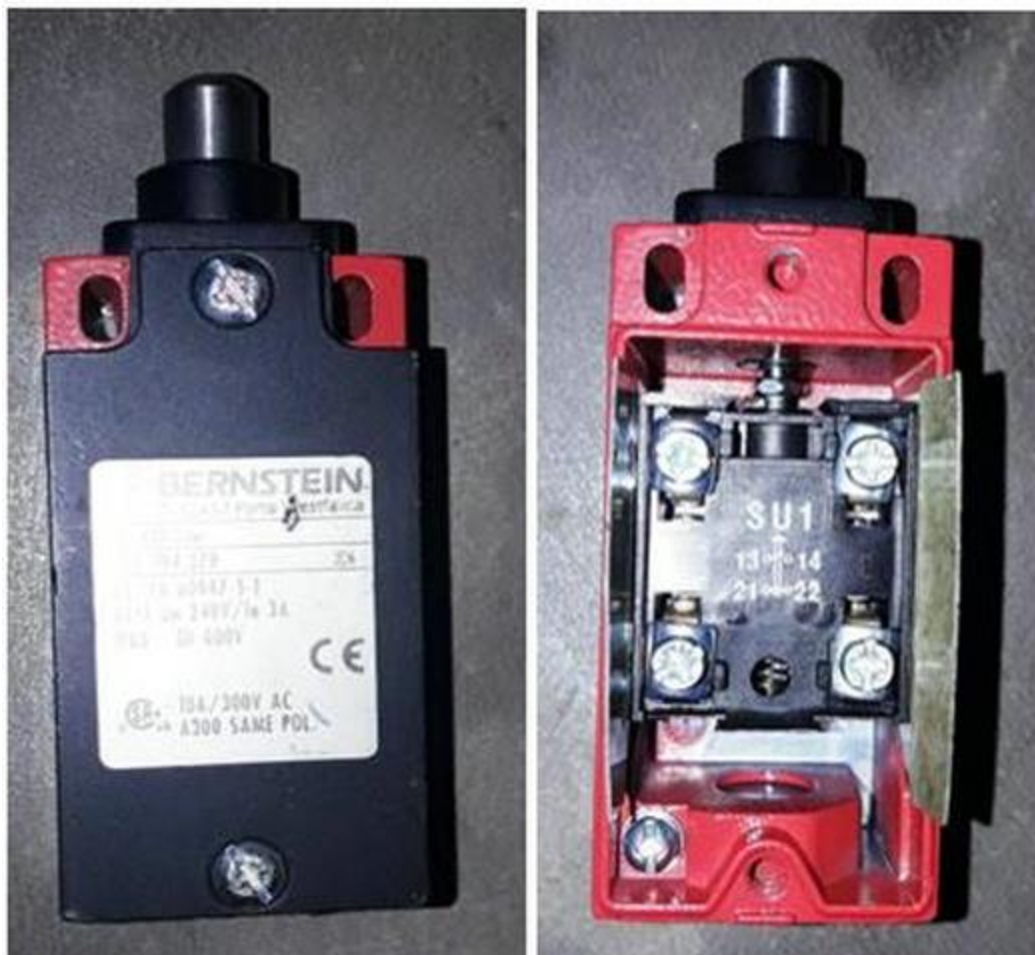
Relevant spare parts	
Description	Item No.
ENDSTOP SWITCH 6021194379 GC-S	60103640
