# BMW Airhead Oil Filter Canister Displacement: Service Practice, Load Paths, and the \$2,000 O-Ring Myth

## **Abstract**

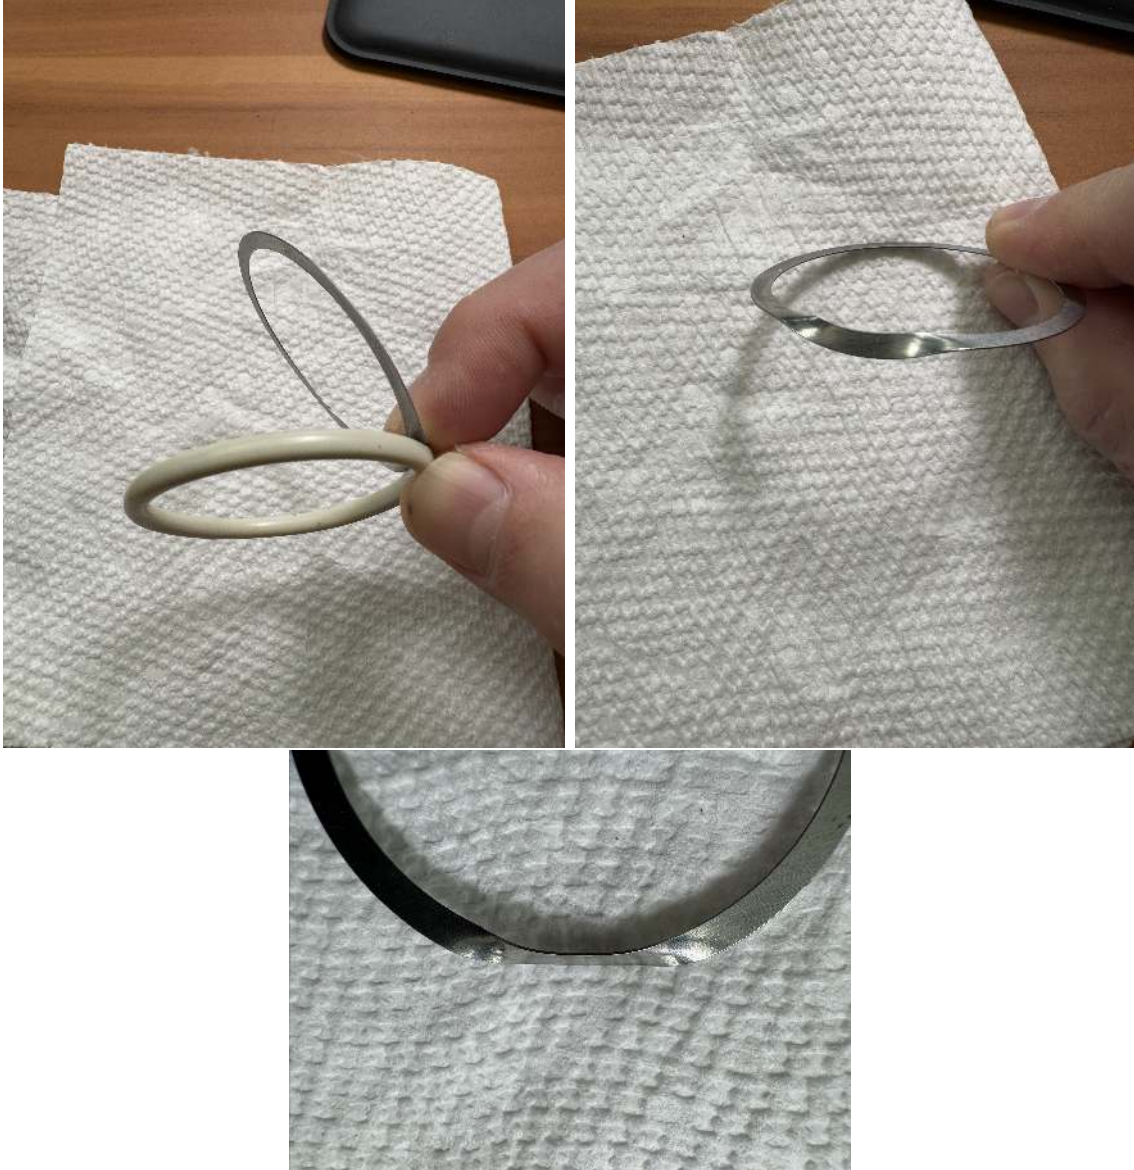
**Figure 1:** *O-ring and shim condition as found. The shim shows smooth, continuous plastic curvature in the region rendered unsupported by radial displacement of the canister mouth. The O-ring appears nominal in the images and is included for reference; its contribution to the observed deformation arises from load redistribution under geometric constraint rather than from visible material distortion.*

The O-ring visible in Fig. 1 appears nominal and is included primarily for reference. Its mechanical role is indirect but decisive: once local support at the canister mouth was compromised, the O-ring—effectively incompressible in volume—continued to transmit its axial preload into the seal stack. With the load path constrained by the surrounding geometry, this preload was redistributed into the unsupported portion of the shim, producing smooth local plastic bending without requiring global overload or gross misalignment. In this condition, the O-ring transitions from a compliant sealing element to an effective load-transmitting medium.

Distinguishing rigid-body motion from localized yielding is difficult *in situ*; however, both mechanisms are consistent with the observed seal extrusion shown in Fig. 1. The demonstrated ability to re-center the canister (Fig. 2) strongly supports a lightly retained, non-heroic press-fit rather than a rigidly fixed component.

In this case, the presence of a visibly damaged and displaced O-ring reinforced an incorrect initial diagnosis focused on elastomer behavior. Only after recognizing the canister displace-

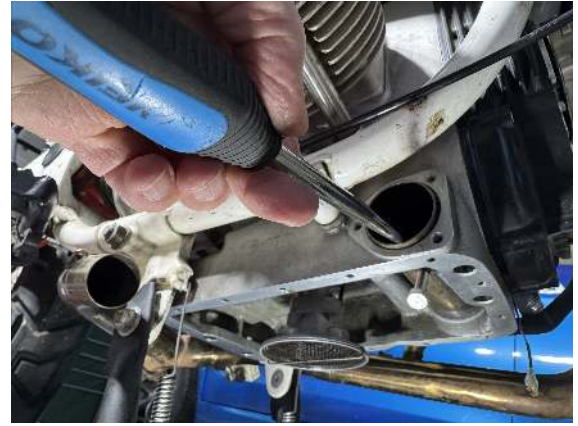
*(b) Counter-torque applied to maintain axial alignment and prevent bore damage.*

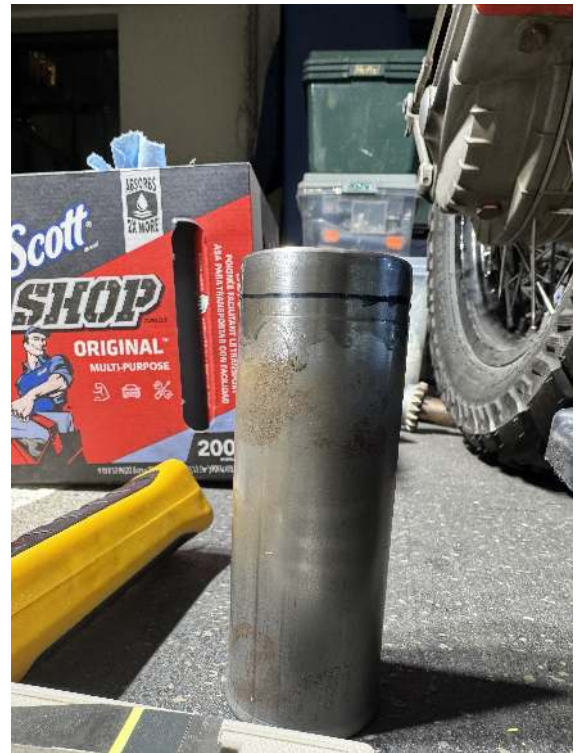
*(d) Replacement canister distal end cleaned and lightly oiled prior to insertion. Note the traced insertion depth check line.*

Prior to insertion, the distal end of the replacement canister was cleaned with gray Scotch-Brite to remove light surface oxidation and condition the surface for uniform contact during seating. The contact region was then lightly lubricated with engine oil to reduce insertion friction and mitigate the risk of galling.

- Final depth control was achieved through direct measurement by transferring the wear mark from the original canister onto the replacement canister (Fig. 3d), and tapping the replacement canister into the bore until this reference mark was reached (Fig. 3g). This approach leverages the confirmed axial equivalence of the original and replacement canisters, with any residual variation accommodated using external shims.
