# BMW Airhead Oil Filter Canister Displacement: Service Practice, Load Paths, and the \$2,000 O-Ring Myth

## **Abstract**

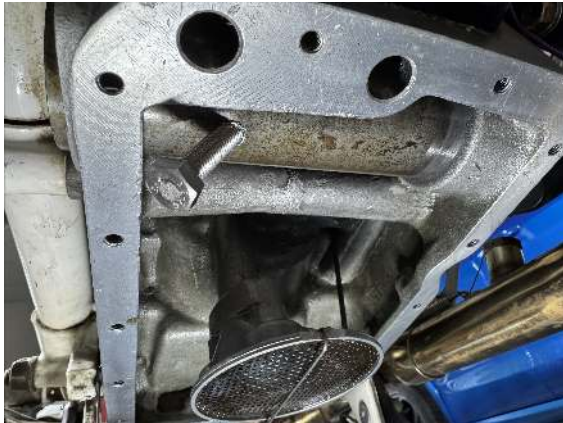
*(a) Localized wall deformation during drive-out tapping. The bolt contact reaction at the canister wall was effectively radial prior to tapping. Plastic deformation and bolt rotation within the thin sheet are unavoidable.*

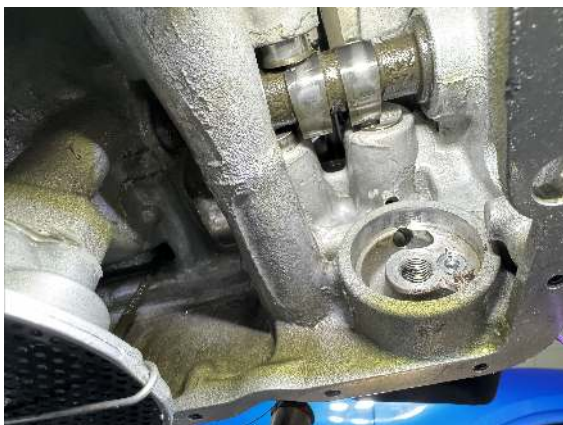
*(c) Canister removed after controlled tapping sequence.*

5. **Completion and inspection.** Once released, remove the canister by hand. Carefully remove all chip containment measures and clean the cavity thoroughly. Inspect the bore for scoring, raised material, or damage before proceeding with installation.

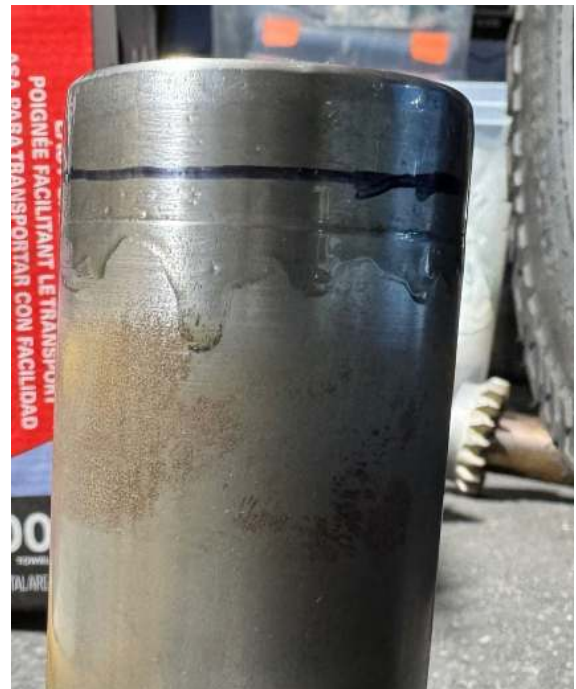
*(d) Replacement canister distal end cleaned and lightly oiled prior to insertion. Note the traced insertion depth check line.*

Prior to insertion, the distal end of the replacement canister was cleaned with gray Scotch-Brite to remove light surface oxidation and condition the surface for uniform contact during seating. The contact region was then lightly lubricated with engine oil to reduce insertion friction and mitigate the risk of galling.
