# BMW Airhead Oil Filter Canister Displacement: Service Practice, Load Paths, and the \$2,000 O-Ring Myth

## **Abstract**

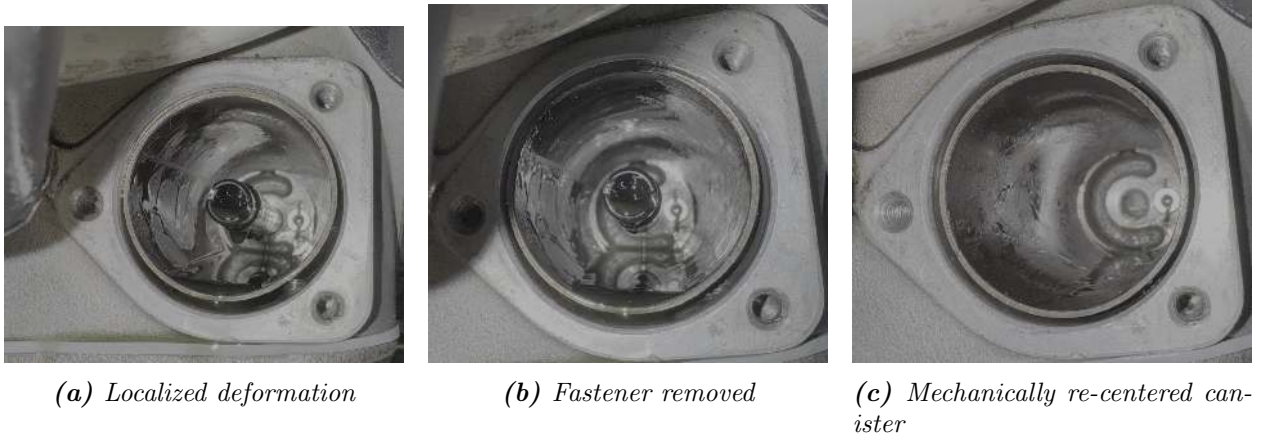
**Figure 2:** Canister displacement and recovery sequence, demonstrating dominant rigid-body motion about the distal press-fit region. (a) Localized deformation at the canister mouth caused by unintended radial jacking. Note the bolt protrusion visible in the lower-right quadrant (near the 5 o'clock position). (b) After fastener removal, partial elastic spring-back occurs, but full self-centering does not occur without an applied corrective moment. (c) Deliberate mechanical re-centering at the mouth restores nominal alignment. The central PIPE was removed at this stage to provide clearance for controlled levering without interference.

The mechanical response of the canister to this interference is documented in Fig. 2(a–c). After removal of the fastener, partial elastic spring-back was observed, but the canister did not fully re-center on its own. Deliberate mechanical re-centering at the mouth was required to restore alignment, indicating that the dominant response was rigid-body motion rather than purely elastic deformation.

Distinguishing rigid-body motion from localized yielding is difficult *in situ*; however, both mechanisms are consistent with the observed seal extrusion shown in Fig. 1. The demonstrated ability to re-center the canister (Fig. 2) strongly supports a lightly retained, non-heroic press-fit rather than a rigidly fixed component.
