BMW Airhead Oil Filter Canister Displacement: Service Practice, Load Paths, and the \$2,000 O-Ring Myth

Abstract

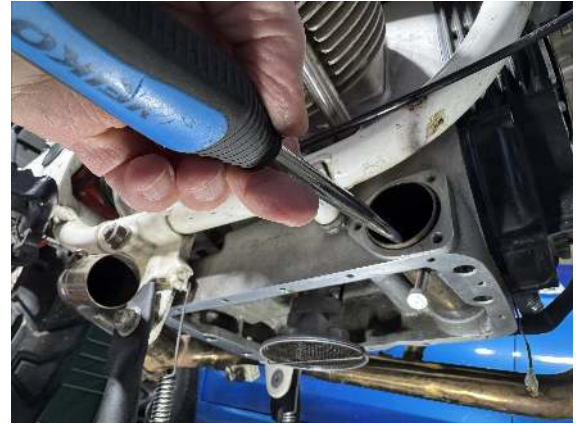
(b) Counter-torque applied to maintain axial alignment and prevent bore damage.

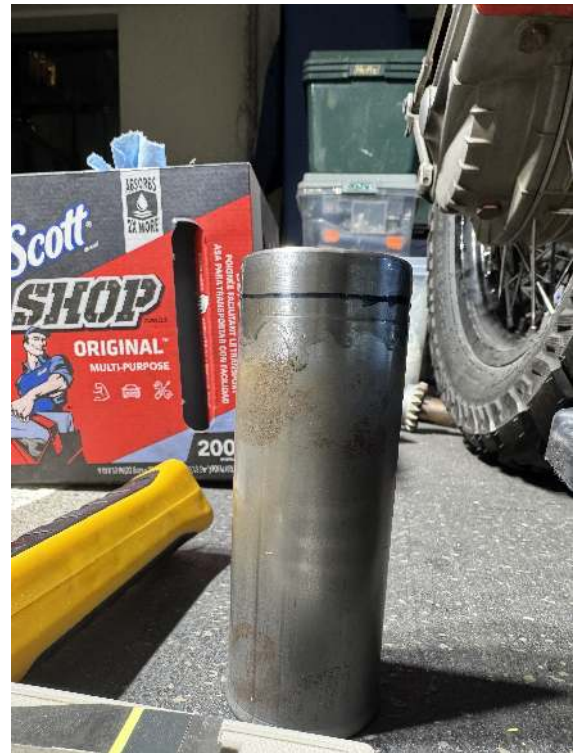
(d) Replacement canister distal end cleaned and lightly oiled prior to insertion. Note the traced insertion depth check line.

Prior to insertion, the distal end of the replacement canister was cleaned with gray Scotch-Brite to remove light surface oxidation and condition the surface for uniform contact during seating. The contact region was then lightly lubricated with engine oil to reduce insertion friction and mitigate the risk of galling.

- Final depth control was achieved through direct measurement by transferring the wear mark from the original canister onto the replacement canister (Fig. 3d), and tapping the replacement canister into the bore until this reference mark was reached (Fig. 3g). This approach leverages the confirmed axial equivalence of the original and replacement canisters, with any residual variation accommodated using external shims.
