BMW Airhead Oil Filter Canister Displacement: Service Practice, Load Paths, and the \$2,000 O-Ring Myth

Custom Konrad

Abstract

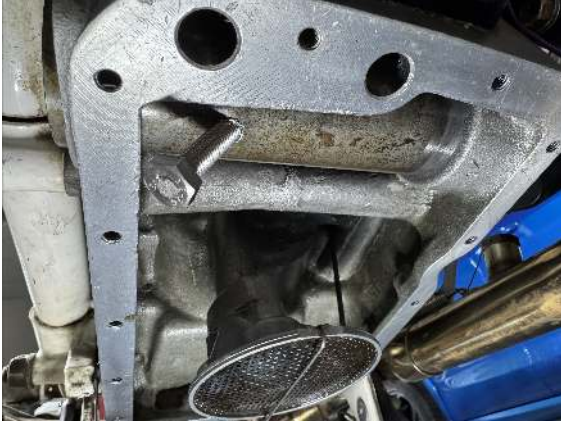
(a) Localized wall deformation during drive-out tapping. The bolt contact reaction at the canister wall was effectively radial prior to tapping. Plastic deformation and bolt rotation within the thin sheet are unavoidable.

Figure 3: Extraction and installation sequence (1 of 2).

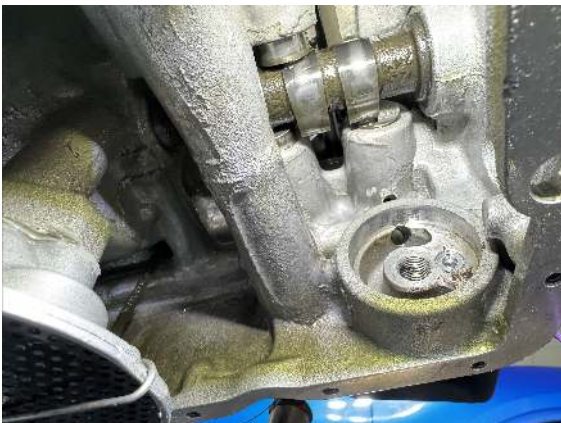
(c) Canister removed after controlled tapping sequence.

5. **Completion and inspection.** Once released, remove the canister by hand. Carefully remove all chip containment measures and clean the cavity thoroughly. Inspect the bore for scoring, raised material, or damage before proceeding with installation.

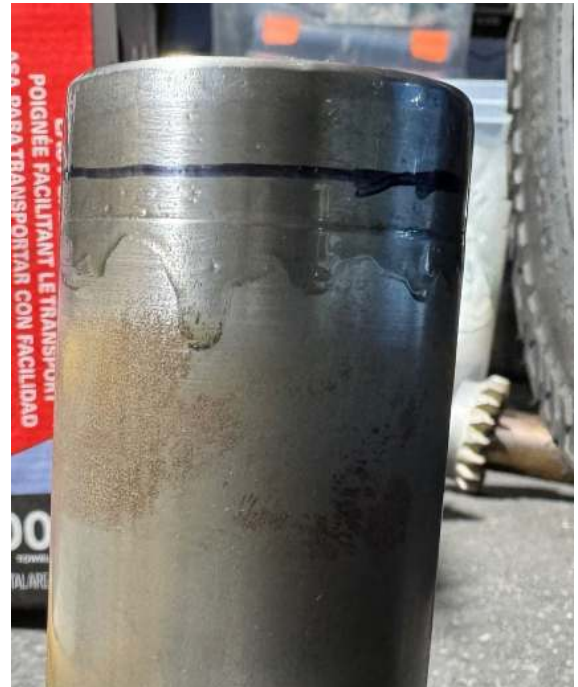
(d) Replacement canister distal end cleaned and lightly oiled prior to insertion. Note the traced insertion depth check line.

Prior to insertion, the distal end of the replacement canister was cleaned with gray Scotch-Brite to remove light surface oxidation and condition the surface for uniform contact during seating. The contact region was then lightly lubricated with engine oil to reduce insertion friction and mitigate the risk of galling.
