BMW Airhead Oil Filter Canister Displacement: Service Practice, Load Paths, and the \$2,000 O-Ring Myth

Custom Konrad

January 11, 2026

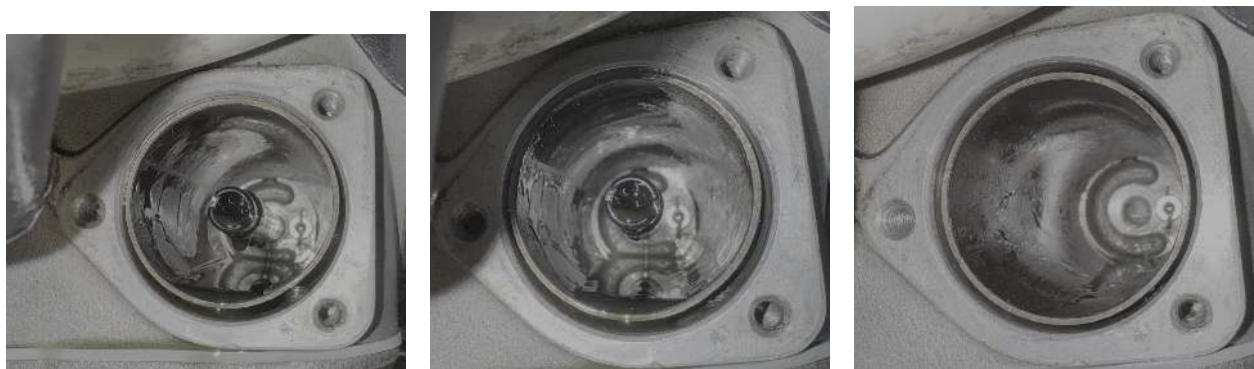
The mechanical response of the canister to this interference is documented in Fig. 2(a–c). After removal of the fastener, partial elastic spring-back was observed, but the canister did not fully re-center on its own. Deliberate mechanical re-centering at the mouth was required to restore alignment, indicating that the dominant response was rigid-body motion rather than purely elastic deformation.

(a) Localized deformation identified (b) Fastener removed as first corrective action (c) Canister mechanically re-centered by controlled levering

Figure 2: Canister displacement and recovery sequence, demonstrating dominant rigid-body motion about the distal press-fit region. (a) Localized deformation at the canister mouth caused by unintended radial jacking. Note the bolt protrusion visible in the lower-right quadrant (near the 5 o'clock position). (b) After fastener removal, partial elastic spring-back occurs, but full self-centering does not occur without an applied corrective moment. (c) Deliberate mechanical re-centering at the mouth restores nominal alignment of the canister relative to the crankcase bore. The central PIPE was removed at this stage to provide clearance for controlled levering without interference.

Distinguishing rigid-body motion from localized yielding is difficult *in situ*; however, both mechanisms are consistent with the observed seal extrusion shown in Fig. 1. The demonstrated ability to re-center the canister (Fig. 2) strongly supports a lightly retained, non-heroic press-fit rather than a rigidly fixed component.

The immediate mechanical issue was resolved by re-centering the canister, a field-normal repair consistent with long-standing independent service practice. Nominal alignment was restored, and the system could have been reassembled and returned to service, as illustrated in Fig. 2. In many cases, this outcome would represent a reasonable and sufficient repair.
