# BMW Airhead Oil Filter Canister Displacement: Service Practice, Load Paths, and the \$2,000 O-Ring Myth

Custom Konrad

January 11, 2026

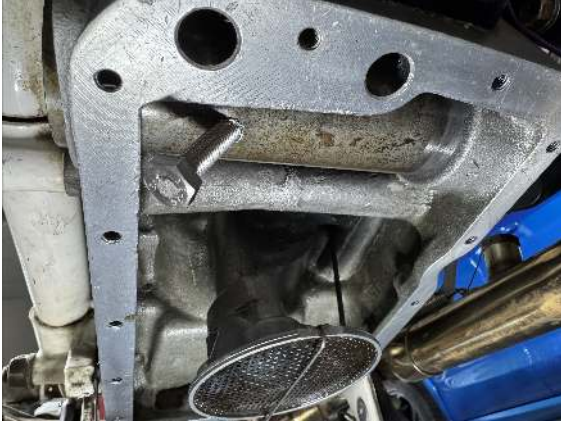
*(a) Localized wall deformation during drive-out tapping. The bolt orientation was perpendicular to the canister prior to tapping. Plastic deformation and bolt rotation within the thin sheet are unavoidable.*

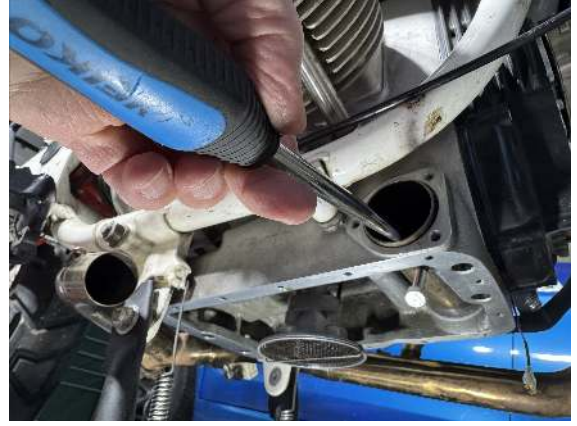
*(b) Counter-torque applied to maintain axial alignment and prevent bore damage.*

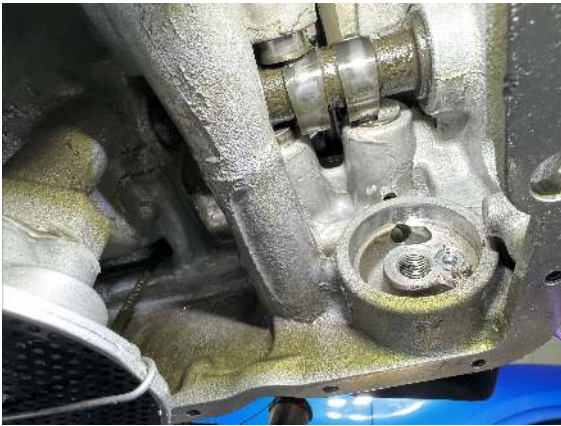
*(c) Canister removed after controlled tapping sequence.*

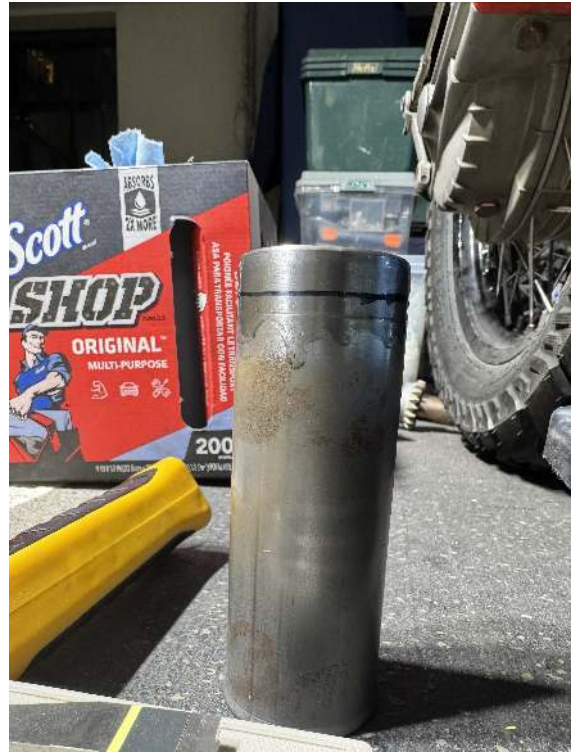
*(d) Replacement canister distal end cleaned and lightly oiled prior to insertion. Note the traced insertion depth check line.*

Prior to insertion, the distal end of the replacement canister was cleaned with gray Scotch-Brite to remove light surface oxidation and condition the surface for uniform contact during seating. The contact region was then lightly lubricated with engine oil to reduce insertion friction and mitigate the risk of galling.

- Final depth control was achieved through direct measurement by transferring the wear mark from the original canister onto the replacement canister (Fig. 3d), and tapping the replacement canister into the bore until this reference mark was reached (Fig. 3g). This approach leverages the confirmed axial equivalence of the original and replacement canisters, with any residual variation accommodated using external shims.
