تقرير درس مستفاد رقم (002) من حادث (طائرة البيل ووحدة التحكم بمروحة الذيل)

قسم السلامة والبيئة والجدارة/ قيادة الطيران المشترك

Lessons Learned report No. (002): Bell 407 accident

Safety, Environment and Worthiness Section

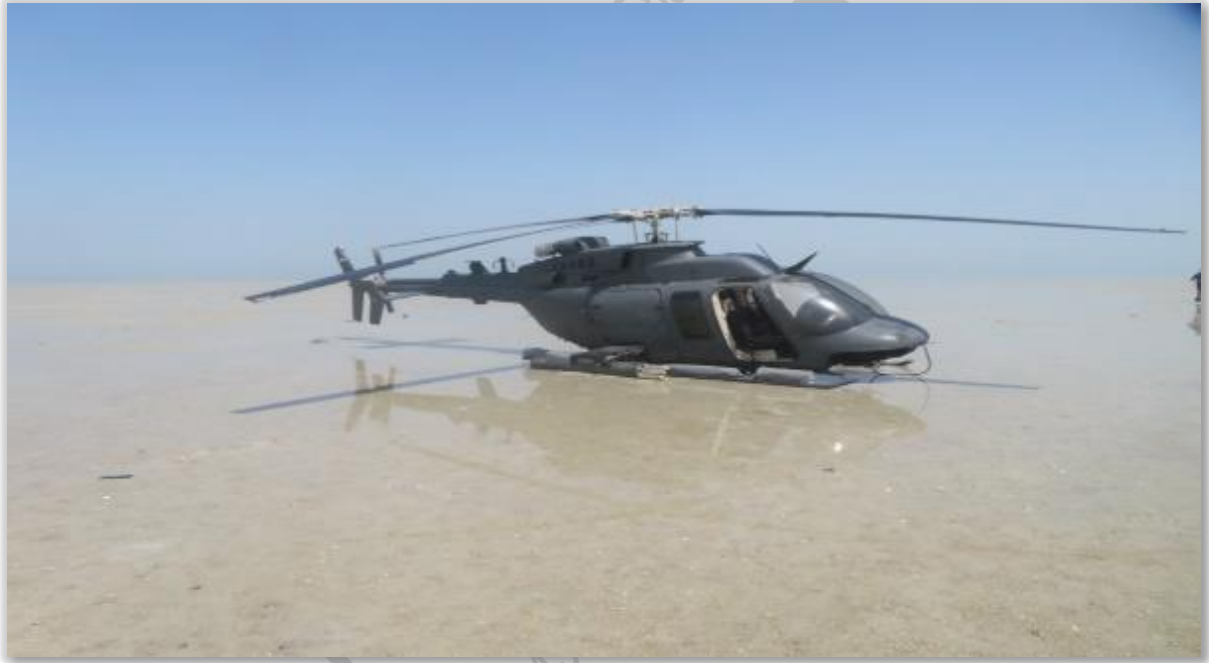
الشكل رقم (1)

سبب ارتطام مروحة الذيل في الجزء الخلفي لذيل الطائرة (Stabilizer The) عن طريق إجراء خاطئ من قبل قائد الطائرة على وحدة التحكم بمروحة الذيل.

- أ. التأكد من اختيار الأطقم الجوية المناسبة لطبيعة المهام الجوية المطلوبة.
- ب. التأكد من التوافق بين أطقم الطيران أثناء العمل على تعبئة نموذج تقييم المخاطر والوضع في الحسبان الخبرات وساعات الطيران لدى كل طاقم، والتقييد بالتعليمات المحددة في النموذج.
- ج. التأكد من تدريب جميع الطيارين على تشغيل أجهزة الرؤية الحرارية المختلفة على الطائرة أو تحديد بعض الطيارين للعمل على كل نوع من هذه الأنواع.
- د. التركيز على دورة طب الطيران وتنقيف الأطقم الجوية عن التحديات والمخاطر التي قد يتعرضون لها أثناء فترة المناوبة ومخاطر بيئة العمليات التي يعملون بها، وإعطائهم النصائح والإرشاد في كيفية المحافظة على اللياقة العالية والقدرة على التركيز.

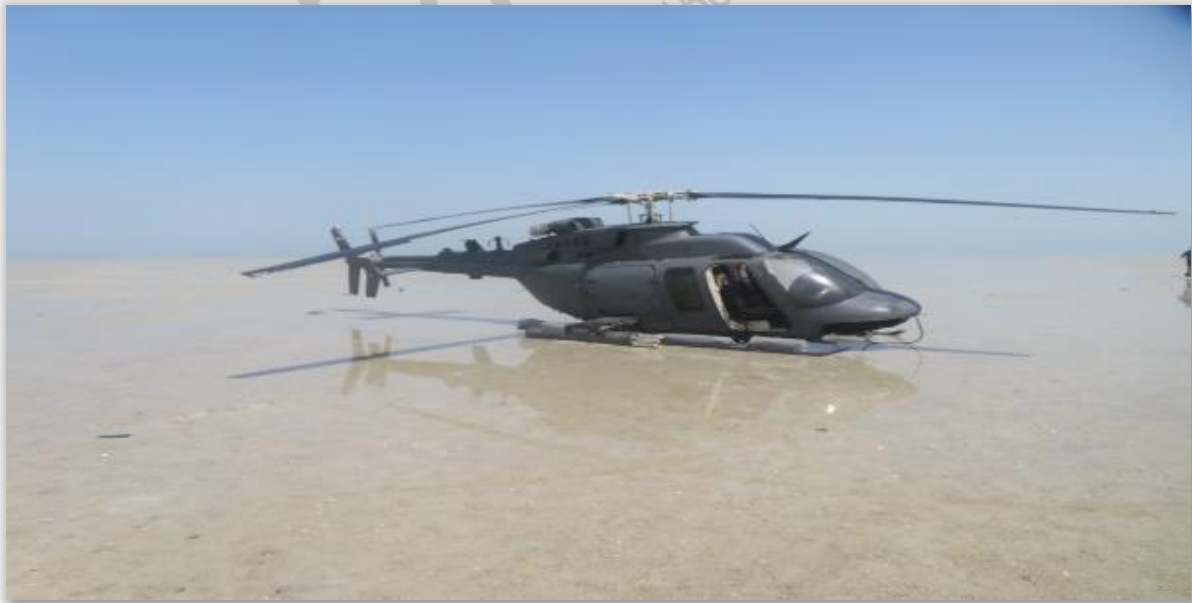
Figure1

A. Immediate cause. (human error) The tail rotor contacted the stabilizer due to an erroneous action by the pilot on the controls during a critical phase of flight.

A. Crew Assignment and Briefing Procedures: Commanders and briefing officers shall ensure thorough evaluation of the complexity and specific requirements of assigned flight training tasks prior to briefing and approving aircrew assignments.

B. Crew Mix and Risk Assessment: When reviewing and approving Risk Assessment Forms (RAF), Commanders and briefing officers shall verify that an appropriate crew mix is established. This process must explicitly consider the total flight hours and relevant experience of each crew member, as well as their demonstrated ability to adhere to the instructions and procedures outlined in the RAF.

C. Enhanced Thermal Vision Device Training: Ensure that all pilots are proficient in the operation of Thermal Vision Devices.

D. Aviation Medicine and Crew Readiness Training: The aviation medicine curriculum shall be reinforced to specifically educate aircrew on the potential physiological and psychological challenges and risks associated with their operational rotations. This training must emphasize the hazards of fatigue, the importance of maintaining flight fitness, and strategies for sustaining focus and cognitive performance within their demanding operational environment.
