Figure 1. The south baulk of the 10 m long trench dug for a new lateral. Drawn by Hamish Williams, Teri Anderson & Luke Tremlett.

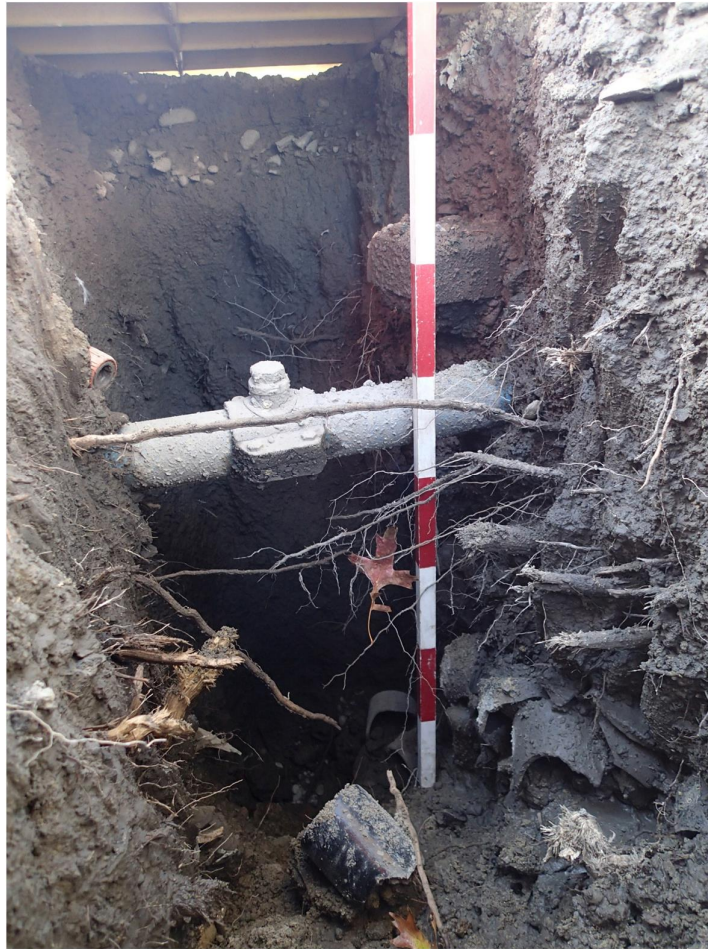
**Feature 1 (the rubbish feature), at right. Looking east.**

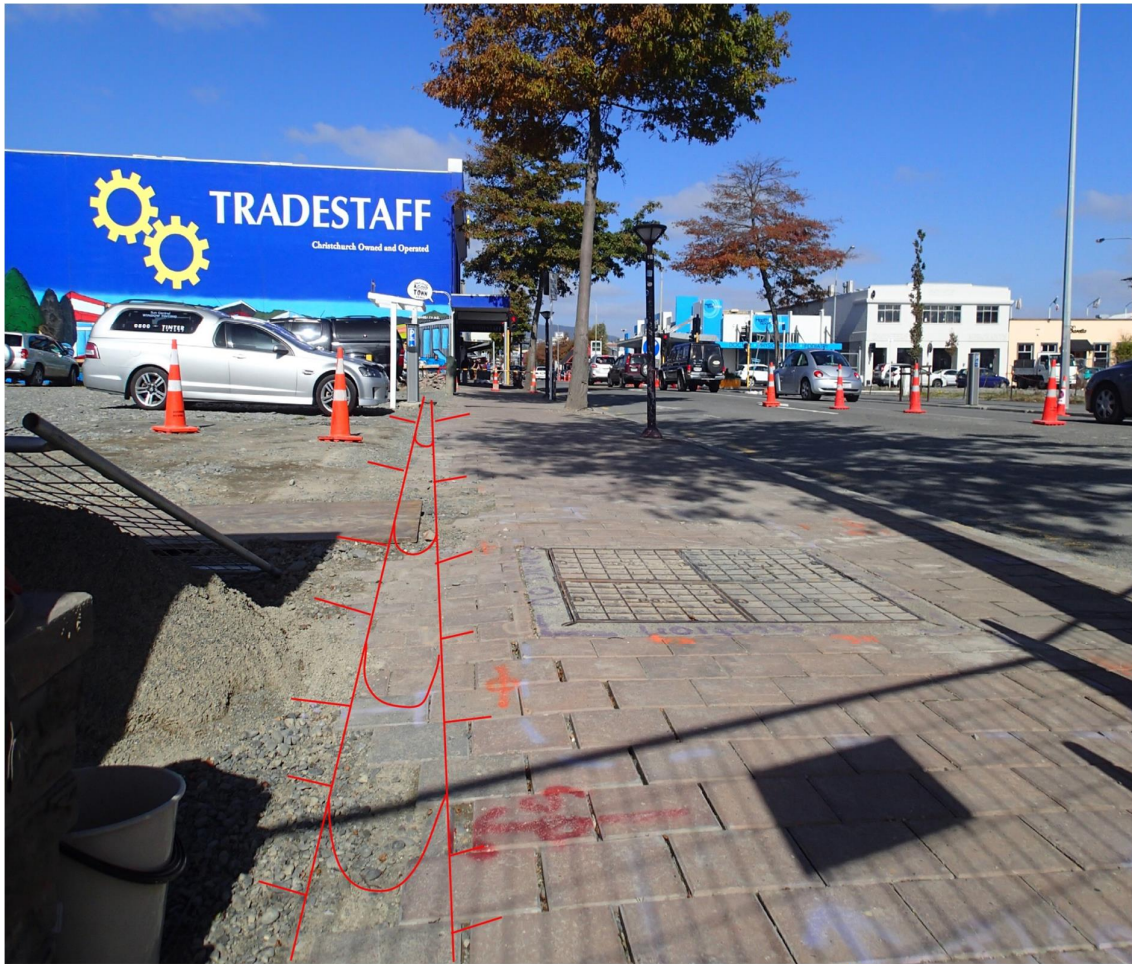
Looking south from 614 Colombo Street, showing the approximate line of the 19<sup>th</sup> century ditch.
