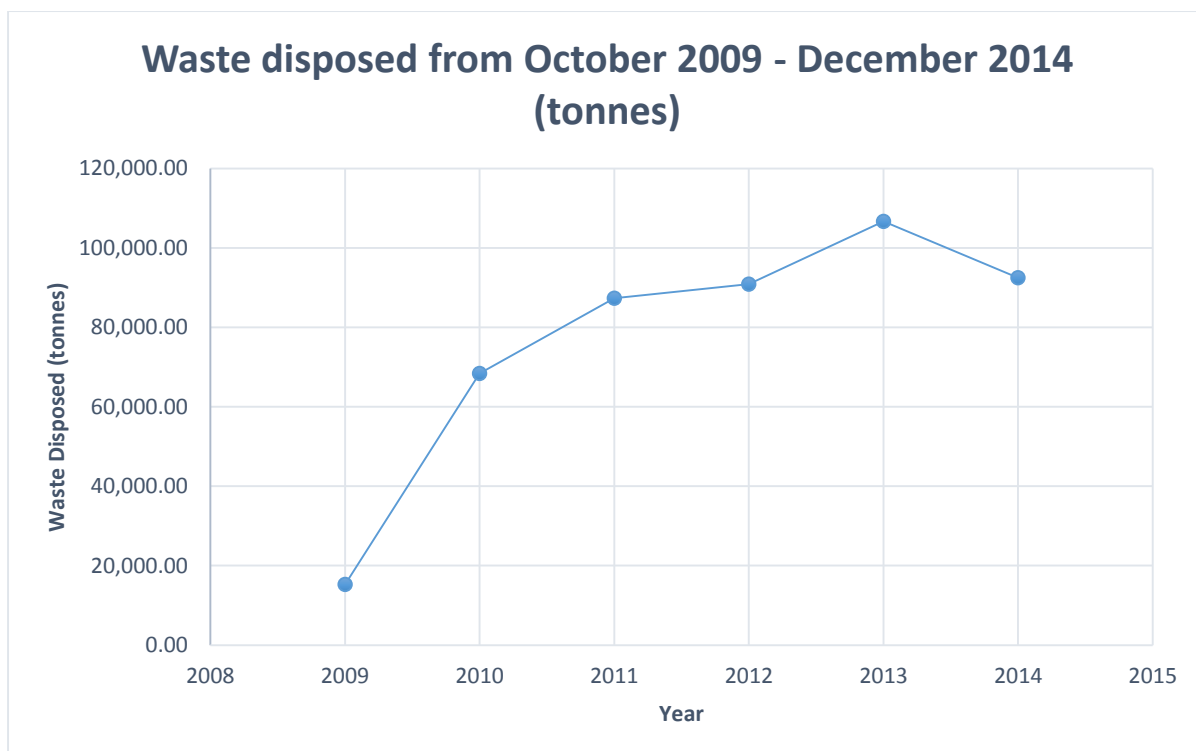
**Figure 5: Amount of waste disposed of since October 2009 – December 2014(tonnes)**

**Source: Gamodubu Landfill Waste Tonnage Report (2010-2014)**
