[Resistor ASM - GSVEM HVAC]

Thermal Fuse Open in Resistor ASM(52429971)

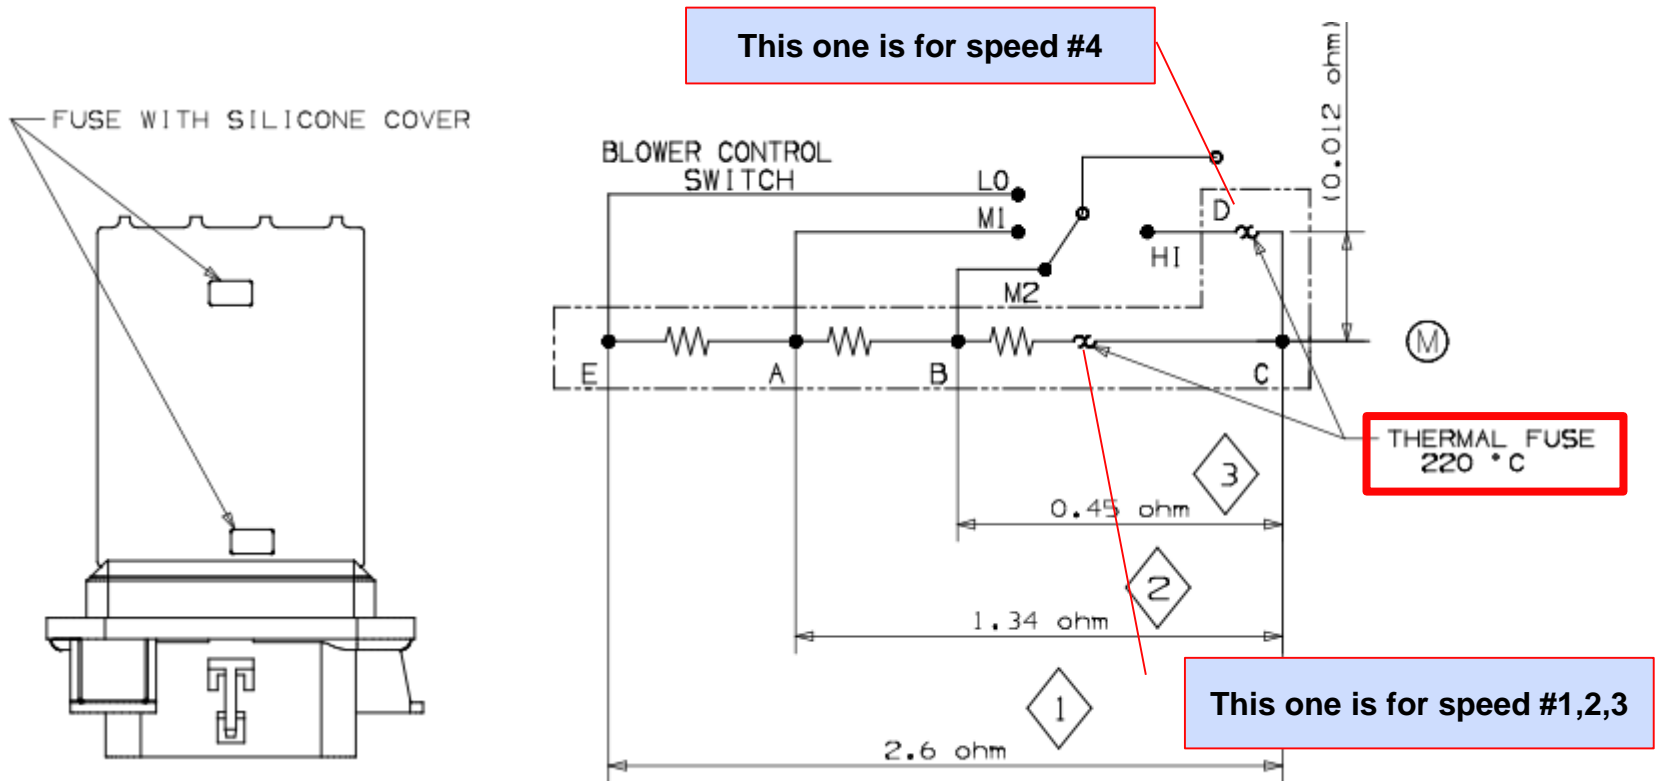
- Blower motor does not work at speed # 4 in vehicle condition.

- Thermal fuse was opened to protect system
- It's from electric shock in vehicle condition

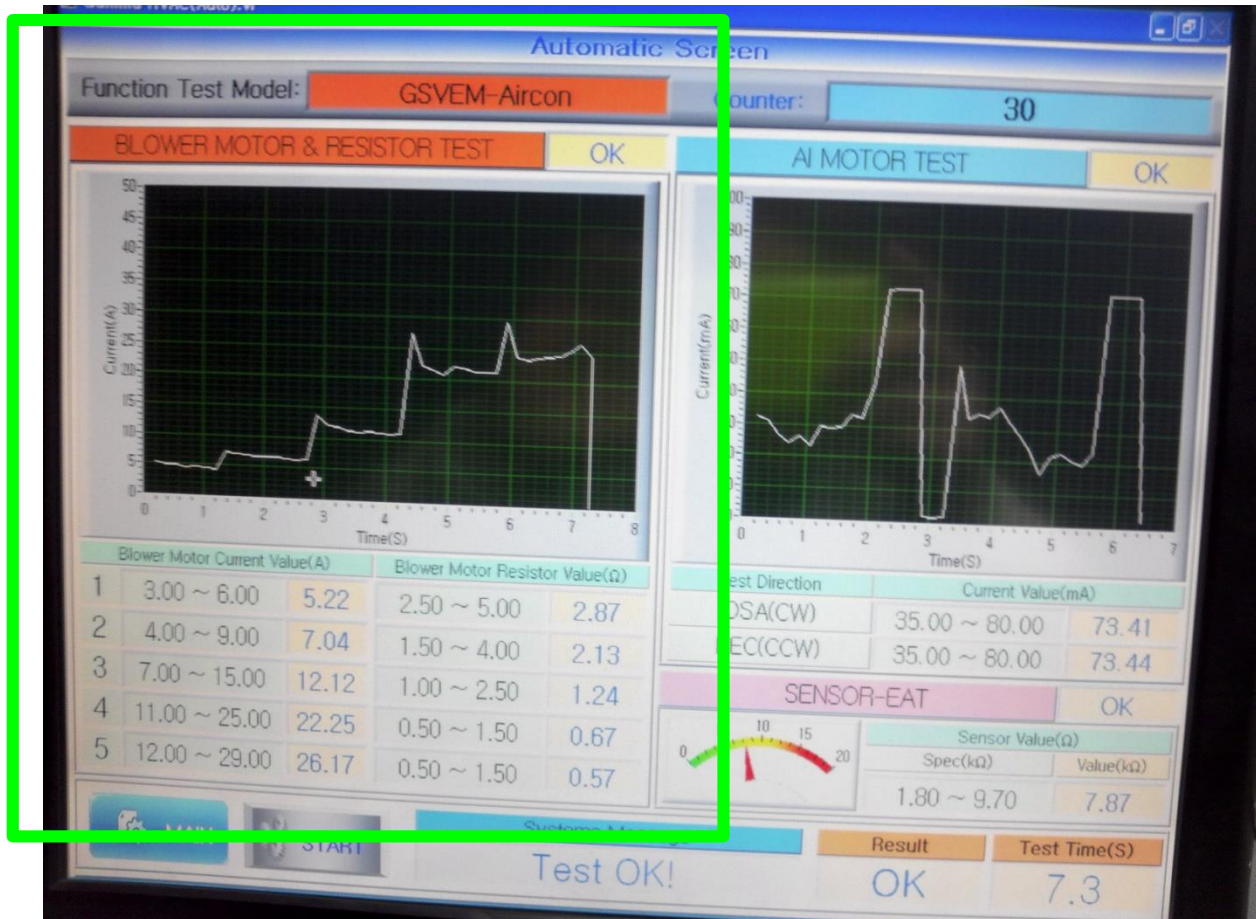
UzECC Process

- ❖ **Test 100%** with function tester
- ❖ Check **ampere and resistance** with connecting resistor and blower motor for each speed
