ALARM ADDRESS	A23.6	ALARM NO.	2086
OP. MESSAGE	COOLANT FILTER ALARM. CHANGE IMMEDIATELY !!		
Related Signal	Input: X1.3 (MV154/154APC/MV204) °		
CAUSE	<p>The chip jammed in the coolant filter °</p>

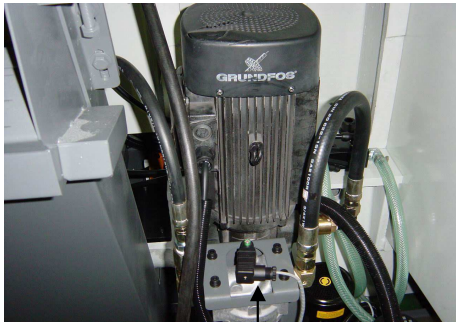
<p>Coolant filter detector</p>		
ACTION	<p>1. Push EMG. Stop °</p> <p>2. Replace filter with new one °</p>

<p>3. Cancel alarm by reset button on FANUC panel °</p>
