ALARM ADDRESS	A12.3	ALARM NO.	1183
ALARM TEXT	NOW => SPDL AT UNCLAMP POS.		
Related Signal	<p>Input: X2.1 (MV154/154APC/MV204) , X7.5 (184C) °</p> <p>Output: Y2.7 (MV154/154APC/MV204) , Y6.2 (184C) °</p> <div style="display: flex; justify-content: space-around; align-items: flex-end;"> <div style="text-align: center;">

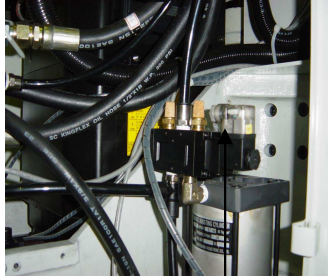
<p>Spindle tool clamp coil °</p> </div> <div style="text-align: center;">

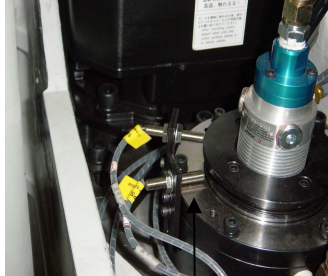
<p>Spindle tool unclamp sensor °</p> </div> </div>		
CAUSE	In ATC service mode, This is a prompt for operator °		
ACTION
