Input Address:
2111 PLUM ST,
AURORA, IL, 60506

Roof Condition:

Total Roof Score: 12

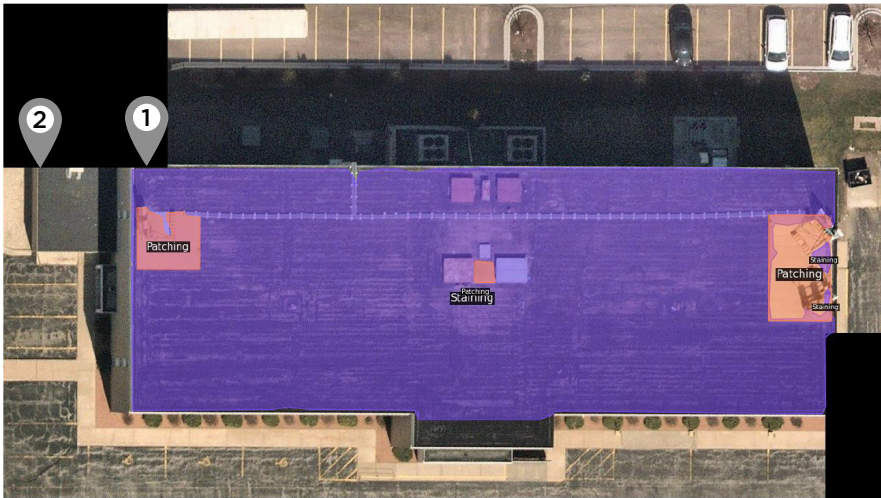
DAMAGE:

DETECTED DAMAGE AREA:

Water pooling:	55%
Staining:	89%
Patching:	64%
Tarp:	0%
Missing shingle:	3%
Other damage:	4%
Other damage:	4%

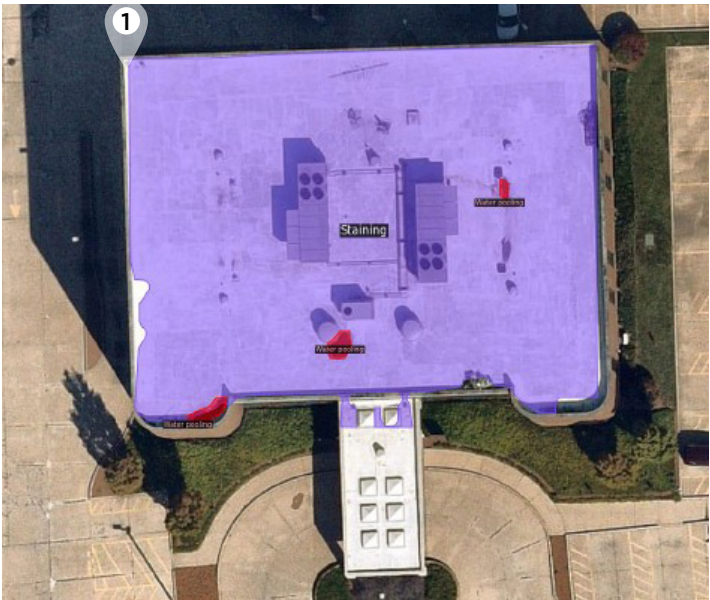
DETECTED EQUIPMENT:

HVAC/Cooling tower:	2
Skylight:	Minimal
Solar panel:	N/A
Pipeline:	Detected
Other Equipment:	N/A
Other Equipment:	N/A
