Stewardship for Lyon Hills

Lead Steward: Emily

2023-12-18

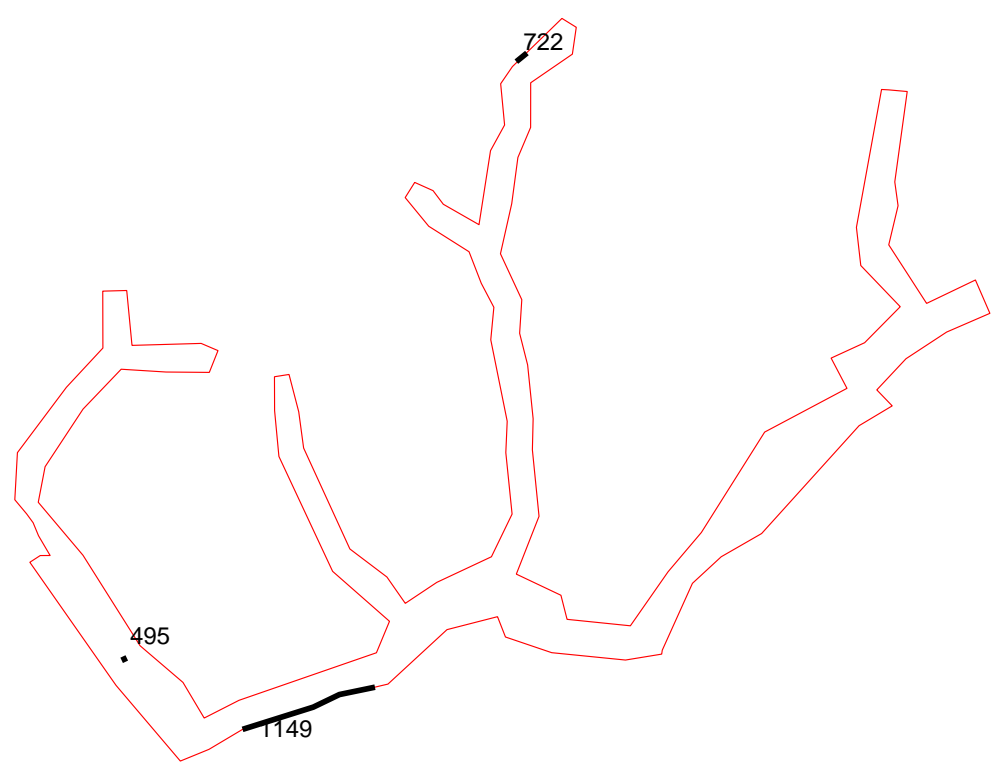
Boundary Issues (lines)

OBJECTID	Year	Issue	Description	Resolved
1149	2023	Mowing	Scallop mowing between posts	No
722	2022		Hay bales rolled through fence. Farmer patched fence. Hay bales still in stream	No
495	2021	Cattle	Cattle stepping into easement around creek crossing	No

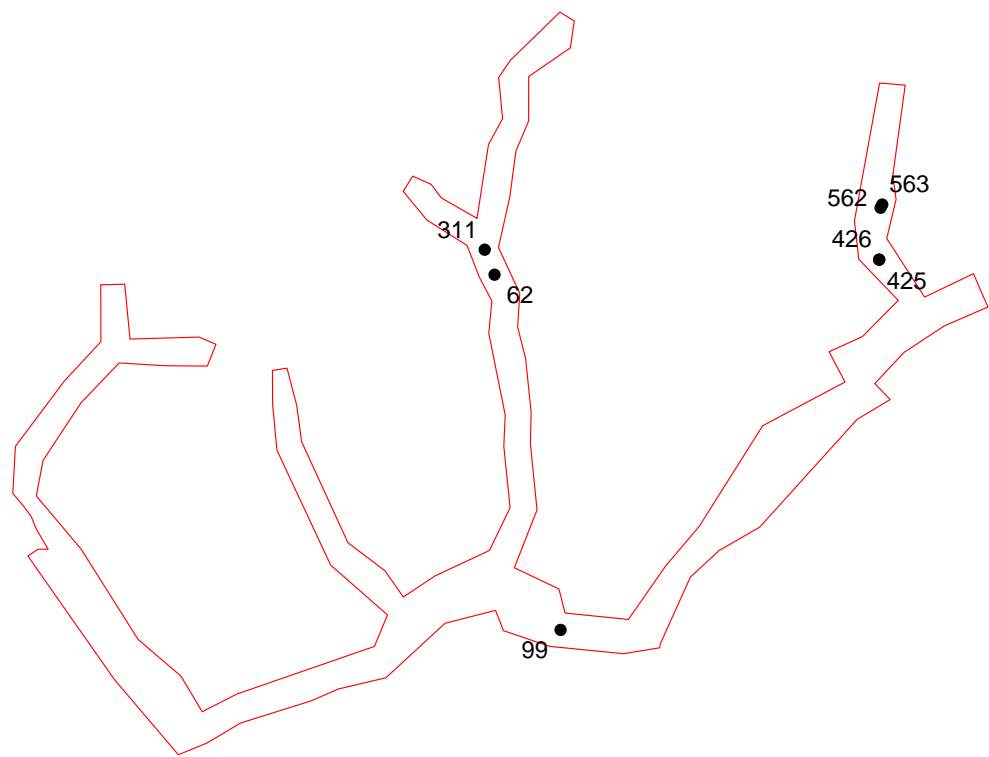
Channel Issues (points)

OBJECTID	Year	Subtype	Issue	Description	Resolved
637	2023	Channel Stability/Erosion	ErosionScour	Erosion and Aggradation	No
986	2023	Channel Stability/Erosion	ErosionScour		No
987	2023	Channel Stability/Erosion	AggradationDeposition		No
1055	2023	Channel Stability/Erosion	ErosionScour	Incising	No
1056	2023	Channel Stability/Erosion	ErosionScour	Left bank	No
1148	2023	Channel Stability/Erosion	ErosionScour	Right bank eroding	No
633	2022	Needs Livestakes			Yes
634	2022	Needs Livestakes			Yes
635	2022	Needs Livestakes		Low wet area draining from field.	Yes
926	2022	Channel Stability/Erosion	AggradationDeposition		No
425	2022	Failed Structure			No
426	2022	Failed Structure		Slumping after Boulder toe	No
562	2022	Failed Structure			No
563	2022	Failed Structure		Piping. Put some small rocks in; made a slight improvement	No
636	2021	Needs Livestakes			Yes
99	2021	Failed Structure	Failed/Not Functional	Failed j-hook	Yes

493	2021	Needs Livestakes		Needs livestock	No
494	2021	Needs Livestakes		Needs livestock	No
496	2021	Needs Livestakes		Needs livestock	No
504	2021	Needs Livestakes		Needs livestock around structures	No
506	2021	Needs Livestakes		Needs livestock on meander bend	No
512	2021	Needs Livestakes		Needs livestock on right bank	No
515	2021	Needs Livestakes		Needs livestock on left bank (maybe right bank, too)	No
639	2021	Channel Stability/Erosion	ErosionScour		No
62	2021	Failed Structure		Failed log sill. Undercutting. Disconnected from grade? And no splash rock to reduce drop.	No
311	2021	Failed Structure	Failed/Not Functional	Too high	No

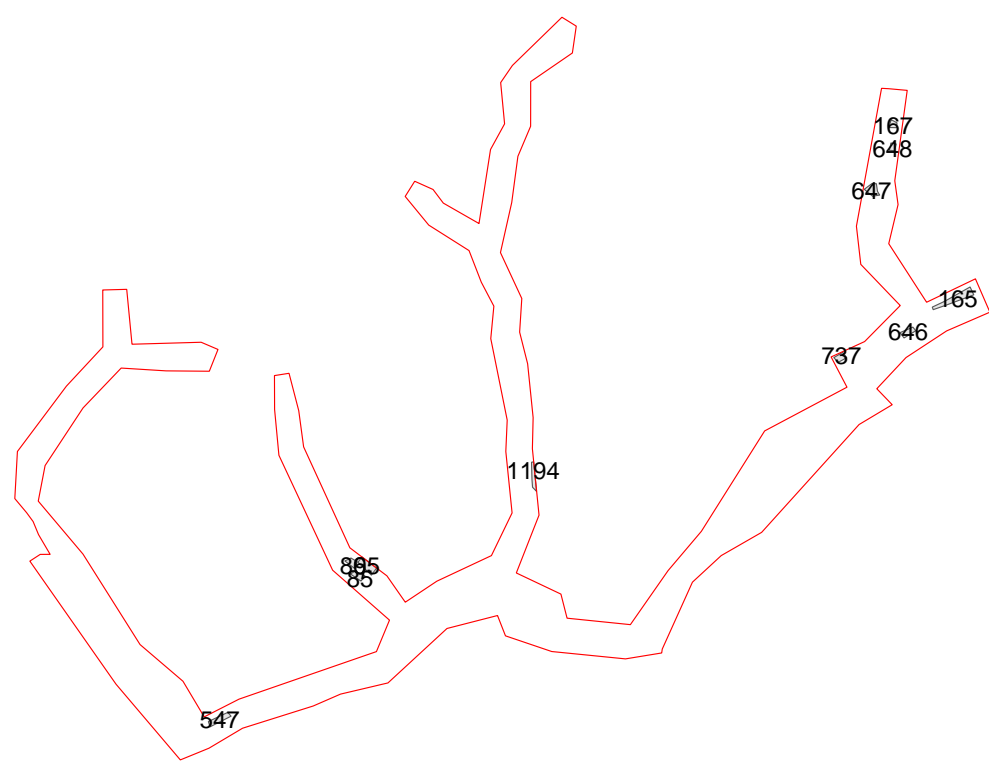
Vegetation Issues (polygons)

OBJECTID	Year	Issue	Description	Treatment	TreatDate	Resolved
1194	2023	Bare Areas, Low Stem Vigor/Height and Density	Need amendments and seed			No
646	2022		Bare area	Summer seed mix (millet, clover, humic plus)	05/2022	No
647	2022	Bare Areas and Low Stem Density		Summer seed mix (millet, clover, humic plus)	05/2022	No
737	2022		Bare area	Summer seed mix (millet, clover, humic plus)	05/2022	No
648	2022		Low stem density/bare area	Summer seed mix (millet, clover, humic plus)	05/2022	No
167	2021	Bare Areas and Low Stem Density		Summer seed mix (millet, clover, humic plus)	05/2022	No
95	2021	Bare Areas		Summer seed mix (millet, clover, humic plus)	05/2022	No
86	2021	Bare Areas	Bare area	Summer seed mix (millet, clover, humic plus)	05/2022	No
86	2021	Bare Areas	Bare area	cool season seeding, cord matting	10/2022	No
547	2021	Bare Areas		Summer seed mix (millet, clover, humic plus)	05/2022	No
165	2021	Bare Areas and Low Stem Density	Bare areas and some rilling	Summer seed mix (millet, clover, humic plus)	05/2022	No

85	2021	Bare Areas	Bare area	Summer seed mix (millet, clover, humic plus)	05/2022	No

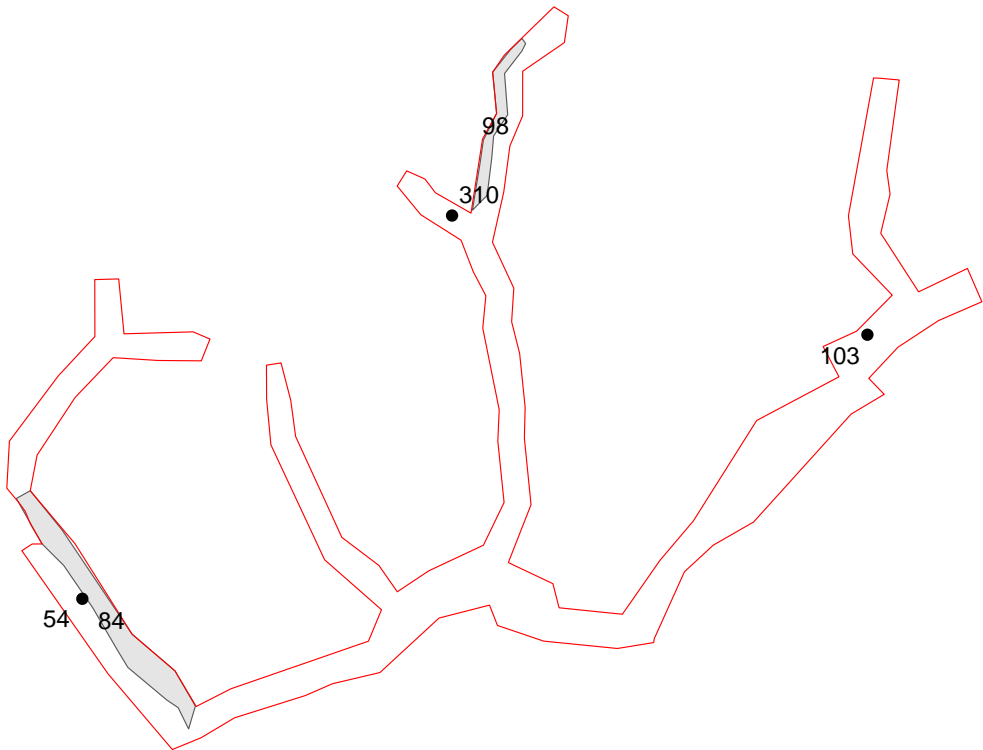
Weed Issues – Chinese Privet

OBJECTID	Year	Species1	Species2	Issue	Treatment	Method	TreatDate	Resolved
84	2023	Chinese Privet	Oriental Bittersweet		Cut stump BS, privet, HS	Cut Stump	09/2021	No
1129	2023	Japanese Honeysuckle	Oriental Bittersweet	HS BS blackberry				No
1011	2023	Multiflora Rose						No
1738	2023	Oriental Bittersweet		Climbing vine	Cut and treated vine	Cut Stump	08/2023	Yes
1010	2023	Oriental Bittersweet	Japanese Honeysuckle	Climbing vines	Cut and treated vines	Cut Stump	08/2023	No
61	2023	Oriental Bittersweet	Multiflora Rose	Climbing BS and isolated MF				No
845	2022	Kudzu						No
681	2022	Princess Tree						No
682	2022	Princess Tree						No
54	2021	Chinese Privet			Cut stump	Cut Stump	09/2021	Yes
98	2021	Chinese Privet	Oriental Bittersweet					No
103	2021	Chinese Privet	Multiflora Rose	Isolated multiflora occurrence at top of right bank and mature privet on stream bank				No
310	2021	Chinese Privet						No
166	2021	Japanese Honeysuckle	Multiflora Rose					No

97	2021	Multiflora Rose	Oriental Bittersweet	All invasives listed plus honeysuckle. Lots of dense climbing vines at top of reach.	Cut stump	Cut Stump	09/2021	No
96	2021	Multiflora Rose	Oriental Bittersweet		Cut stump	Cut Stump	09/2021	No
1739	2021	Oriental Bittersweet		Climbing vine	Cut and treated vine	Cut Stump	08/2023	Yes
59	2021	Oriental Bittersweet	Chinese Privet		Cut stump	Cut Stump	09/2021	Yes
83	2021	Oriental Bittersweet	Chinese Privet		Cut stump	Cut Stump	09/2021	No
52	2021	Oriental Bittersweet		Climbing BS in a couple locations on right floodplain				No
55	2021	Oriental Bittersweet	Chinese Privet					No
100	2021	Oriental Bittersweet	Chinese Privet	Small invasive cluster along tree line				No
60	2021	Princess Tree	Tree Of Heaven	Young princess trees and mature TOH	Cut stump	Cut Stump	09/2021	Yes
63	2021	Tree Of Heaven	OTHER	Canopy TOH and monoculture of Harlequin Glorybower at top of reach	Cut stump	Cut Stump	09/2021	No

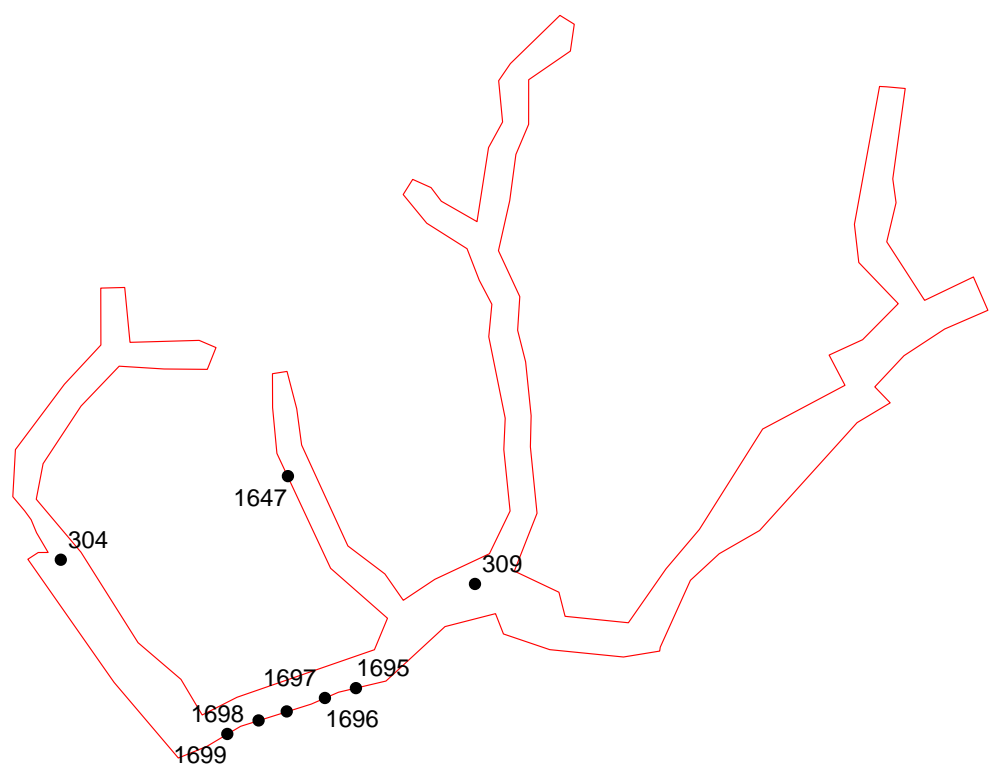
Miscellaneous Issues

OBJECTID	Year	Subtype	Description	Resolved
1647	2023	Misc	Small gate	No
1695	2023	Misc	Add post and sign	No
1696	2023	Misc	Add post and sign	No
1697	2023	Misc	Add post and sign	No
1698	2023	Misc	Add post and sign	No
1699	2023	Misc	Add post and sign	No
304	2021	Misc	Mature Hemlock. Approx 15-18” DBH. Needs treatment.	No
309	2021	Misc	Mature Hemlocks need treatment. DBH 12-15”	No
