Stewardship for Falling Creek

Lead Steward: Hanna

2023-12-18

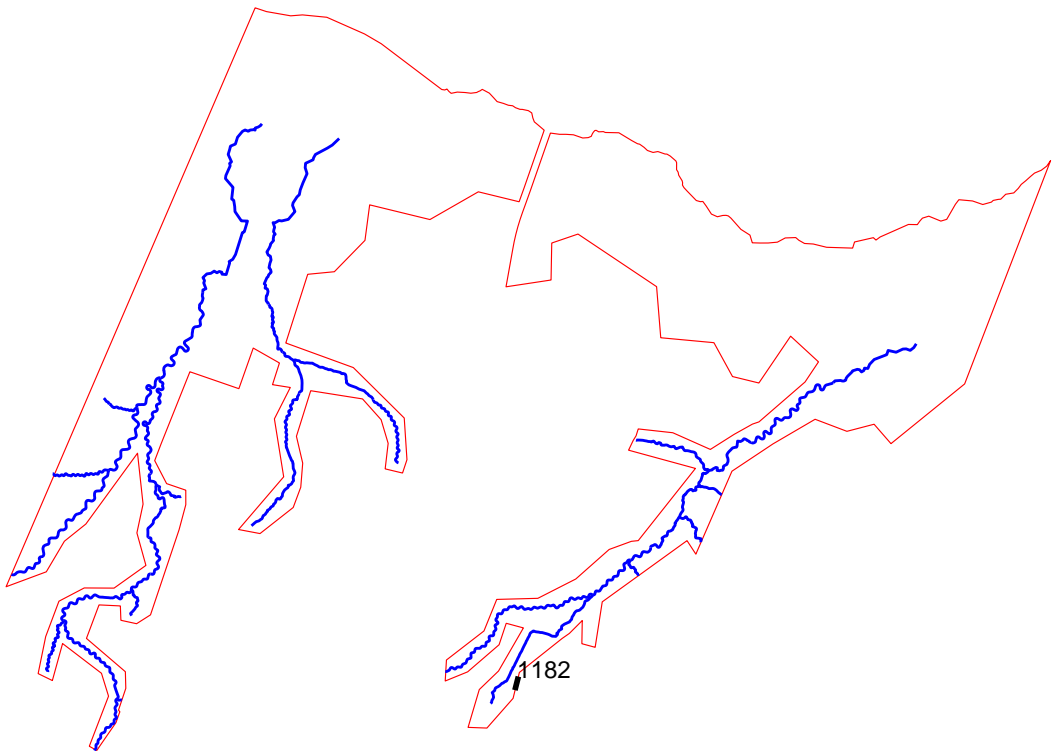
Boundary Issues (lines)

OBJECTID	Year	Issue	Description	Resolved
1182	2023	Other	Restaple middle strand of barbed wire	No
1019	2022	Mowing	Food plot discovered within easement. Some cutting with weed eater and seed put down.	No

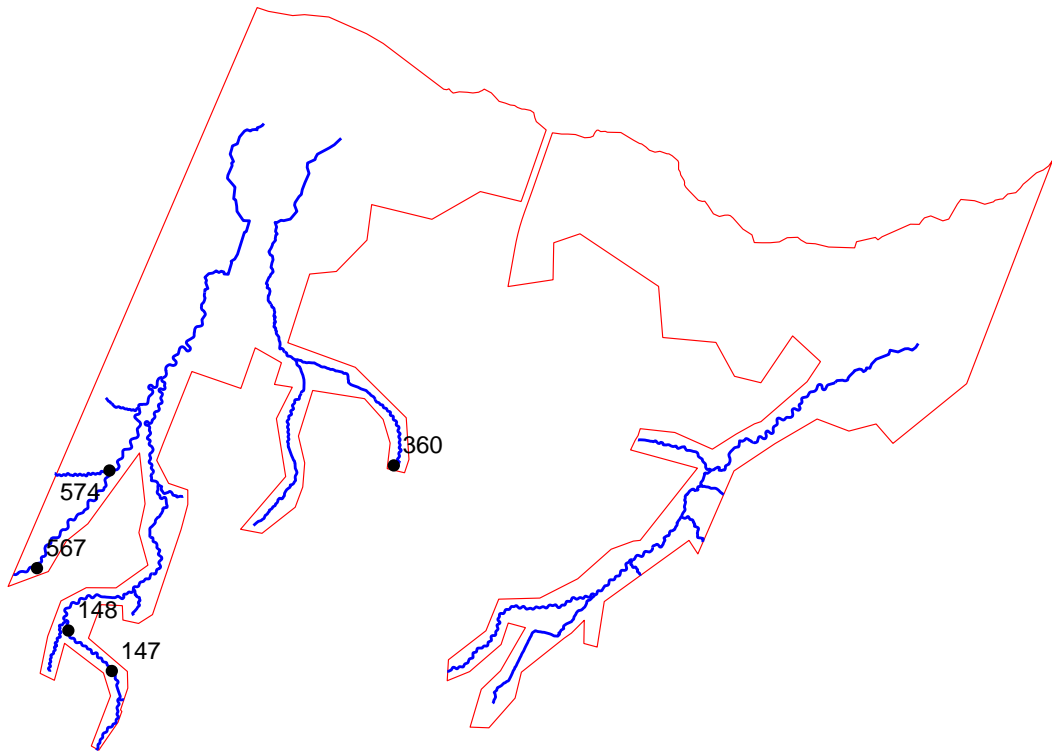
Channel Issues (points)

OBJECTID	Year	Subtype	Issue	Description	Treatment	TreatDate	Resolved
1006	2023	Channel Stability/Erosion	Other	No flow. Spring fed further down			No
721	2022	Channel Stability/Erosion	SlumpingSettling	Drainage from slope enters channel. Small holes in bank and portion of bank sloughed away.	Installed livestakes, plugs, and tried to plug the biggest hole	02/2022	No
800	2022	Channel Stability/Erosion	ErosionScour				No
881	2022	Needs Livestakes					No
891	2022	Channel Stability/Erosion					No
360	2022	Failed Structure	Erosion/Scoured	BMP failing? Drain tile seems messed up maybe? This could be the LOs repair in 2020			No
567	2022	Failed Structure		Widening bends, sediment flush, scour, log fallen into stream.			No
574	2022	Failed Structure		Confluence reveals incision in main stem. Headcut?			No
573	2021	Needs Livestakes			Added about 20 livestakes to outside bends and shearing banks	03/2023	Yes
530	2021	Channel Stability/Erosion	ErosionScour	Scour around and at bottom of lunker logs. Scour of outside bends.			Yes

147	2021	Failed Structure	Other	Soil behind lunker log washing out or slumping in	Added 5 plugs behind log	09/2021	Yes
893	2021	Channel Stability/Erosion	AggradationDeposition	bend fills in with sand, channel hard to define around multi-stem willow. Remove willow. Rake and shovel out channel	removed aggraded sand in bend, beefed up outside bed, removed debris jams	02/2023	No
527	2021	Channel Stability/Erosion	ErosionScour	Incision and scour on bends. Add live stakes.	Added 15 Juncus plugs to bends.	09/2021	No
529	2021	Channel Stability/Erosion	ErosionScour	Scour on outside bends and behind lunker log. Add livestakes.	Added plugs around banks, sill, and lunker log	09/2021	No
528	2021	Channel Stability/Erosion	ErosionScour	Incision and scour			No
570	2021	Needs Livestakes					No
574	2021	Needs Livestakes					No
894	2021	Channel Stability/Erosion		Watch for stability where ATV used to drive across. Needs livestakes?			No

148	2021	Failed Structure	Erosion/Scoured	Log sill Scoured around ends. Added plugs. Needs live stakes and sill shaving.			No

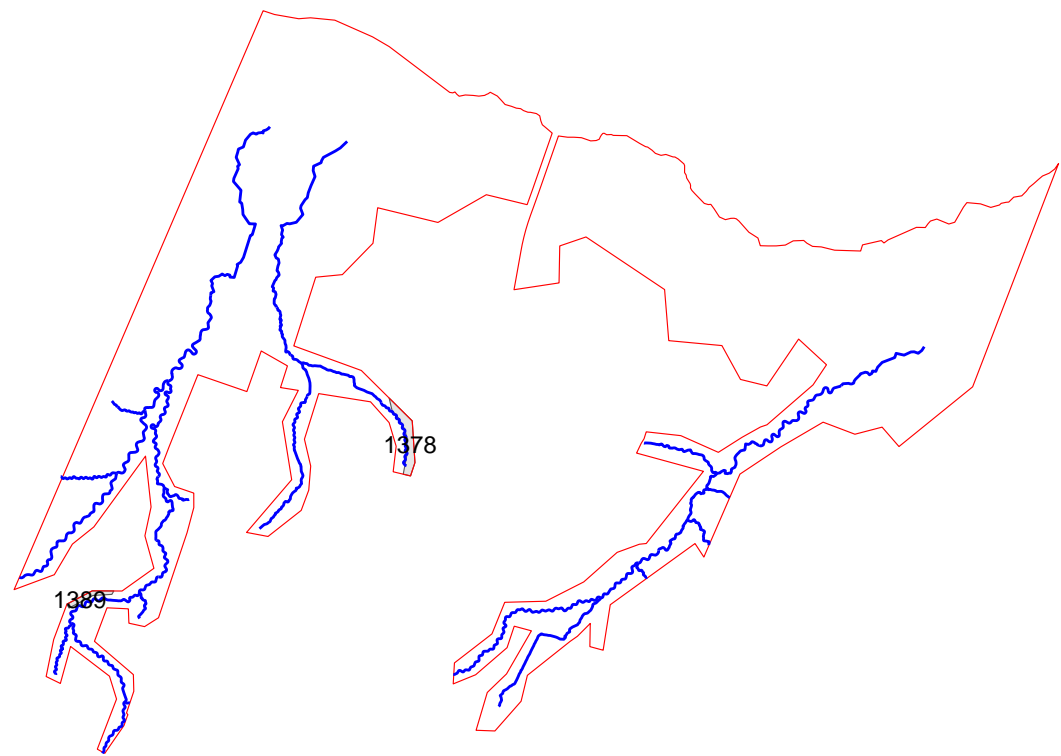
Vegetation Issues (polygons)

OBJECTID	Year	Issue	Description	Treatment	TreatDate	Resolved
1378	2023	Low Stem Vigor/Height		Tree boosters	06/2023	Yes
1389	2023	Low Stem Vigor/Height and Density	area could use tree boosters			No

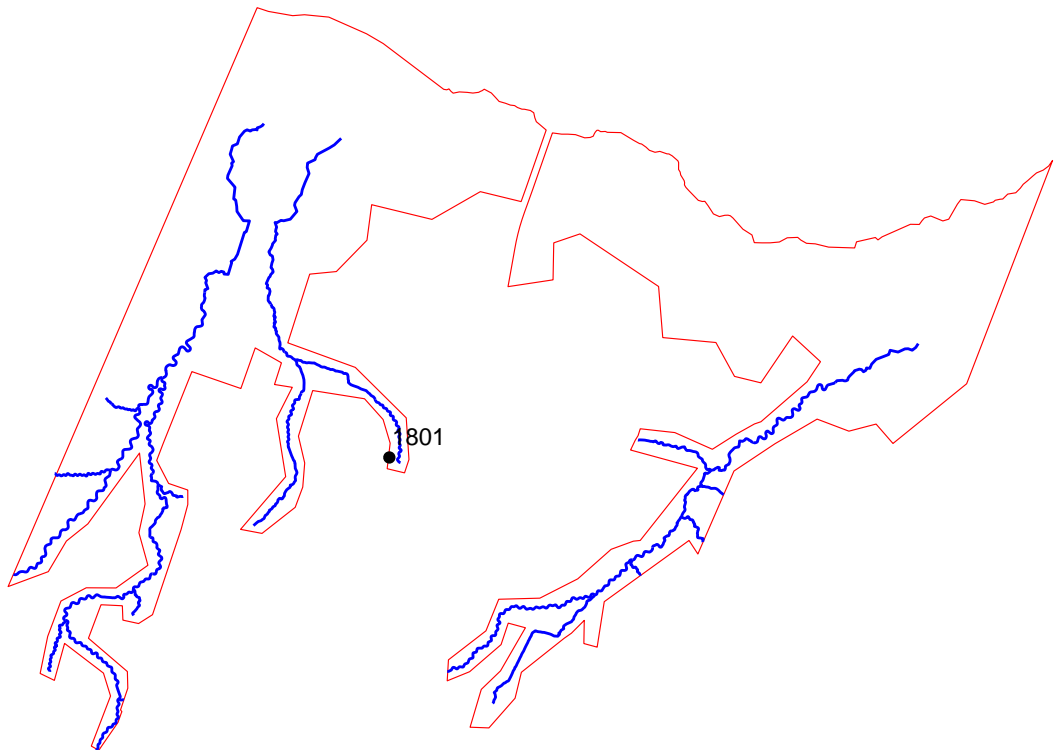
Weed Issues – Callery Pear

OBJECTID	Year	Species1	Species2	Issue	Treatment	Method	TreatDate	Resolved
1801	2023	Callery Pear		1 callery pear to cut stump				No
1783	2023	Chinaberry		patch of chinaberry needs Tx				No
1802	2023	Chinaberry		mature chinaberry				No
1803	2023	Chinaberry		saw sized chinaberry. candidate for stem injector, bring machete to access base through smilax				No
1083	2023	Chinese Privet	Japanese Honeysuckle	privet dense, then scattered towards northern end of polygon	Privet Tx by contractors		07/2023	No
1788	2023	Chinese Privet		A few mature privet				No
1865	2023	Chinese Privet		Pocket of privet that needs Tx				No
986	2023	Japanese Honeysuckle		LOJA in trees. treat soon				No
1551	2023	Marsh Dewflower		Murdannia ISV	Spray ISV Sadlers and Chickory	Backpack Spray	08/2023	No
984	2023	Tree Of Heaven		Few stems of TOH				No
1008	2023			Isv Tx needed				No
1818	2023			Possible chinaberry patch (no leaves)	3 saw sized stems treated, 3 remain need chainsaw	Cut Stump	12/2023	No

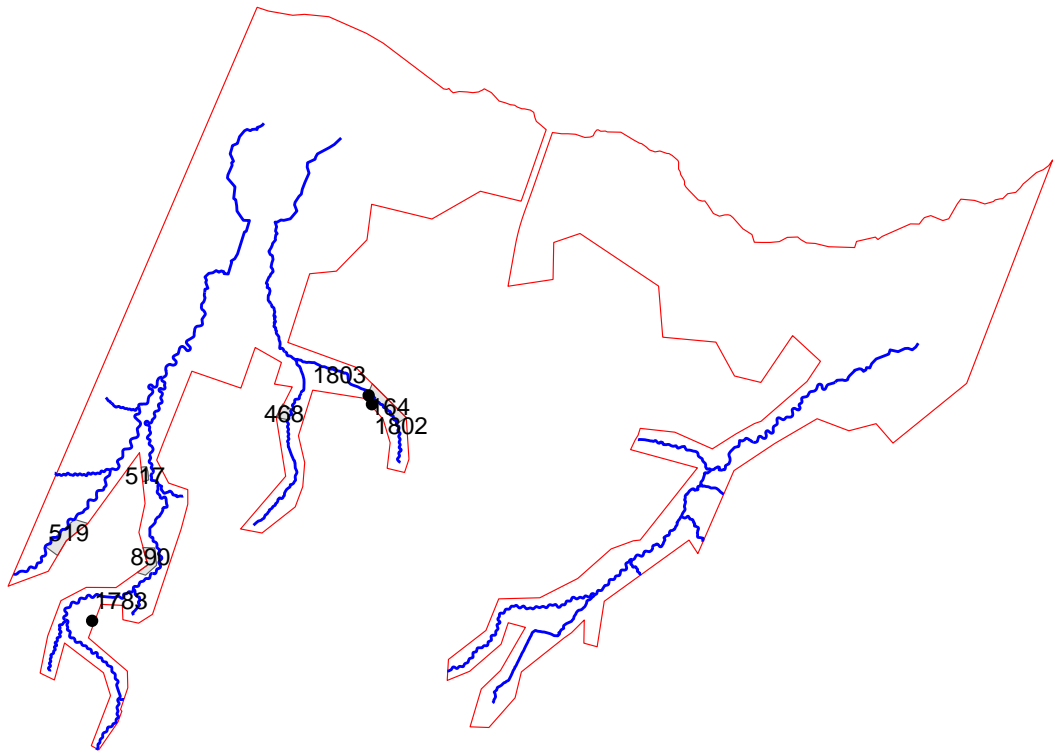
Weed Issues – Chinaberry

566	2022	Blackberry	Chinaberry					No
573	2022	Blackberry	OTHER	Cattails, Blackberry, Pines galore				No
565	2022	Cattail		Cattails in stream				No
727	2022	Cattail		cattails				No
890	2022	Chinaberry						No
568	2022	Chinese Privet						No
572	2022	Chinese Privet		Lopper size, scattered				No
569	2022	Japanese Honeysuckle						No
850	2022	Lespedeza		from contaminated seed mix	foliar	Backpack Spray	06/2022	No
564	2022	Lespedeza	Chinaberry	1 large chinaberry needs Tx				No
824	2022	OTHER	Sweet Gum	Loblolly	Cut pines and cut stump sweetgum. Daylighting around trees overtopped by pine and sweetgum.	Mow	09/2022	Yes
576	2022	OTHER		Remove Willow from channel				No
998	2022	Sweet Gum	OTHER	Loblolly pine and sweetgum				No
999	2022	Sweet Gum	OTHER					No
545	2022	Tree Of Heaven						No
517	2021	Chinaberry		scattered smaller stems, 3 hack'n'squirt stems				Yes
164	2021	Chinaberry		Scattered stems	Chinaberry Tx by contractor		07/2023	No

164	2021	Chinaberry		Scattered stems	Cutstump stems handsaw	Cut Stump	07/2023	No
468	2021	Chinaberry		Saw size	Chinaberry Tx by contractor		07/2023	No
519	2021	Chinaberry	Marsh Dewflower		Chinaberry Tx by contractors		07/2023	No
471	2021	Chinese Privet		Size classes vary from seedlings to saw size	Privet removal around Chicory	Cut Stump	06/2021	No
471	2021	Chinese Privet		Size classes vary from seedlings to saw size	cut stump privet	Cut Stump	07/2022	No
471	2021	Chinese Privet		Size classes vary from seedlings to saw size	Privet removal	Cut Stump	11/2023	No
471	2021	Chinese Privet		Size classes vary from seedlings to saw size	Follow up contractor cutstump, dense root sprouts between cornet creek and anise branch	Cut Stump	12/2023	No
258	2021	Chinese Privet		Some saw sized privet and seedlings.	Privet Tx by contractor		07/2023	No
98	2021	Chinese Privet						No
97	2021	Mimosa		1 stem				No
200	2021	Mimosa		Saw size 1 stem				No

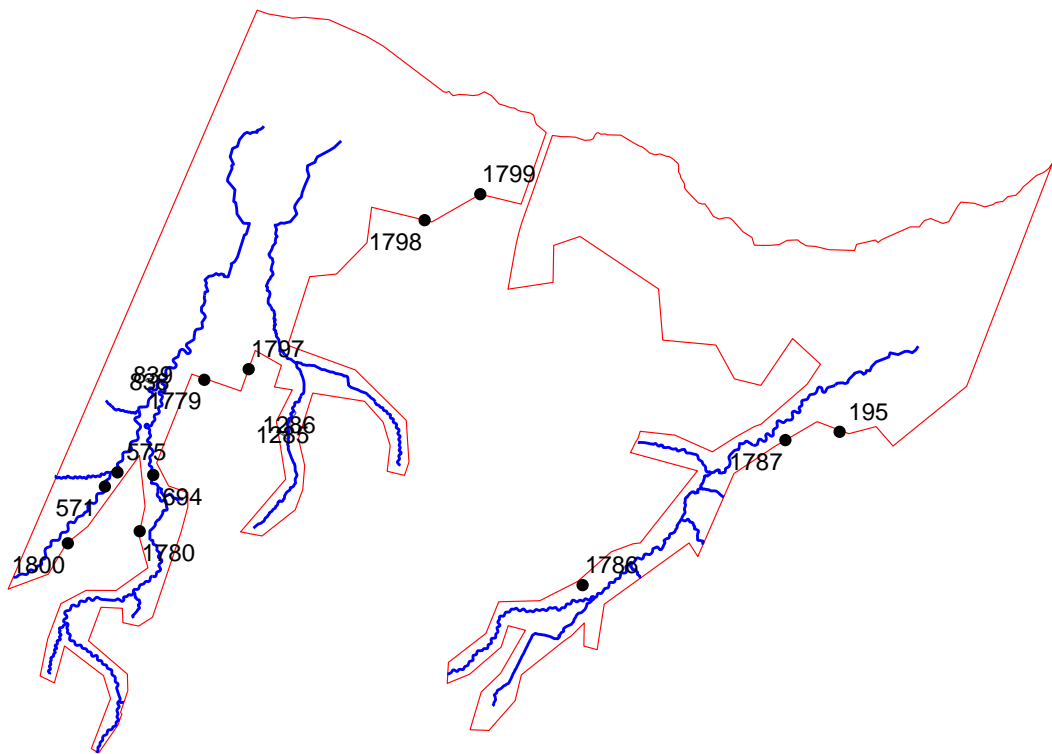
Miscellaneous Issues

OBJECTID	Year	Subtype	Description	LocationOrFeature	Treatment	TreatDate	Resolved
1285	2023	Misc	Repair area left bank LOD				No
1286	2023	Misc	Repair area right bank LOD				No
1787	2023	Misc	tree down on fence		Fence work/clearing completed by Hanna	12/2023	No
1779	2023	Misc	tree down on fence				No
1780	2023	Misc	Tree down on fence				No
1786	2023	Misc	tree down on fence				No
1797	2023	Misc	small tree down on fence				No
1798	2023	Misc	additional signage needed				No
1799	2023	Misc					No
1800	2023	Misc	Tree on fence				No
838	2022	Misc	Cattail patch	Other			No
839	2022	Misc	Cattail patch				No
571	2022	Misc	Livestake outer bend, remove pines				No
575	2022	Misc	Needs plugs				No
694	2022	Misc	Chainsaw works in channel debris				No
195	2021	Misc	Add t-post to low area	Upland			No
