Stewardship for Rosewood

Lead Steward: Hanna

2023-12-18

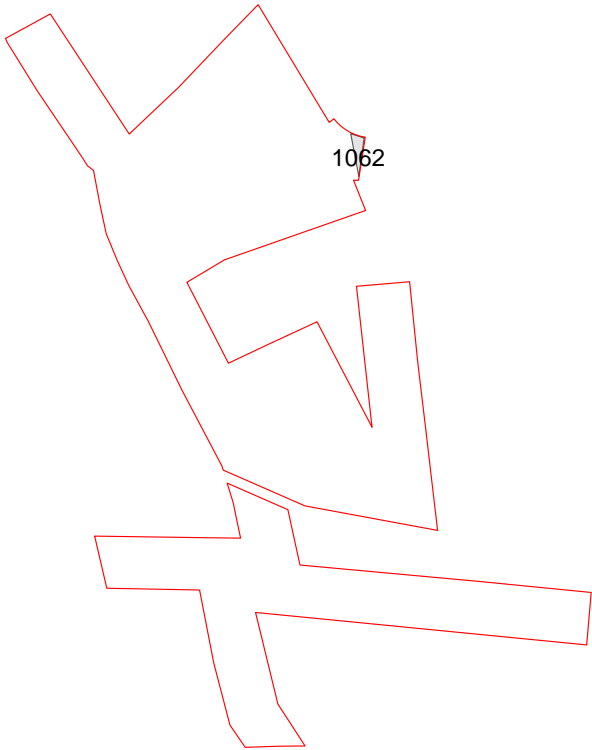
Boundary Issues (polygons)

OBJECTID	Year	Issue	Description	Resolved
1062	2023	Other	Neighbors using CE as backyard/driveway	Yes

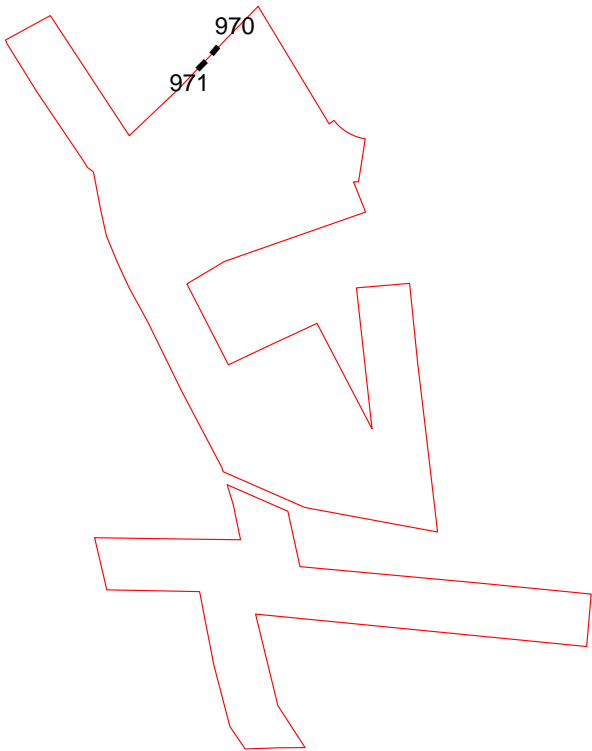
Channel Issues (lines)

OBJECTID	Year	Subtype	Issue	Description	Resolved
970	2023	Channel Stability/Erosion	ErosionScour	Bank eroding, needs a couple live stakes	No
971	2023	Channel Stability/Erosion	ErosionScour	Eroding bank, needs 5 live stakes	No

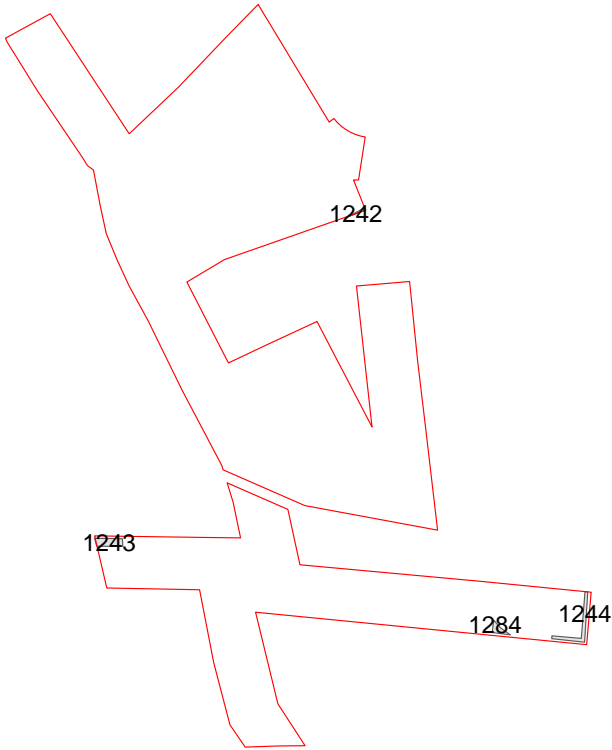
Vegetation Issues (polygons)

OBJECTID	Year	Issue	Description	Resolved
1242	2023	Low Stem Density	Supplemental planting, 3 trees	No
1243	2023	Low Stem Density	Supplemental planting, 12 trees	No
1244	2023	Low Stem Density	Supplemental planting, 30 trees shade/dry tolerant	No
1284	2023	Bare Areas	Cover crop/soil amendment. Sandy!	No

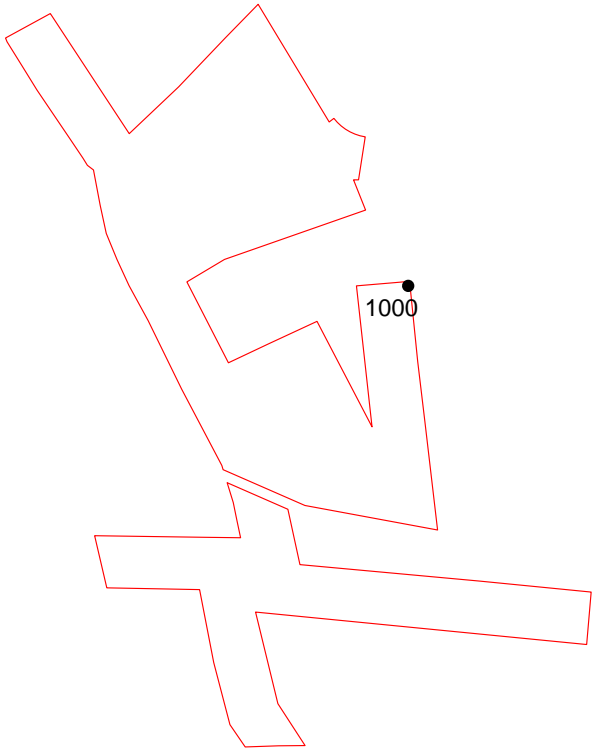
Weed Issues – Chinaberry

OBJECTID	Year	Species1	Species2	Issue	Resolved
1000	2023	Chinaberry		Treat with basal bark	No
1365	2023	Climbing Hempvine	Callery Pear	Keep an eye on weeds	No
1001	2023	Multiflora Rose	Japanese Honeysuckle	Invasives on bank of ditch	No
969	2023			Cattail in ditch	No
1138	2023			Elephant ears in ditch	No
1139	2023			Elephant ears in ditch	No

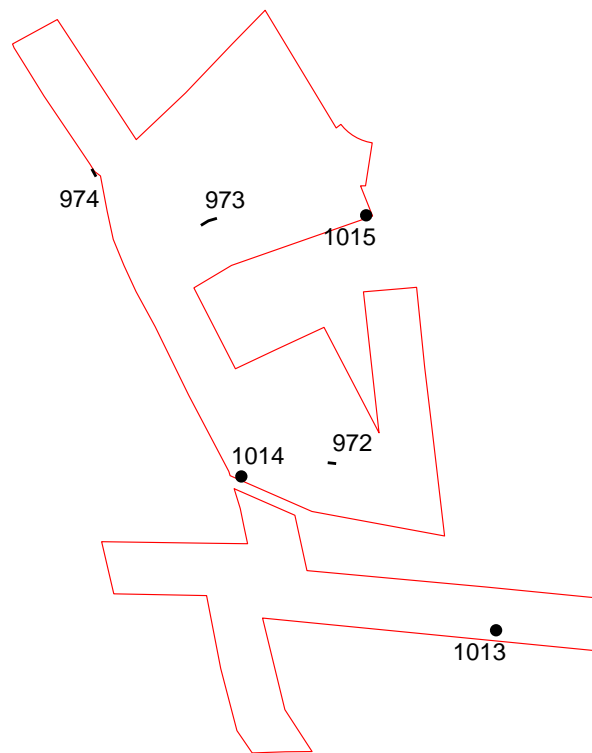
Miscellaneous Issues

OBJECTID	Year	Subtype	Description	LocationOrFeature	Resolved
972	2023	Misc	Grading both sides of bank		No
973	2023	Misc	Grading both sides of bank		No
974	2023	Misc	Grading both sides of bank		No
1013	2023	Misc	Trash/old plastic culvert among trees	Floodplain	No
1014	2023	Misc	Rock pile		No
1015	2023	Misc	Large woody debris pile		No
