Stewardship for Wyant

Lead Steward: Emily

2023-12-18

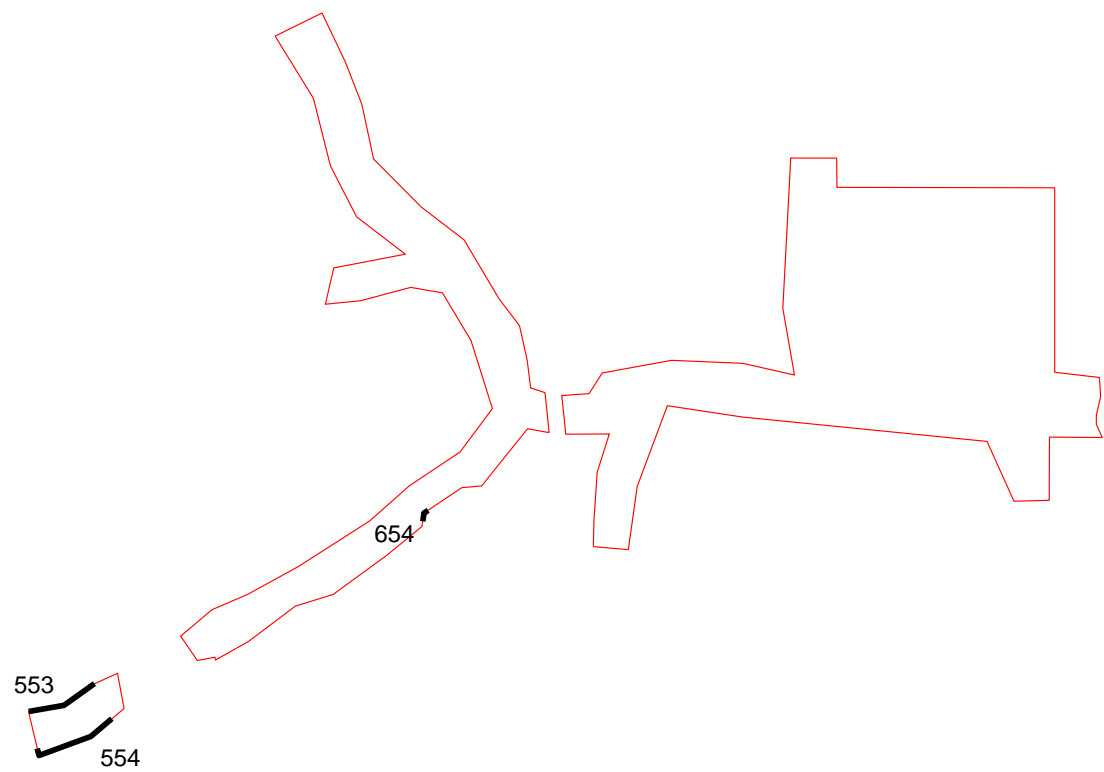
Boundary Issues (lines)

OBJECTID	Year	Issue	Description	Treatment	TreatDate	Resolved
654	2022	Other	Off-site gullies inputting sediment into CE	Additional sign and posts installed (need insulators and another sign on one post)	01/2022	No
654	2022	Other	Off-site gullies inputting sediment into CE	3 coir logs installed along boundary line	04/2023	No
553	2021	Herbicide	Herbicide drift			No
554	2021	Herbicide	Herbicide drift			No

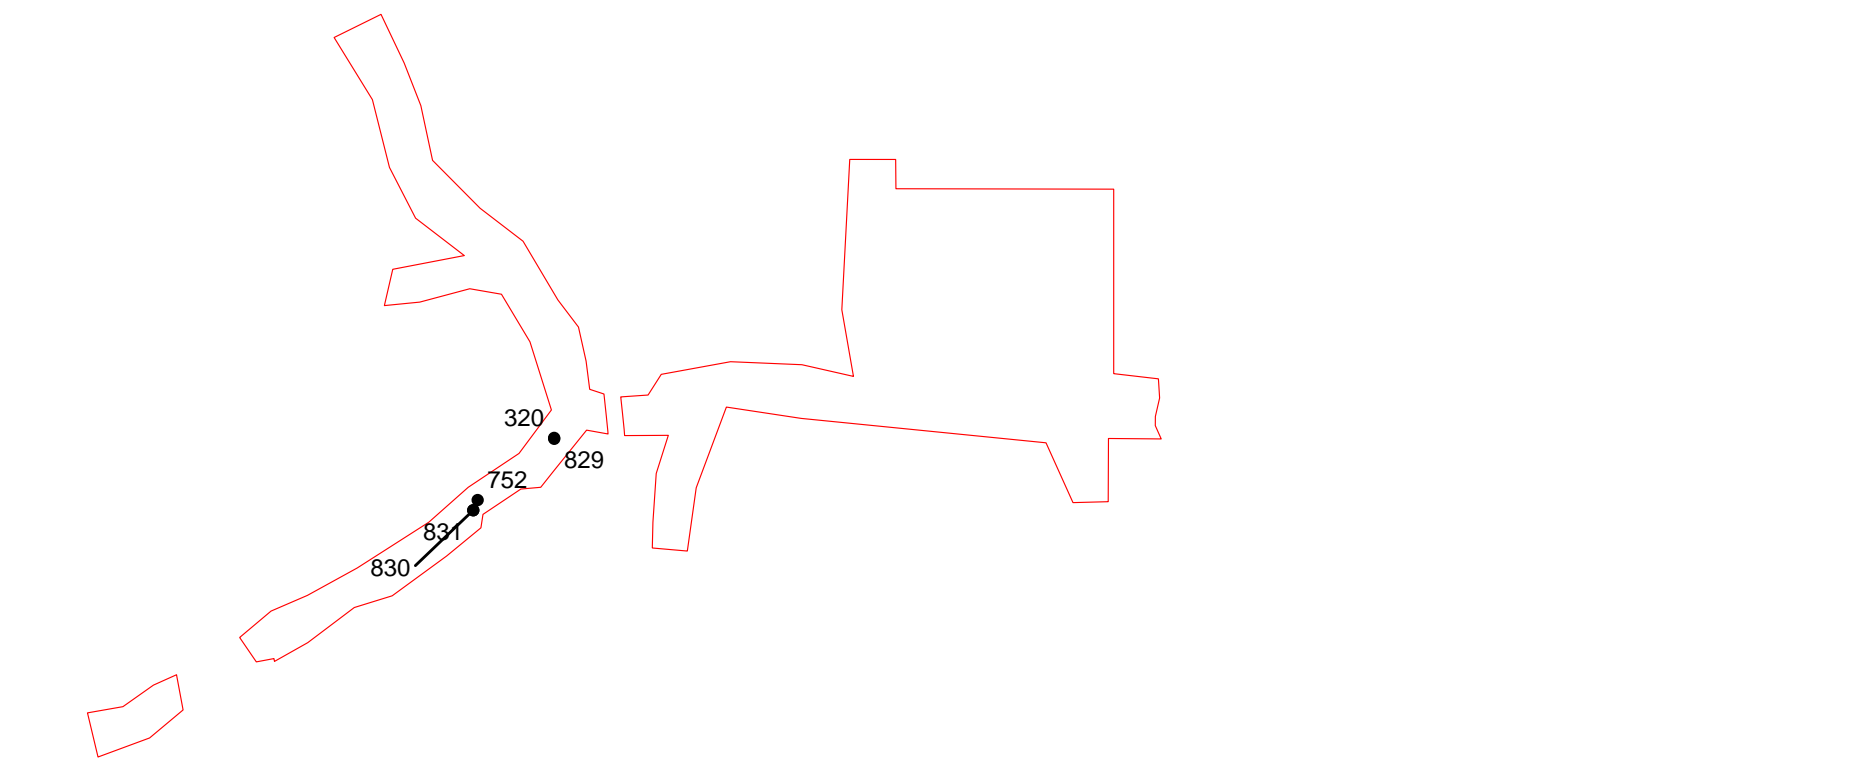
Channel Issues (points)

OBJECTID	Year	Subtype	Issue	Description	Treatment	TreatDate	Resolved
946	2023	Channel Stability/Erosion	ErosionScour		Machine repair	06/2023	Yes
739	2022	Channel Stability/Erosion	ErosionScour				No
806	2022	Channel Stability/Erosion	AggradationDeposition				No
898	2022	Needs Livestakes					No
919	2022	Needs Livestakes					No
920	2022	Needs Livestakes					No
752	2022	Failed Structure	Piping	Piping under log			No
829	2022	Failed Structure		Repair both banks where sill is tied in.			No
830	2022	Failed Structure					No
831	2022	Failed Structure					No
655	2021	Needs Livestakes					No
656	2021	Channel Stability/Erosion	AggradationDeposition				No
657	2021	Channel Stability/Erosion		Gully from farm road by gate			No
320	2021	Failed Structure	Piping	Piping around log sill where keyed into bank			No

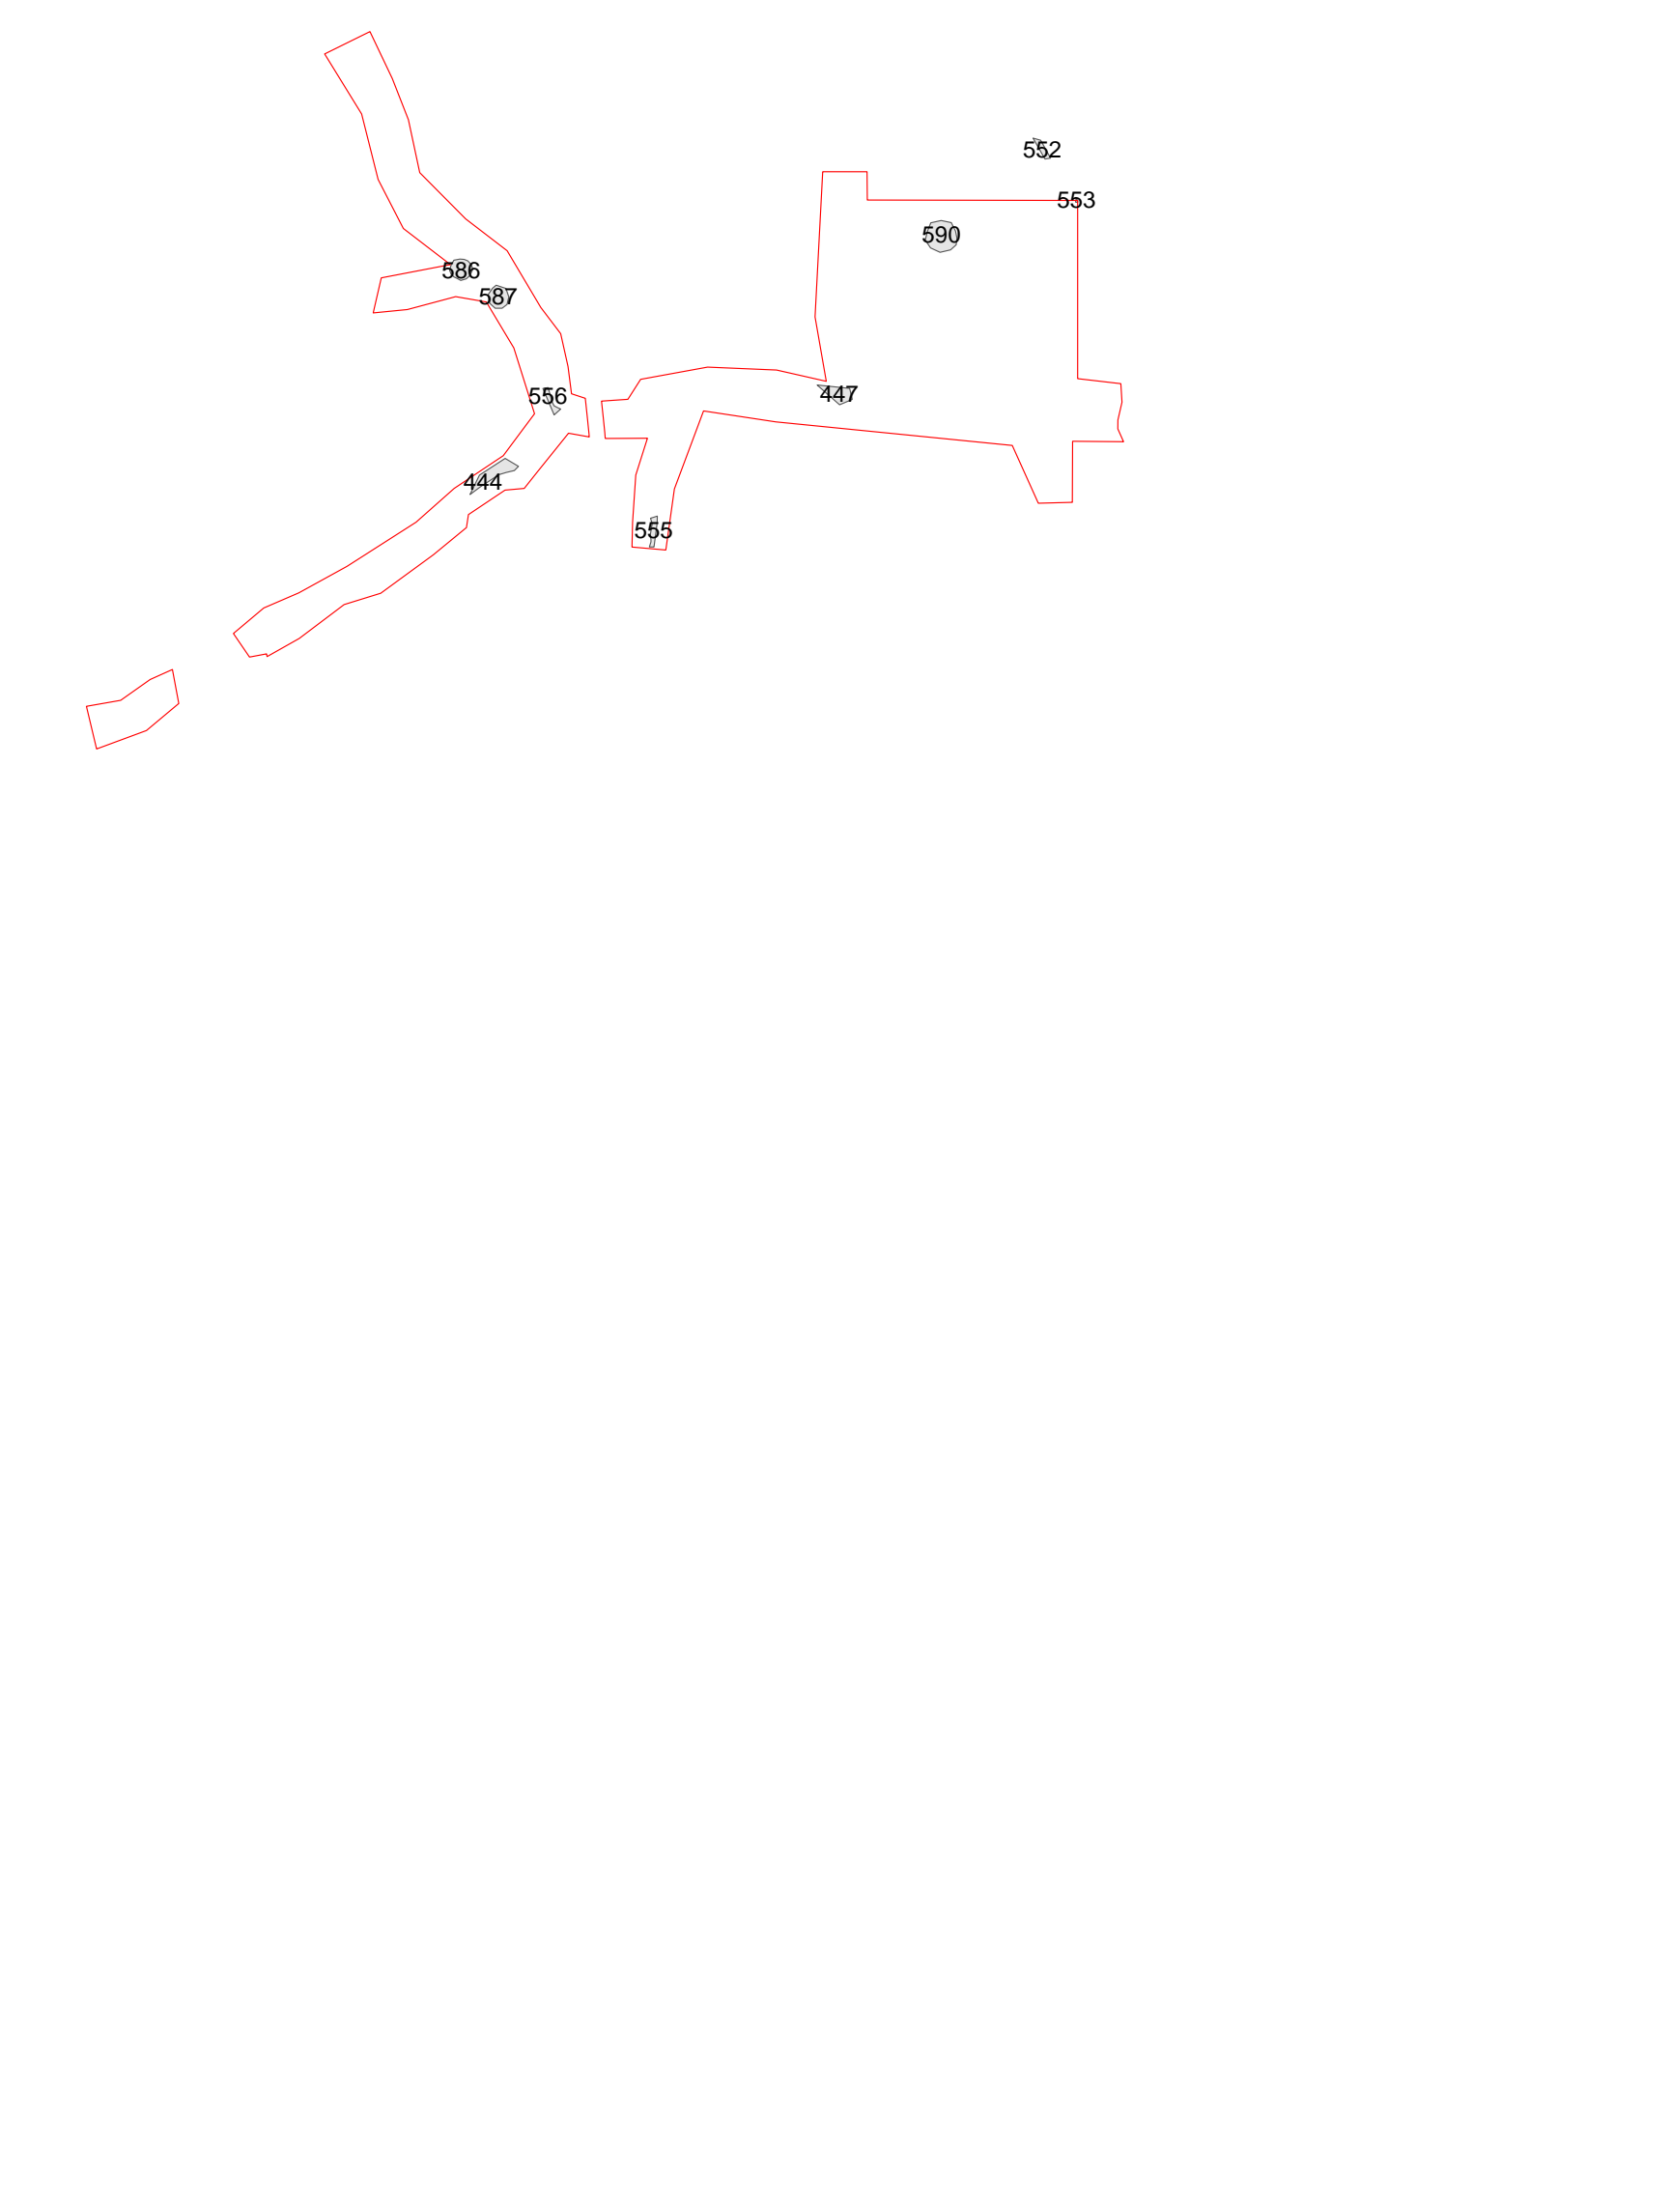
Vegetation Issues (polygons)

OBJECTID	Year	Issue	Description	Treatment	TreatDate	Resolved
586	2023	Low Stem Density	Replanting 2022 and 2023			Yes
587	2023	Low Stem Density	Replanting 2022 and 2023			Yes
590	2023	Low Stem Density	Replanting 2022 and 2023			Yes
555	2021	Bare Areas	Bare area and gullies (wet area)	Gullies smoothed, seeded, strawed, matted. Dead logs placed at top to deflect water.	04/2022	Yes
444	2021	Bare Areas	Bare areas filling in			No
447	2021	Bare Areas	Bare areas healing			No
552	2021	Bare Areas	Very sandy			No
553	2021	Bare Areas				No
556	2021	Bare Areas and Low Stem Density	Slightly bare, rocky, and very wet. Seed heavy.			No

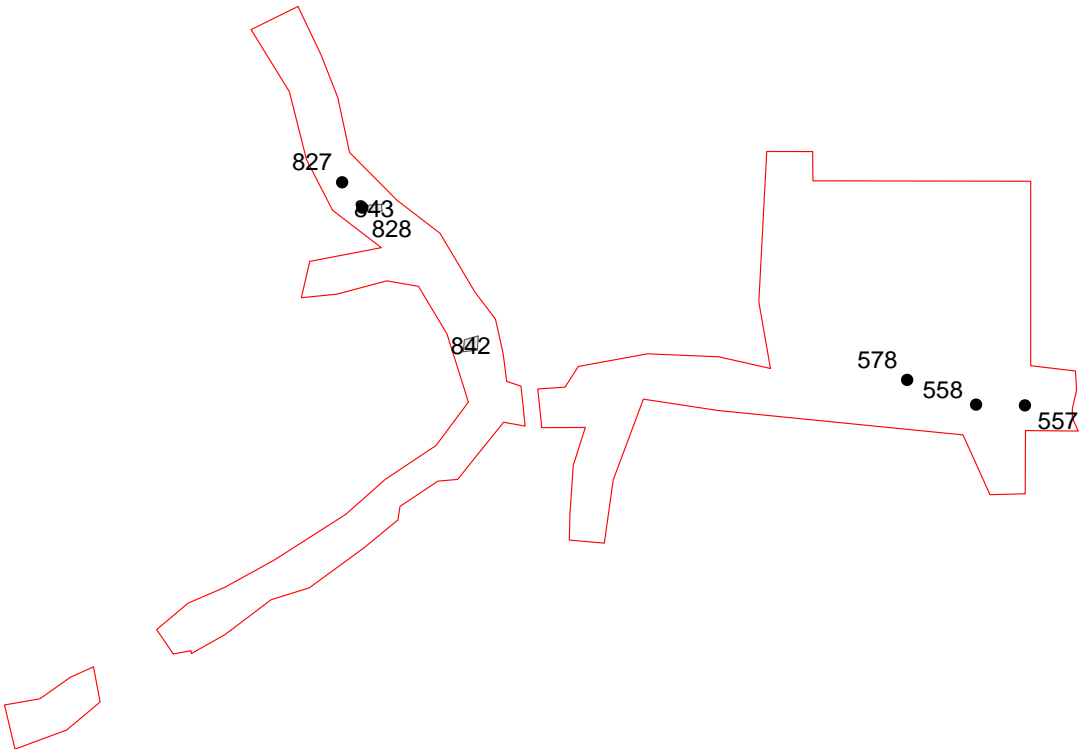
Weed Issues – Cattail

OBJECTID	Year	Species1	Species2	Issue	Treatment	Method	TreatDate	Resolved
842	2023	Cattail						No
1093	2023				5 pct glyphosate plus surfactant. Need to follow-up.	Backpack Spray	07/2023	No
843	2022	Cattail		Cattails				No
557	2022	Cattail						No
558	2022	Cattail						No
578	2022	Cattail						No
827	2022	Cattail						No
828	2022	Cattail						No
832	2022	Japanese Honeysuckle						No
785	2022	Morning Glory						No
561	2022	Multiflora Rose						No
906	2022	Tree Of Heaven						No
805	2022			Most veg. not rooted in stream	In stream veg spray	Backpack Spray	07/2022	No
805	2022			Most veg. not rooted in stream	5 pct glyphosate plus surfactant. Need to finish. Hard to find channel. Most veg not rooted in stream.	Backpack Spray	07/2023	No
446	2021	Chinese Privet						No
551	2021	Chinese Privet	Multiflora Rose					No
554	2021	Chinese Privet						No
167	2021	Chinese Privet						No
319	2021	Chinese Privet	Japanese Honeysuckle					No

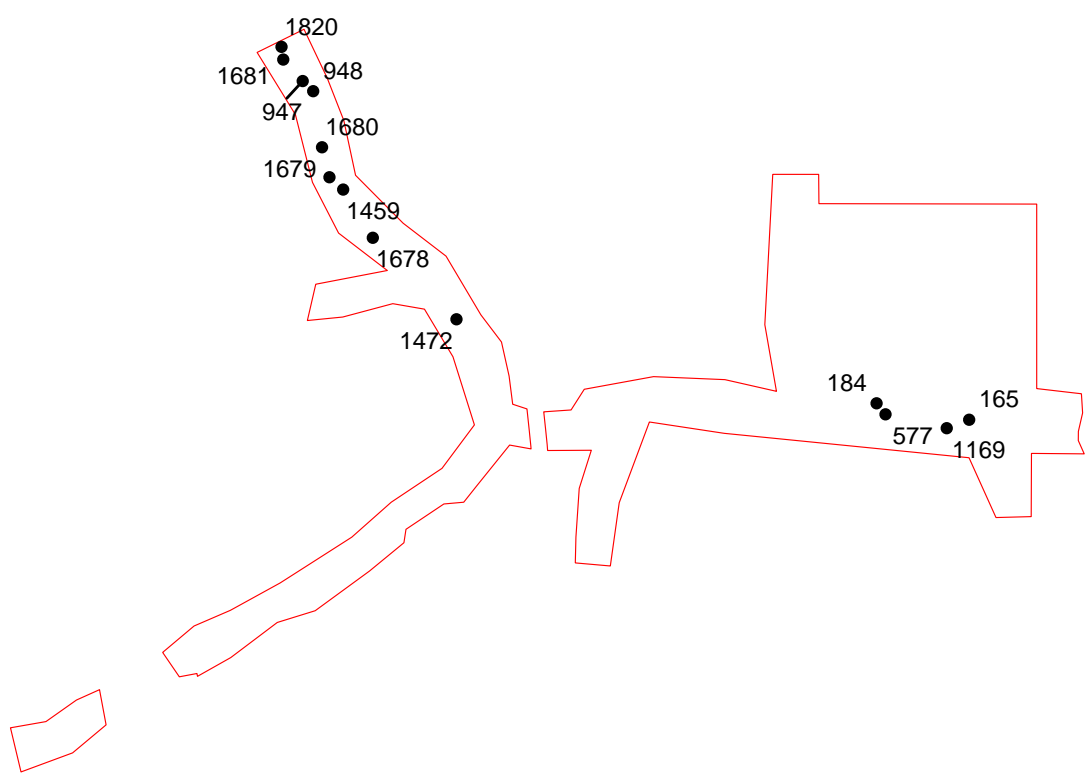
Miscellaneous – Beaver Dam

OBJECTID	Year	Subtype	Description	LocationOrFeature	Treatment	TreatDate	Resolved
947	2023	Beaver Dam			Dam removed by trappers	11/2023	Yes
1681	2023	Beaver Dam			Dam removed by trappers	11/2023	No
1680	2023	Beaver Dam			Dam removed by trappers	11/2023	No
948	2023	Beaver Dam			Dam removed by trappers	11/2023	No
1459	2023	Beaver Dam			Dam removed by trappers	11/2023	No
1169	2023	Beaver Dam			Trapped 2 beaver	07/2023	No
1679	2023	Beaver Dam			Dam removed by trappers	11/2023	No
1678	2023	Beaver Dam			Dam removed by trappers	11/2023	No
1347	2023	Misc	Photo point	Floodplain			No
1348	2023	Misc	Photo description	Floodplain			No
1357	2023	Misc	Cattail photo point				No
1361	2023	Misc	Cattail photo point				No
1362	2023	Misc	Cattail photo point				No
1472	2023	Beaver Dam					No
1819	2023	Misc	Remove tposts and wire	Floodplain			No
1820	2023	Beaver Dam					No
1821	2023	Misc	Remove fence				No
184	2022	Beaver Dam					Yes

577	2022	Beaver Dam					Yes
165	2021	Beaver Dam			Staff raked dam out	09/2021	Yes
