Engineering Portfolio

Matthew Hoeper

Senior Capstone

- Sounding rocket project for the Spaceport America Cup (formerly ESRA/IREC)
- 18 person team composed of ME, EE, and CS majors
- 3 people per sub team
- Aerodynamics and Recovery, Propulsion, Structures, Payload, Avionics, and Computer Science
- Propulsion was my focus

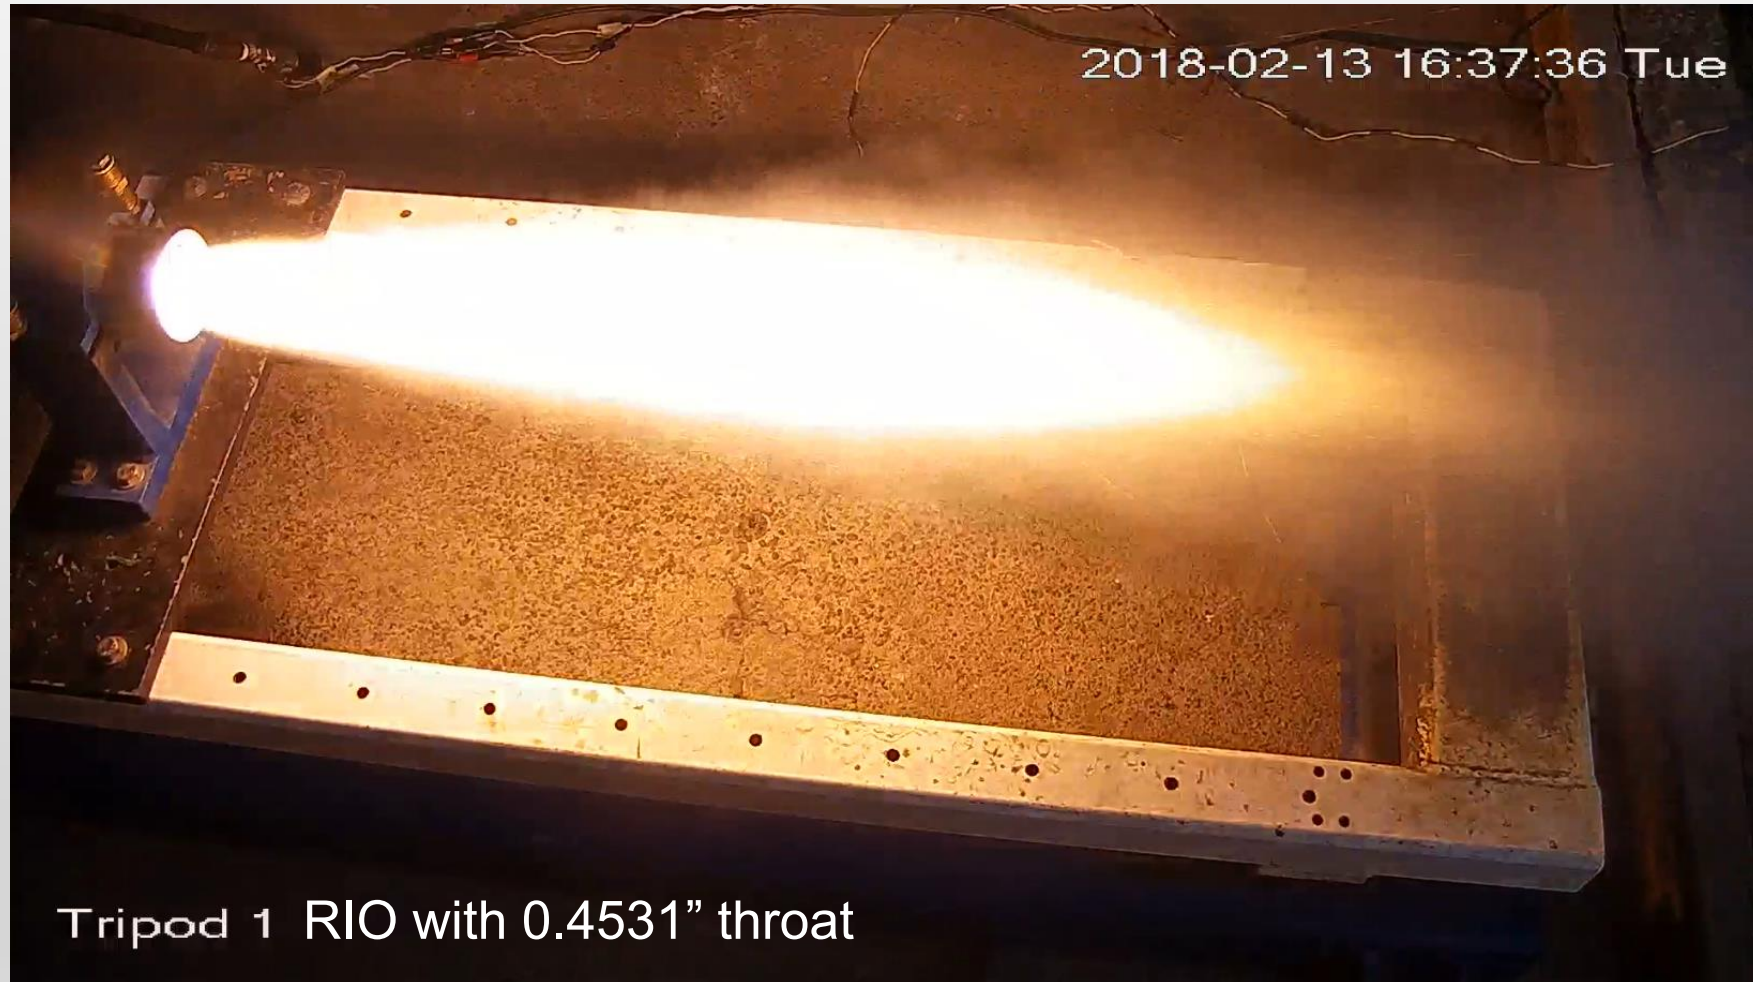
SOS with 0.3438 inch throat

- Performed many sub scale tests to identify and characterize propellants
- First round of testing had “SOS” , a slow burning propellant and “RIO” a high metals, fast propellant
- Performed many sub scale tests to identify and characterize propellants

- SOS was too slow, RIO was too fast
- Removed burn rate enhancer from RIO, called it Bare Bones

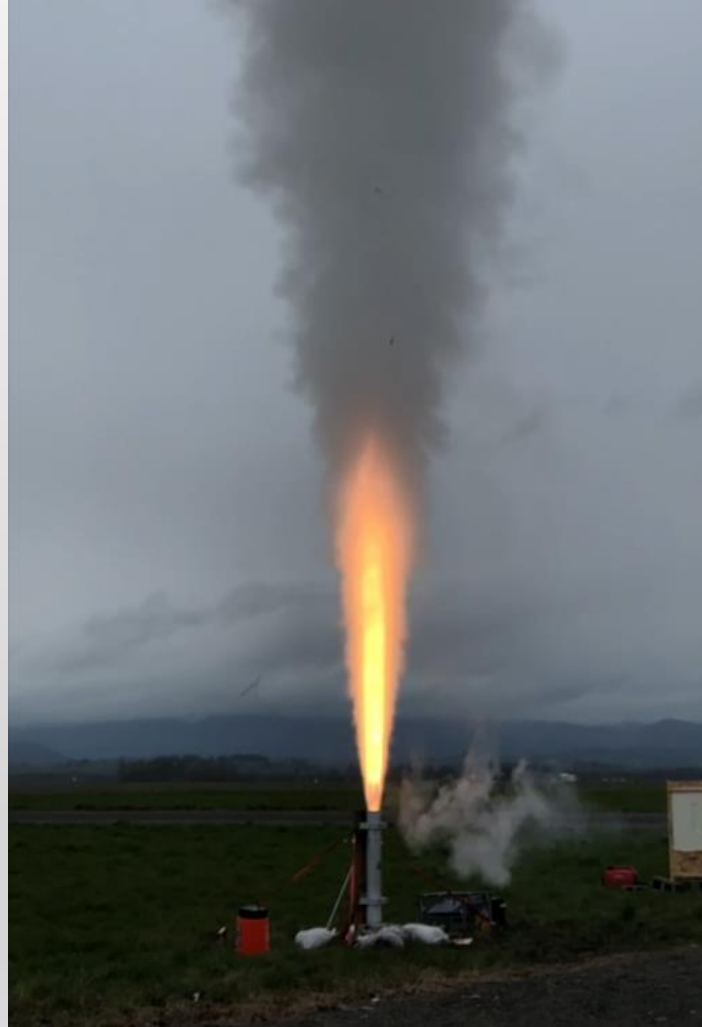
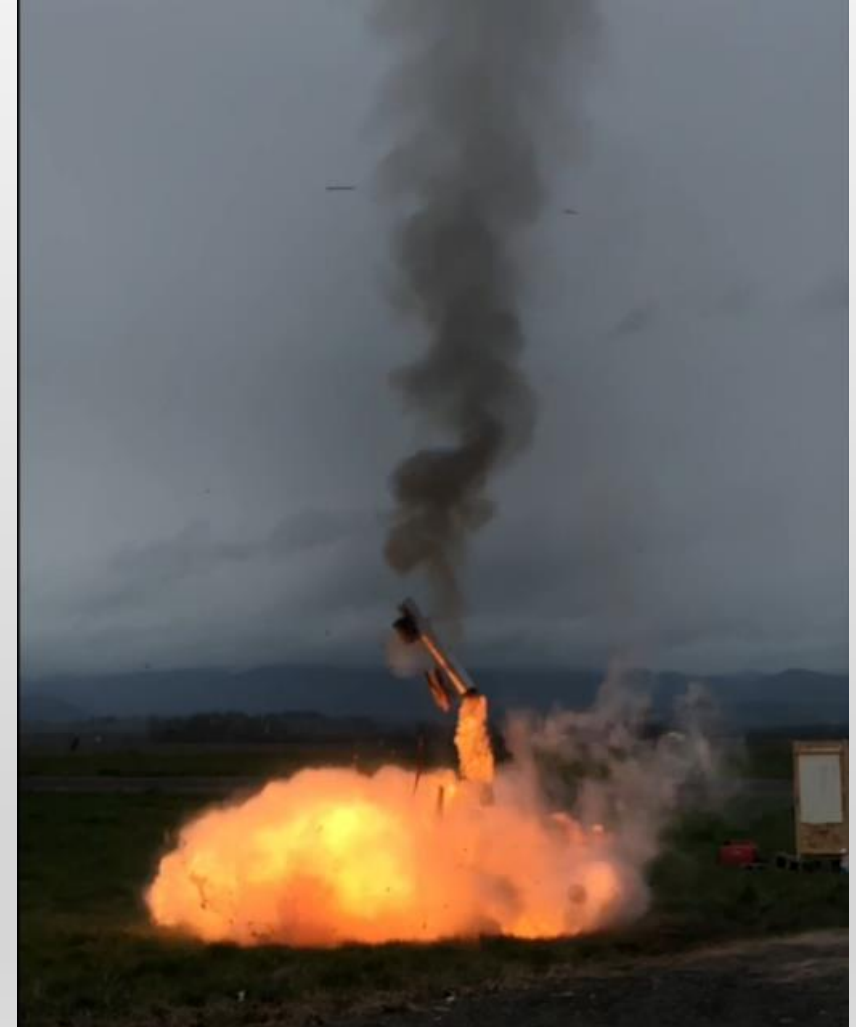
V1.0 Testing

- First full scale static fire on March 3rd, 2018
- Plume is grossly under expanded

.... did not end well

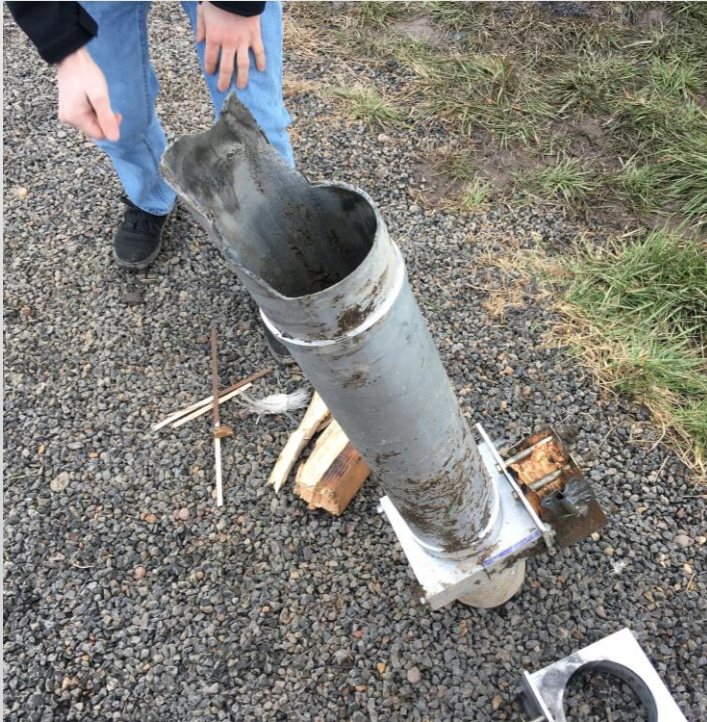
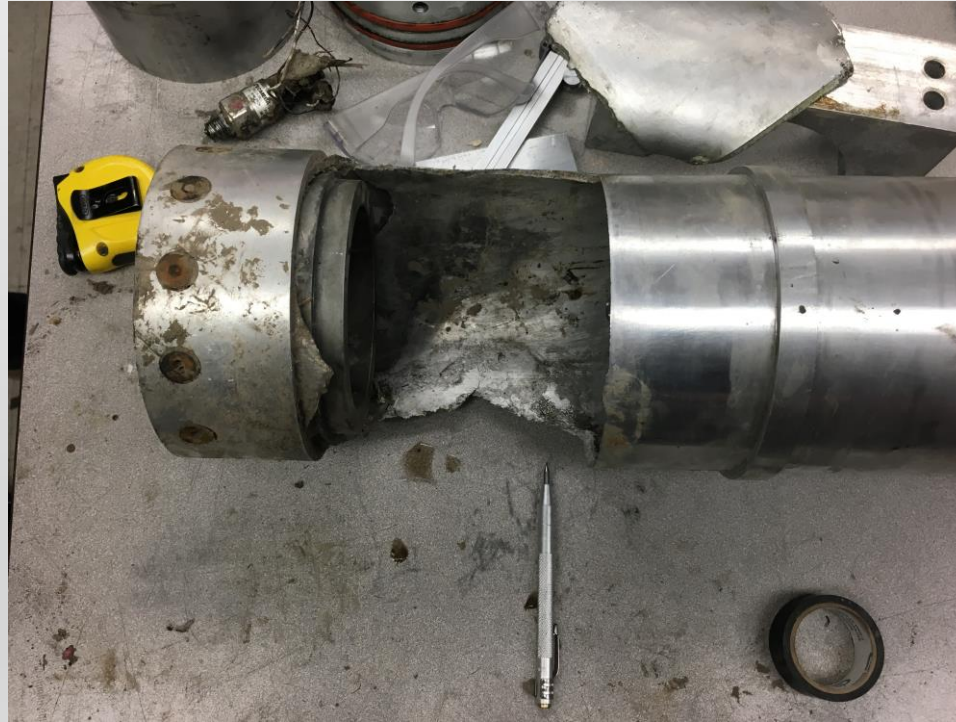
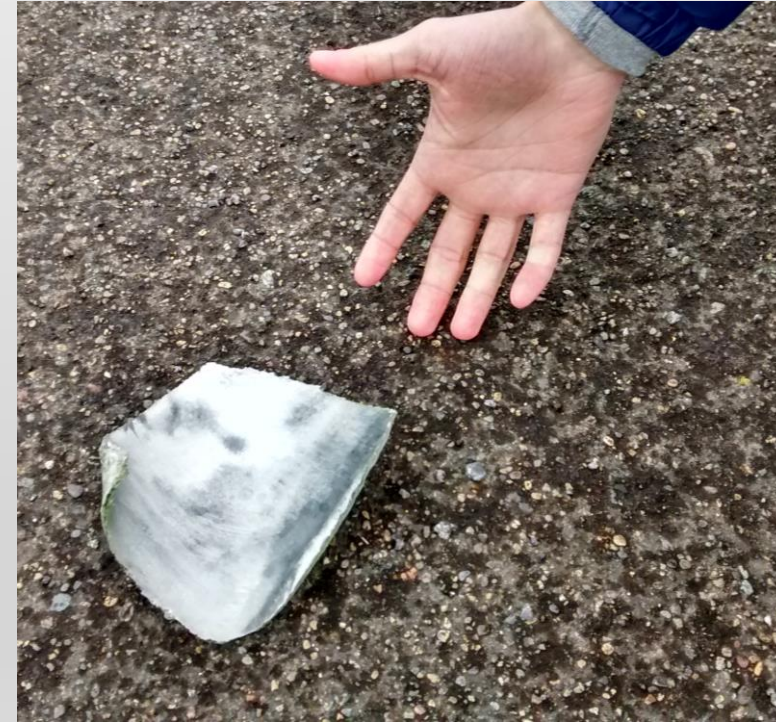
- The casing was designed to have the snap ring groove fail first so that the nozzle would eject
- We figured the wall got much hotter than the groove so that it became the weakest point.

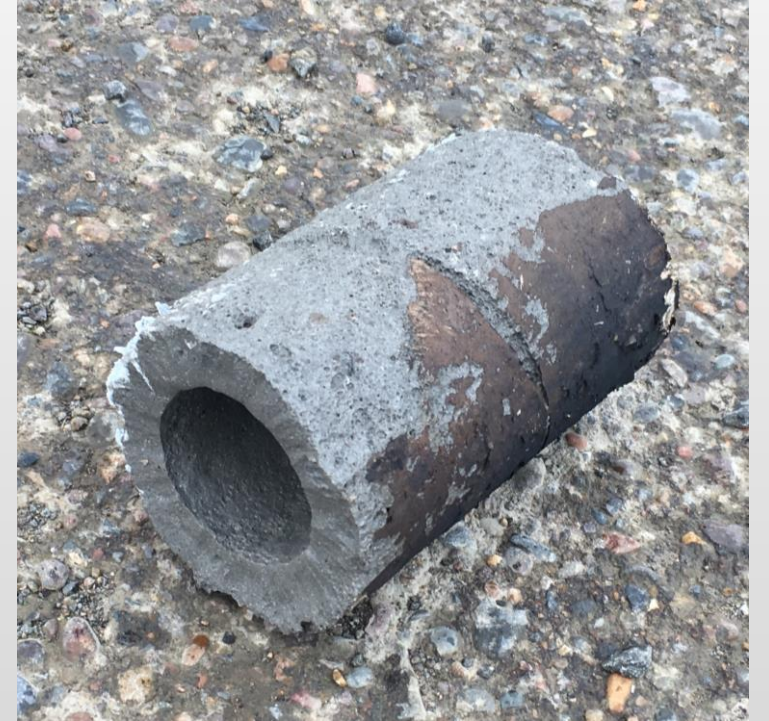
- Notice how the casting tube burned away.
- The extra surface area that was burning contributed to the over pressure. (more mass combusting = higher pressure)

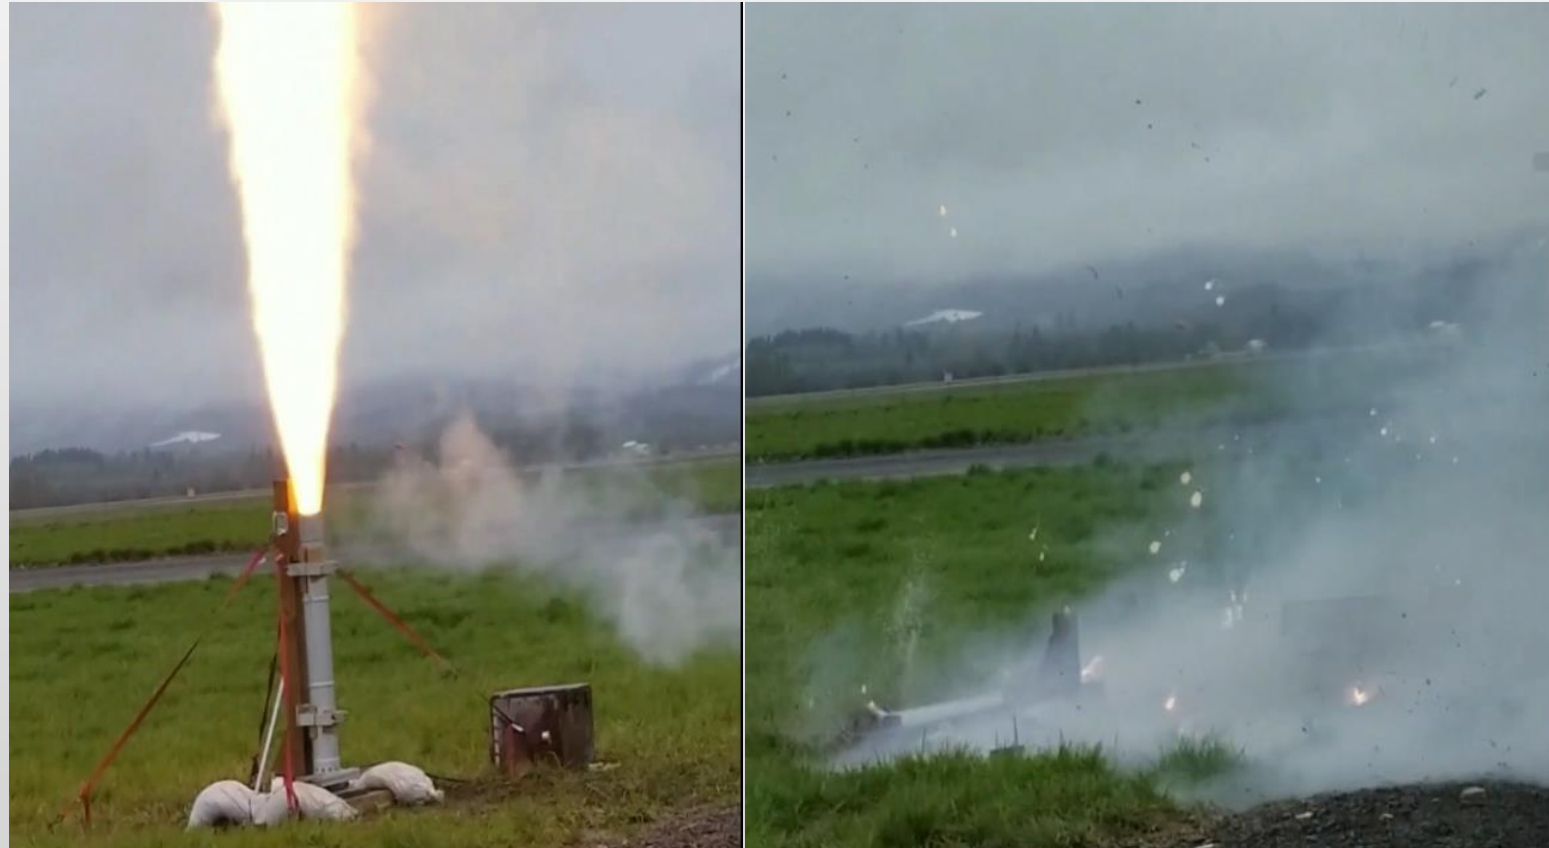
- Second full scale static test fire on March 23rd, 2018

- Burn lasted for about 1 second.
- Expected pressure: 600 psi
- Failure attributed to a bonding agent that was added to the formulation based on a recommendation.
- We were told, "No increase in burn rate"
- The team had doubts about that and went back to subscale testing...

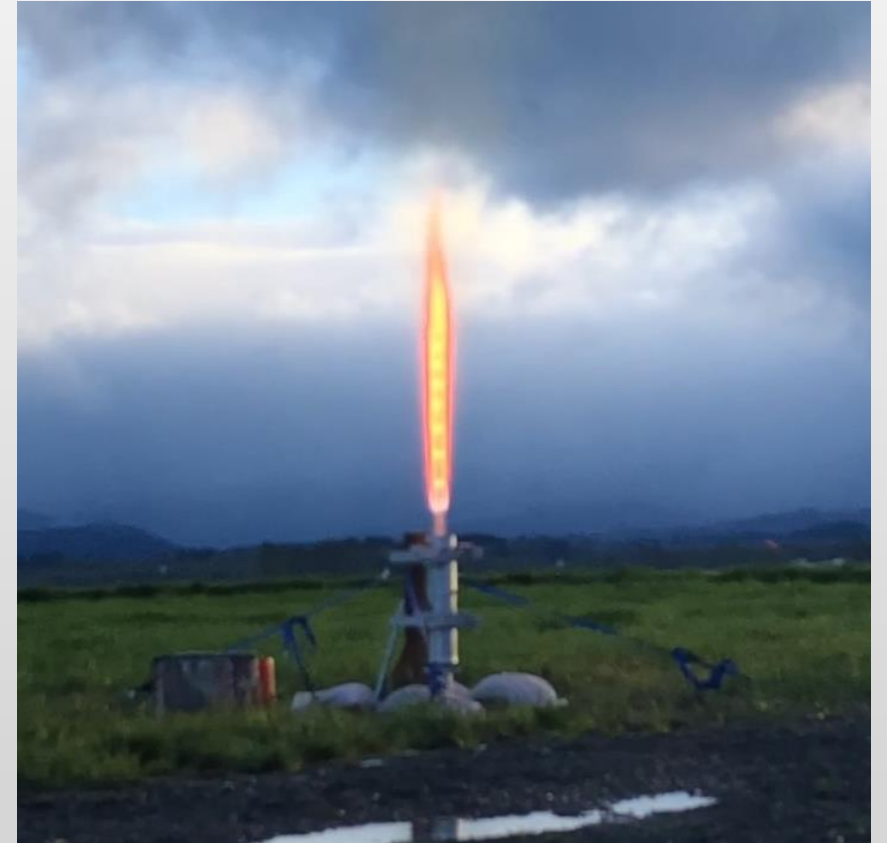
Mid Scale Test

- Team decided to move away from Bare Bones and use a propellant that has been well characterized by Oregon State in the past called Orange Koolaid.
- Performed a “Mid Scale” test that used the diameter from the full scale but only half the length.
- Test was on April 15th.

- Expected max pressure was within 10 psi of the actual.
- We were all very happy, to say the least.
- Transitioned back to full scale.

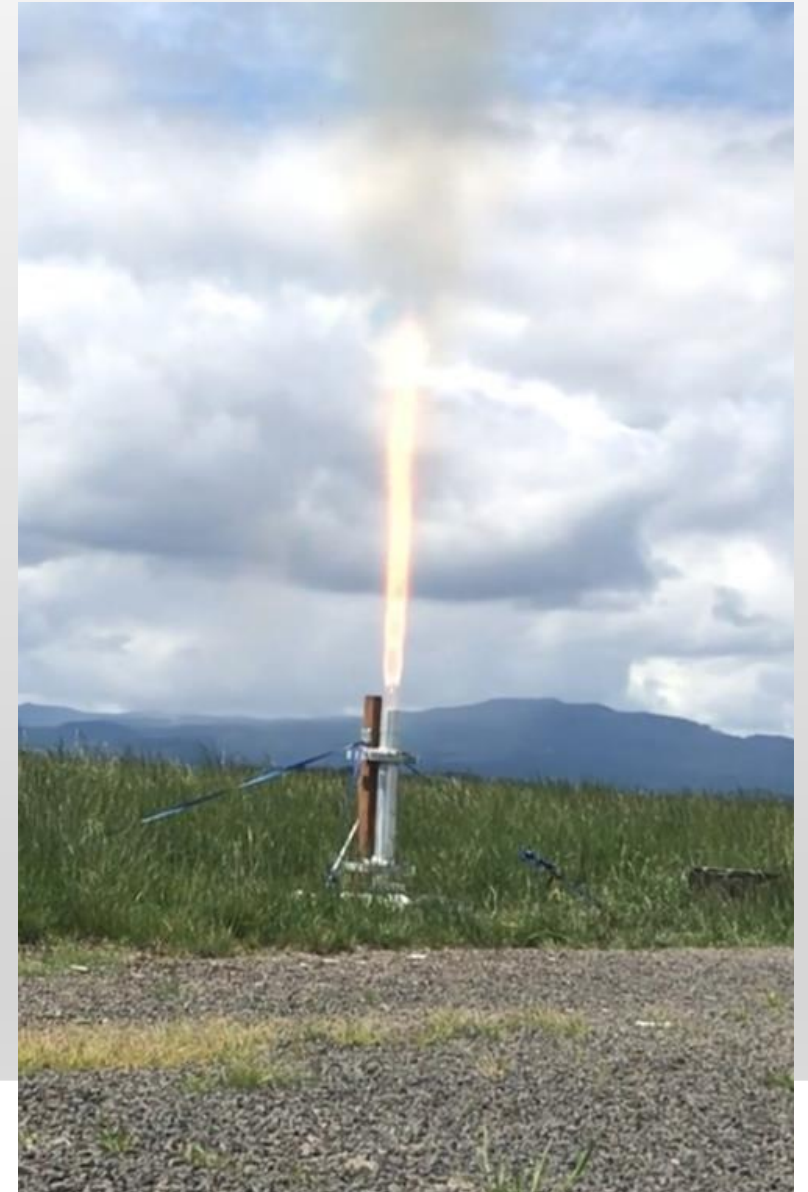
V1.2

- The next iteration of the design was largely the same as the 2nd.
- Wall thickness was 0.20" and edge length was increased by another ½"
- Testing commenced on May 10th

- A few mentors said, "That was the best test I have ever seen"
- We were very pleased with the test
- Solid Rocket Motor Specs:
 - 30 lb propellant
 - 28,500 Ns
 - 787 psi peak pressure
 - 1570 lbf peak thrust
 - 6 sec burn time

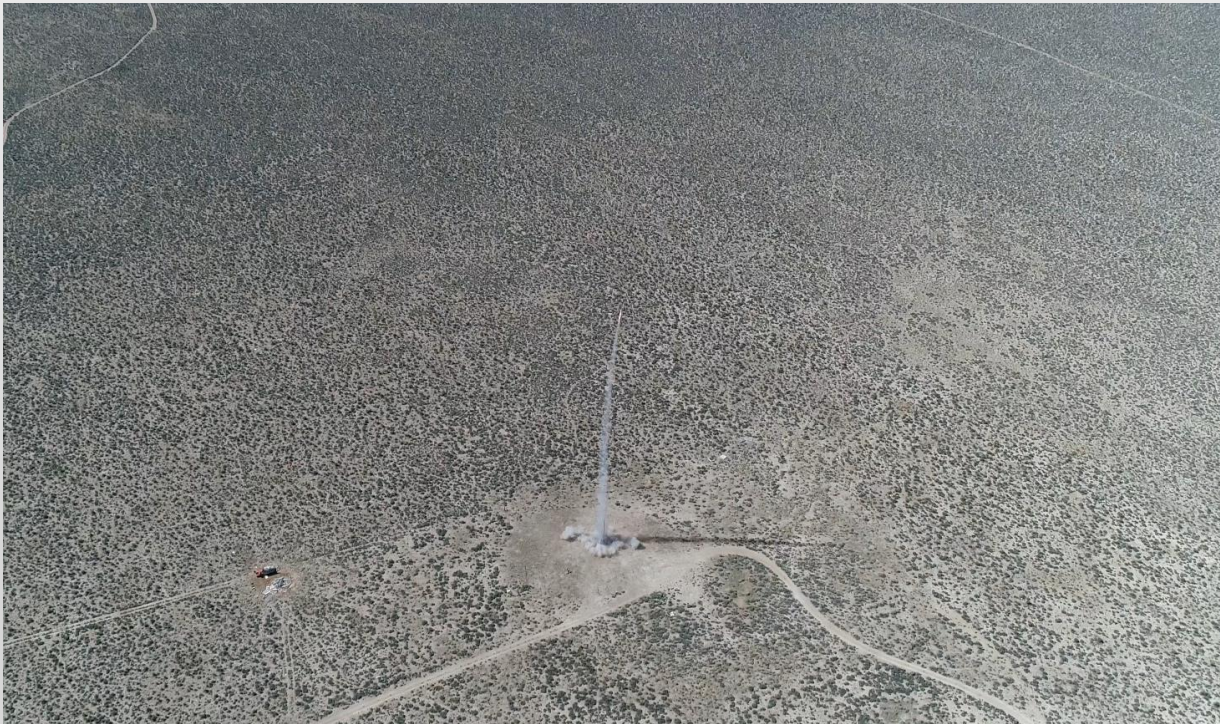
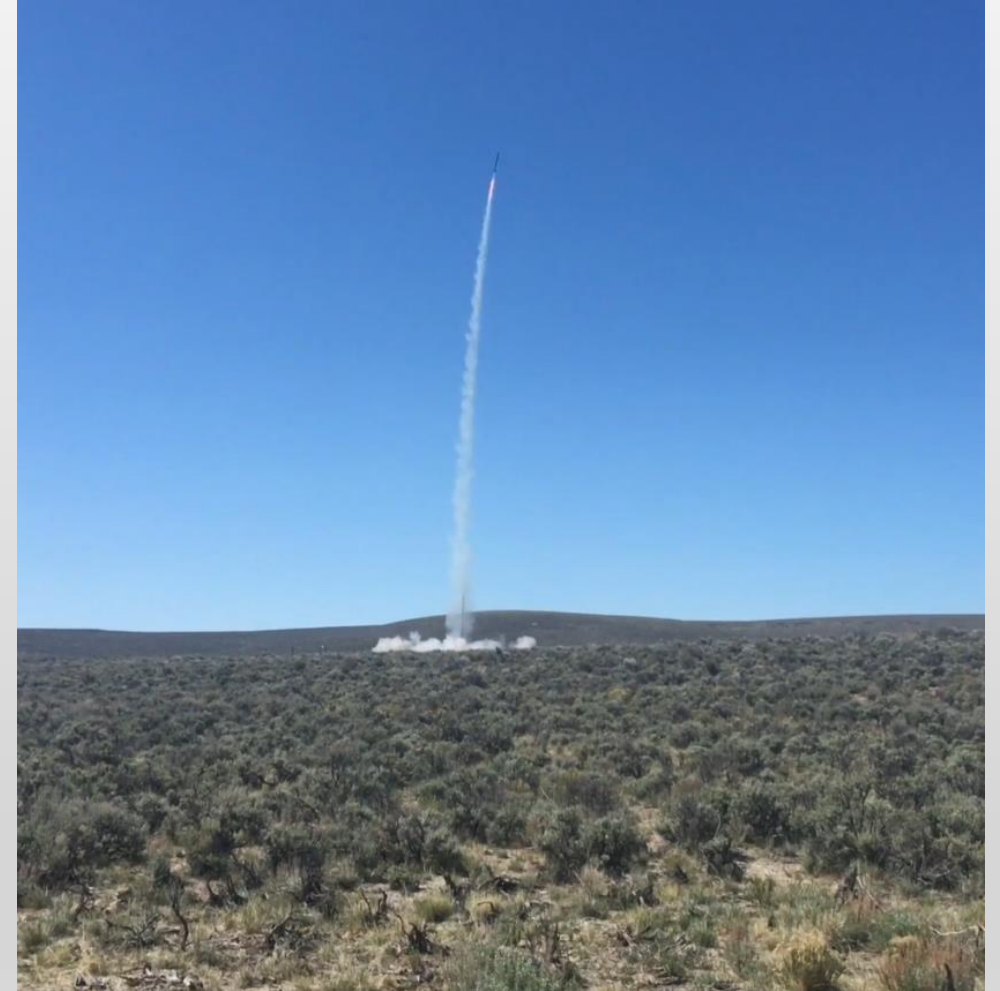
Test Launch

- The rocket performed well and was recovered with only cosmetic damage.

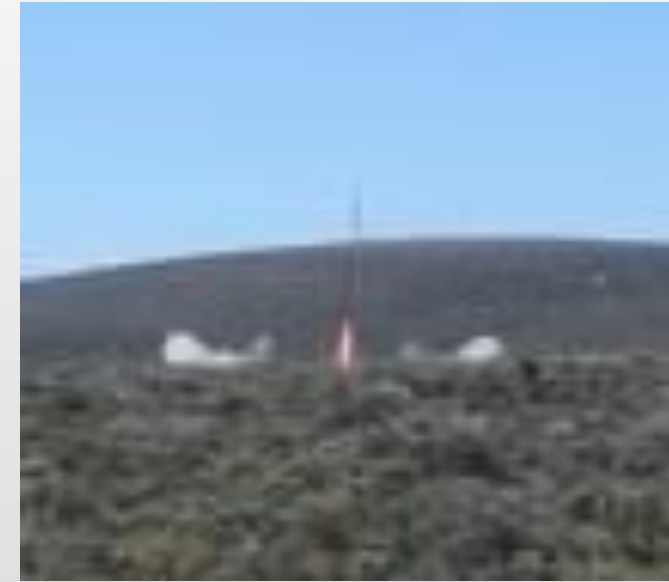
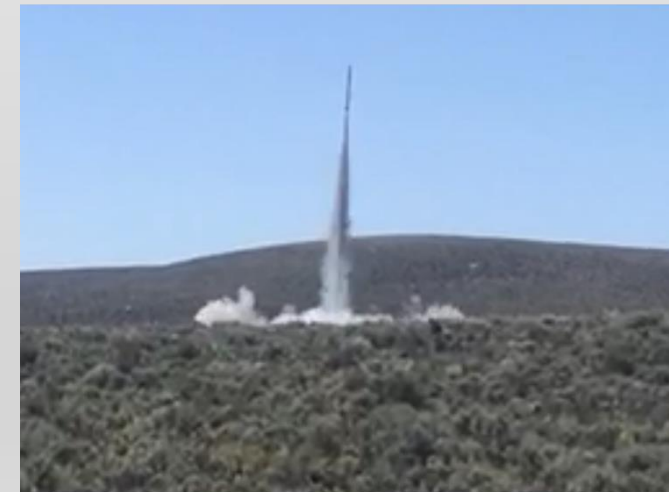
Test Launch

- Chuff off the rail at test launch (combustion instability) which caused the rocket to cock off of vertical
- Suspected cause: hardness of cured propellant
 - Several points lower compared to static test
 - Possibly shearing propellant and clogging the nozzle
- To mitigate, we changed how much curative we added to the propellant mixture for the competition mix.
- 32 seconds to reach 25,000ft, reached ~Mach 1.6

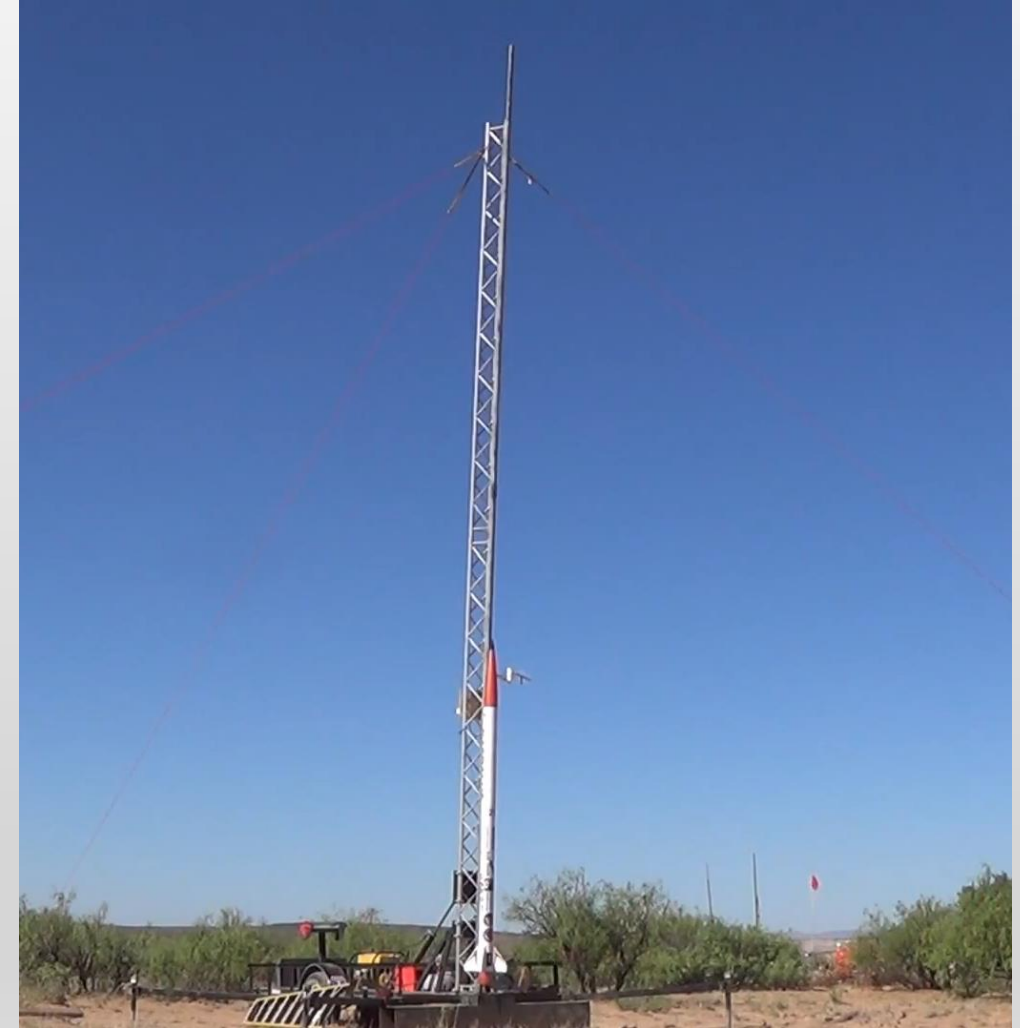
Competition

- Come time to launch, the team had high hopes that we would place well considering we received a 100% on the report score.
- All we had to do was to assemble and launch the rocket. (Something we had dry ran a dozen times)
- Rocket Specs:
27,000 ft AGL
101 lbs wet
12.5ft tall

- Against everyone's hopes and dreams the motor suffered a chuff (combustion instability) at about $t+1s$. The nozzle was ejected along with all of the propellant.
- The upper section of the airframe was shredded. Miraculously, the motor was still fixed to the lower airframe, but only just. The nose cone and payload were recovered with minimal damage.

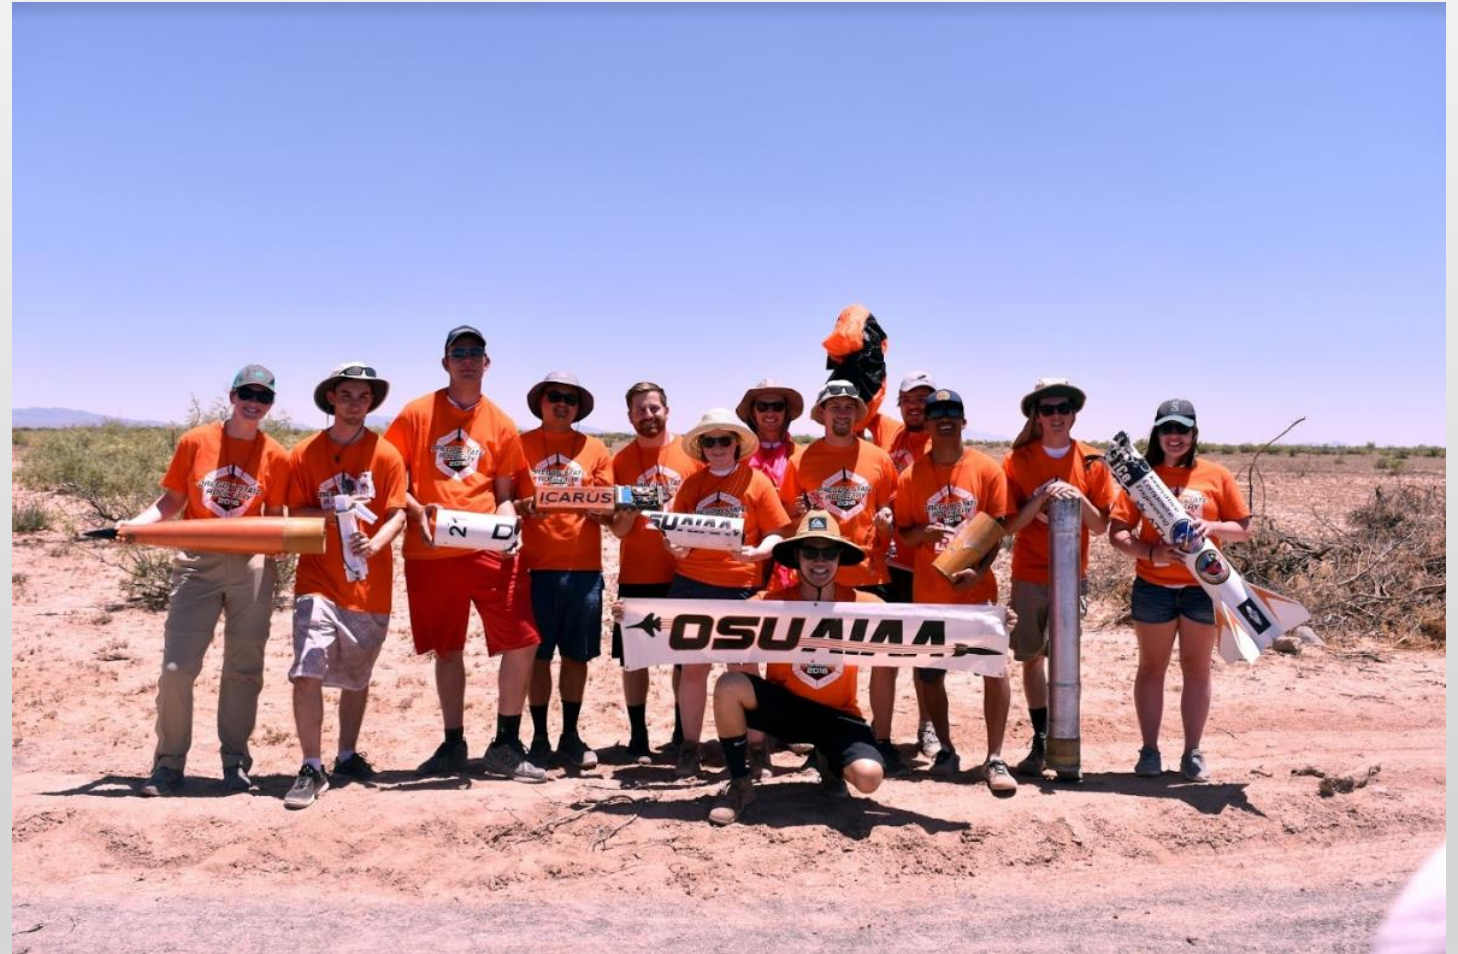
Competition

- What was left...
- The motor was still in one piece with little signs of yield

- The chuffing problem that the motor experienced in both launches was not unique to our team.
- Another rocketry team at OSU was experiencing similar problems
- After Spaceport America, our advisor had asked us to investigate.
- Decided that the reason for chuffing was the ammonium perchlorate quality. (Our source was bad)
- I left for graduate school three weeks before the test, but it was successful: no chuff.
