Operating noise

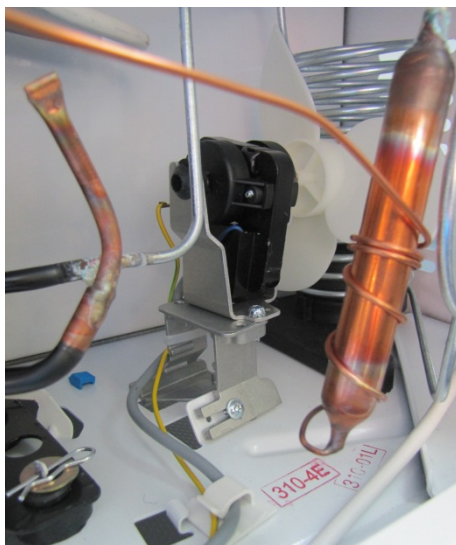
Fault profile: The fan in the compressor recess makes a perceptible operating noise.

To correct: The fan 9870 587 can be installed instead of the standard series fan.
