Posterior Bridge Mrs B

Intra Oral Photos 10/4/12

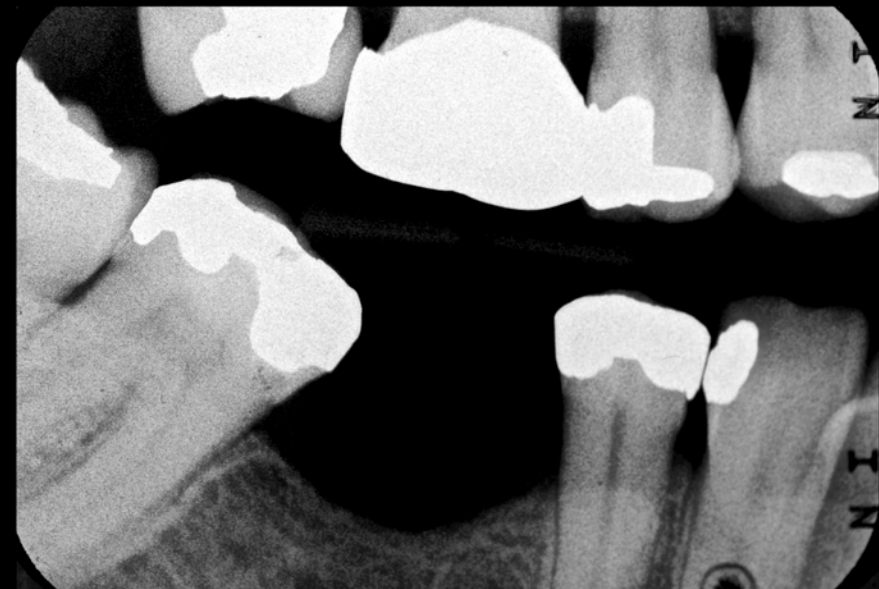
Radiograph

There was one bitewing and an IOPA of the lower right quadrant taken, unfortunately the IOPA has been mislaid. The bitewing shows;

- mild horizontal bone loss with localised bone loss where 45 was lost
- 16 has a huge overhang at the distal of the crown which will need replaced
- 15, 44 and 46 are heavily filled

It was decided to restore 44 and 46 which were heavily filled. These teeth required occlusal protection and indirect restorations with full occlusal coverage were indicated. The issue of the missing tooth 45 was discussed. As a implant was not an option due to Mrs B's desire to avoid surgery it was decided to place a 3 unit bridge. Given the huge variation in angulation's it was decided to make the bridge fixed movable. It was also felt that to keep the preparation on the 46 as minimal as possible a gold crown would be used as a retainer. The restoration was to be constructed within the existing occlusal scheme.

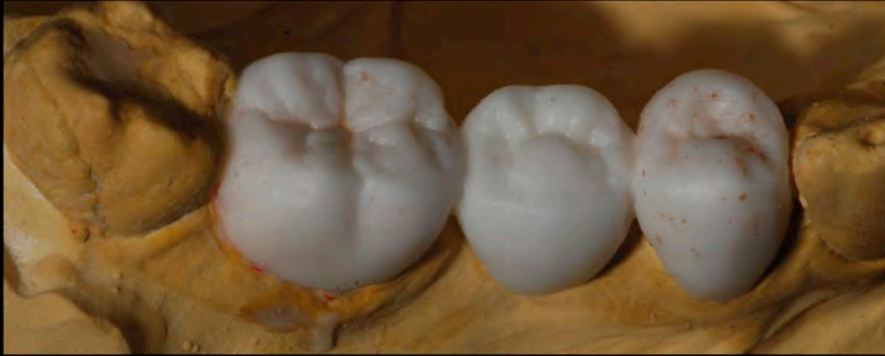
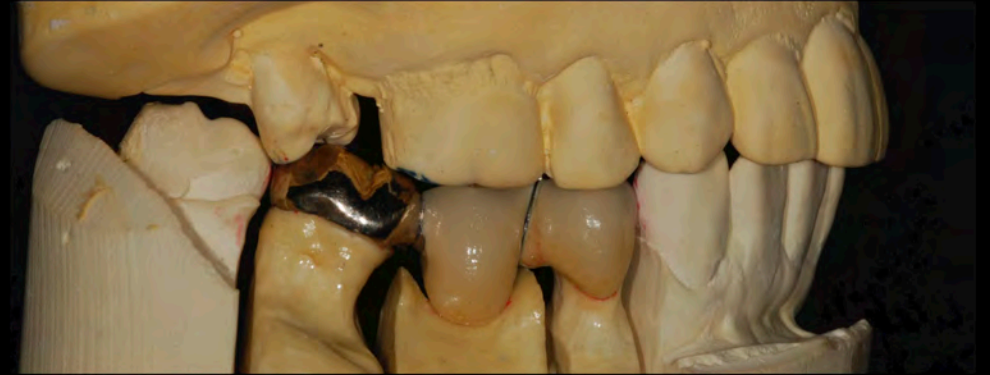
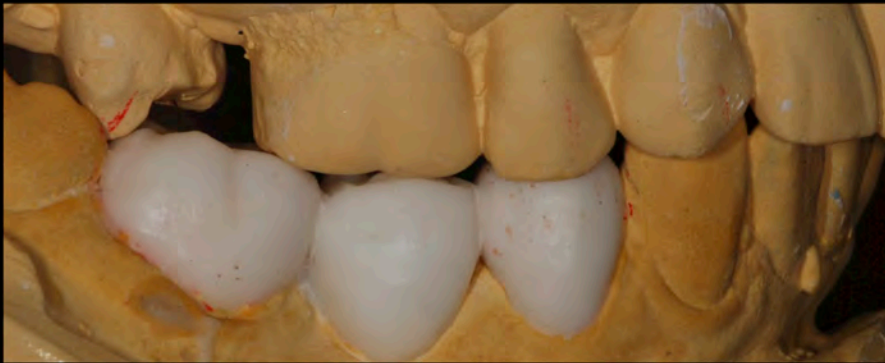
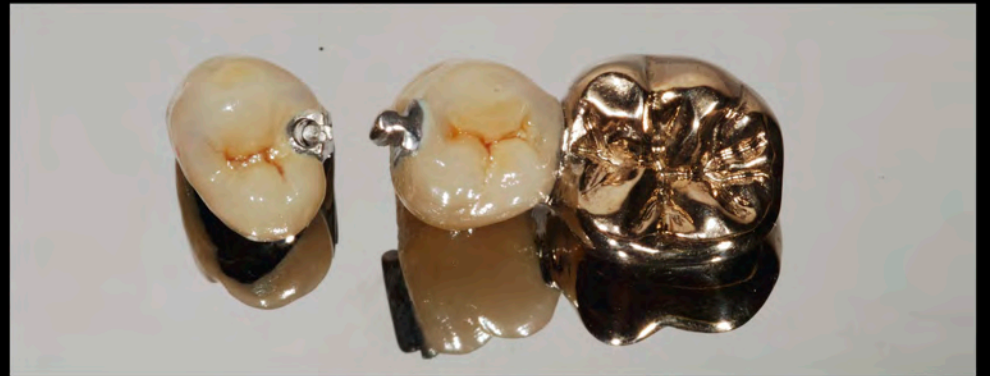
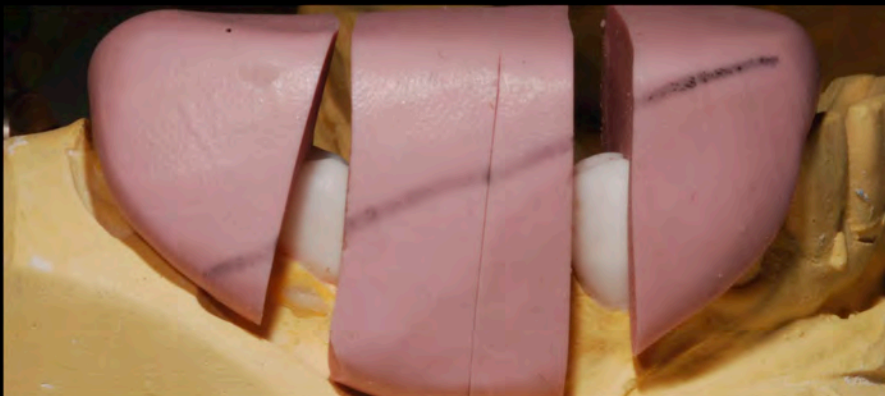
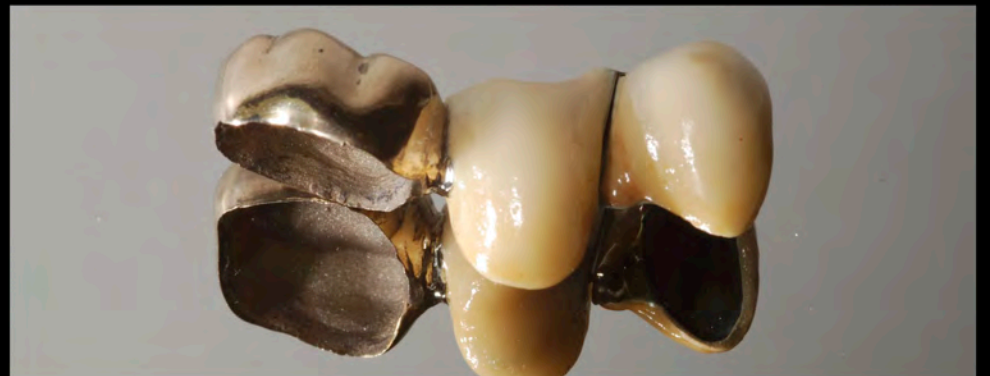
Construction of Fixed Movable Bridge

- 2 sets of articulated study models were constructed, one with a diagnostic wax up of the proposed 3 unit bridge
 - several putty indexes were constructed and sectioned
- teeth 44 and 46 were prepared for the bridge using the putty index's as a guide
- teeth 44 and 46 were temporised using a silicone index, this helped to highlight any areas still under prepared however due to the angulations it was not possible to remove it to adjust the margins.
- provisional restoration removed and preparations refined.
 - impressions and facebow taken
- bridge inserted using zinc phosphate, several areas of the preparations were eased slightly as per reduction guide to ease placement.
 - no adjustments to bridge required, original occlusion reestablished with right lateral guidance on 43 and 44 and the same centric stops on 43 and 47

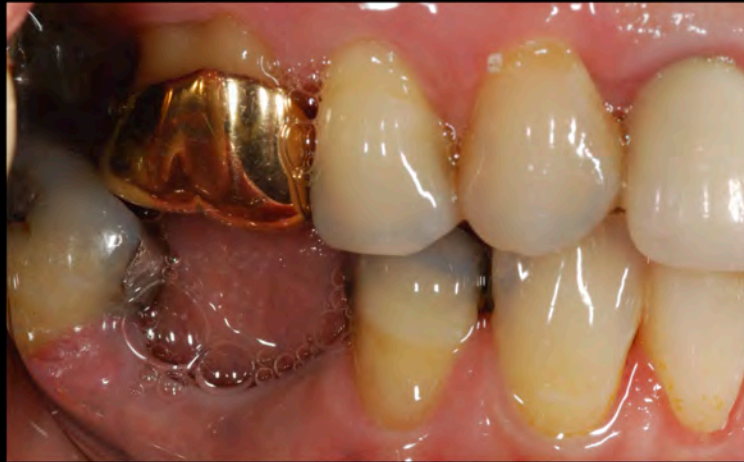
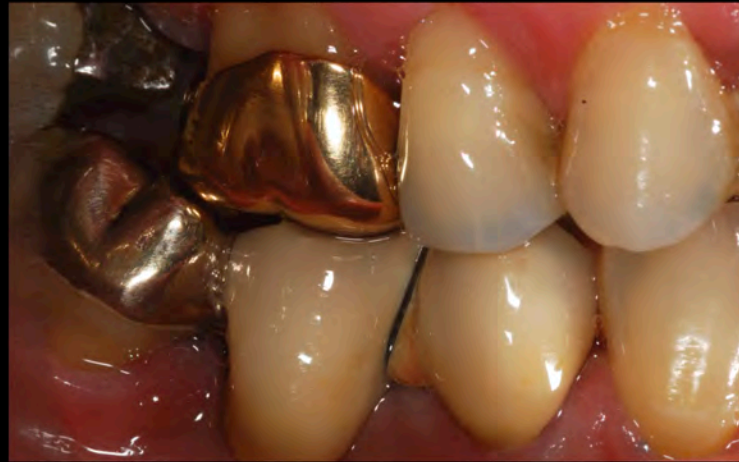
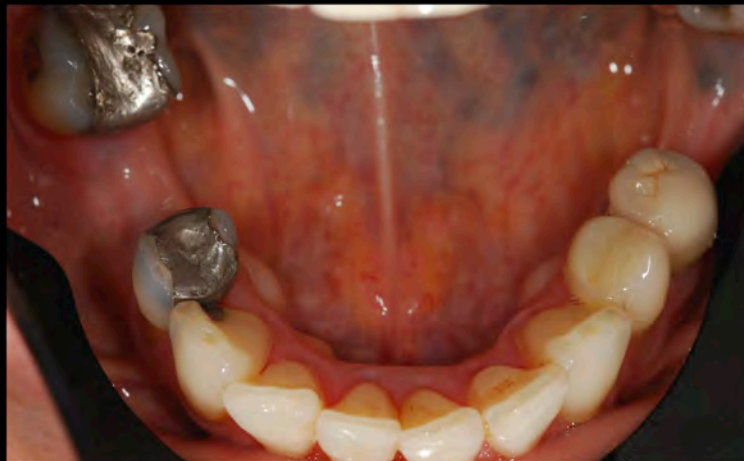
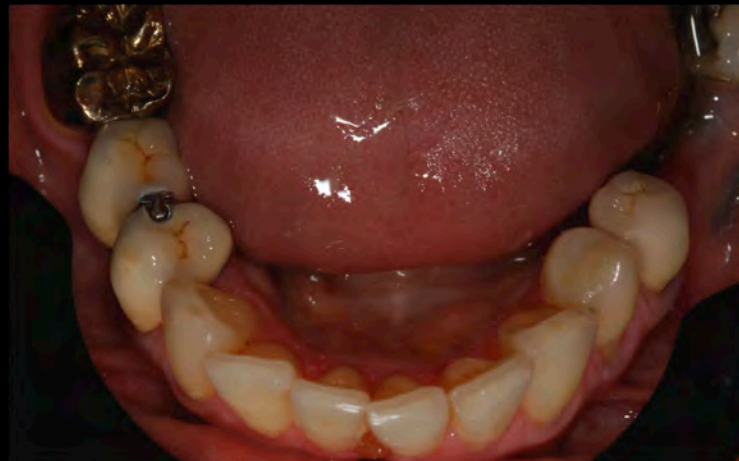
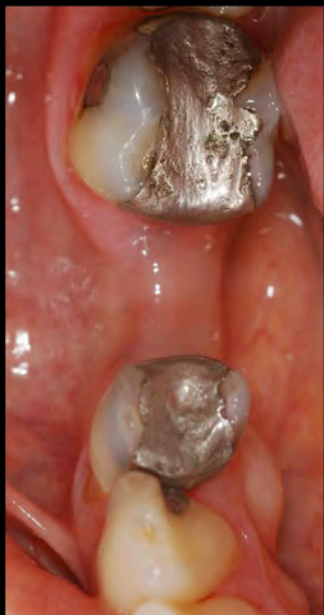
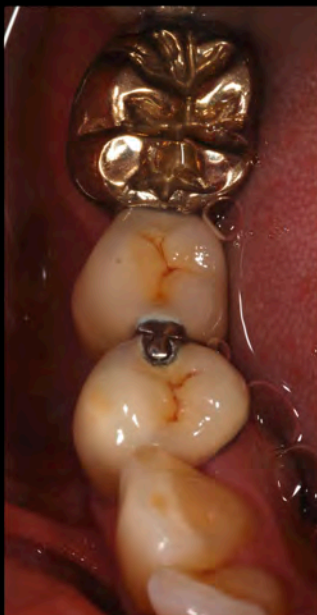
Final Result

This was a challenging case given the very different angulations of the teeth involved and the restricted access. The technician also found this quite a challenging case due to the angulations involved and the materials used. He had to get a special gold alloy that could be soldered to and the incorporation of the fixed movable joint made this more difficult.

Ideally the fixed movable joint would have been within the distal of the 44, however given the angulations involved this was not possible.

Despite all this a good result was achieved, one that the patient is very happy with.

Restorations were also required on 43 and 47 as decay was noted after the teeth had been prepared.
